# **Industrial Stormwater Success Stories: From Clueless to Superstars**

18<sup>th</sup> Annual USEPA Region 6 SW/MS4 Conference

Kerri McCabe, Inspector Supervisor

ADEQ – Office of Water Quality

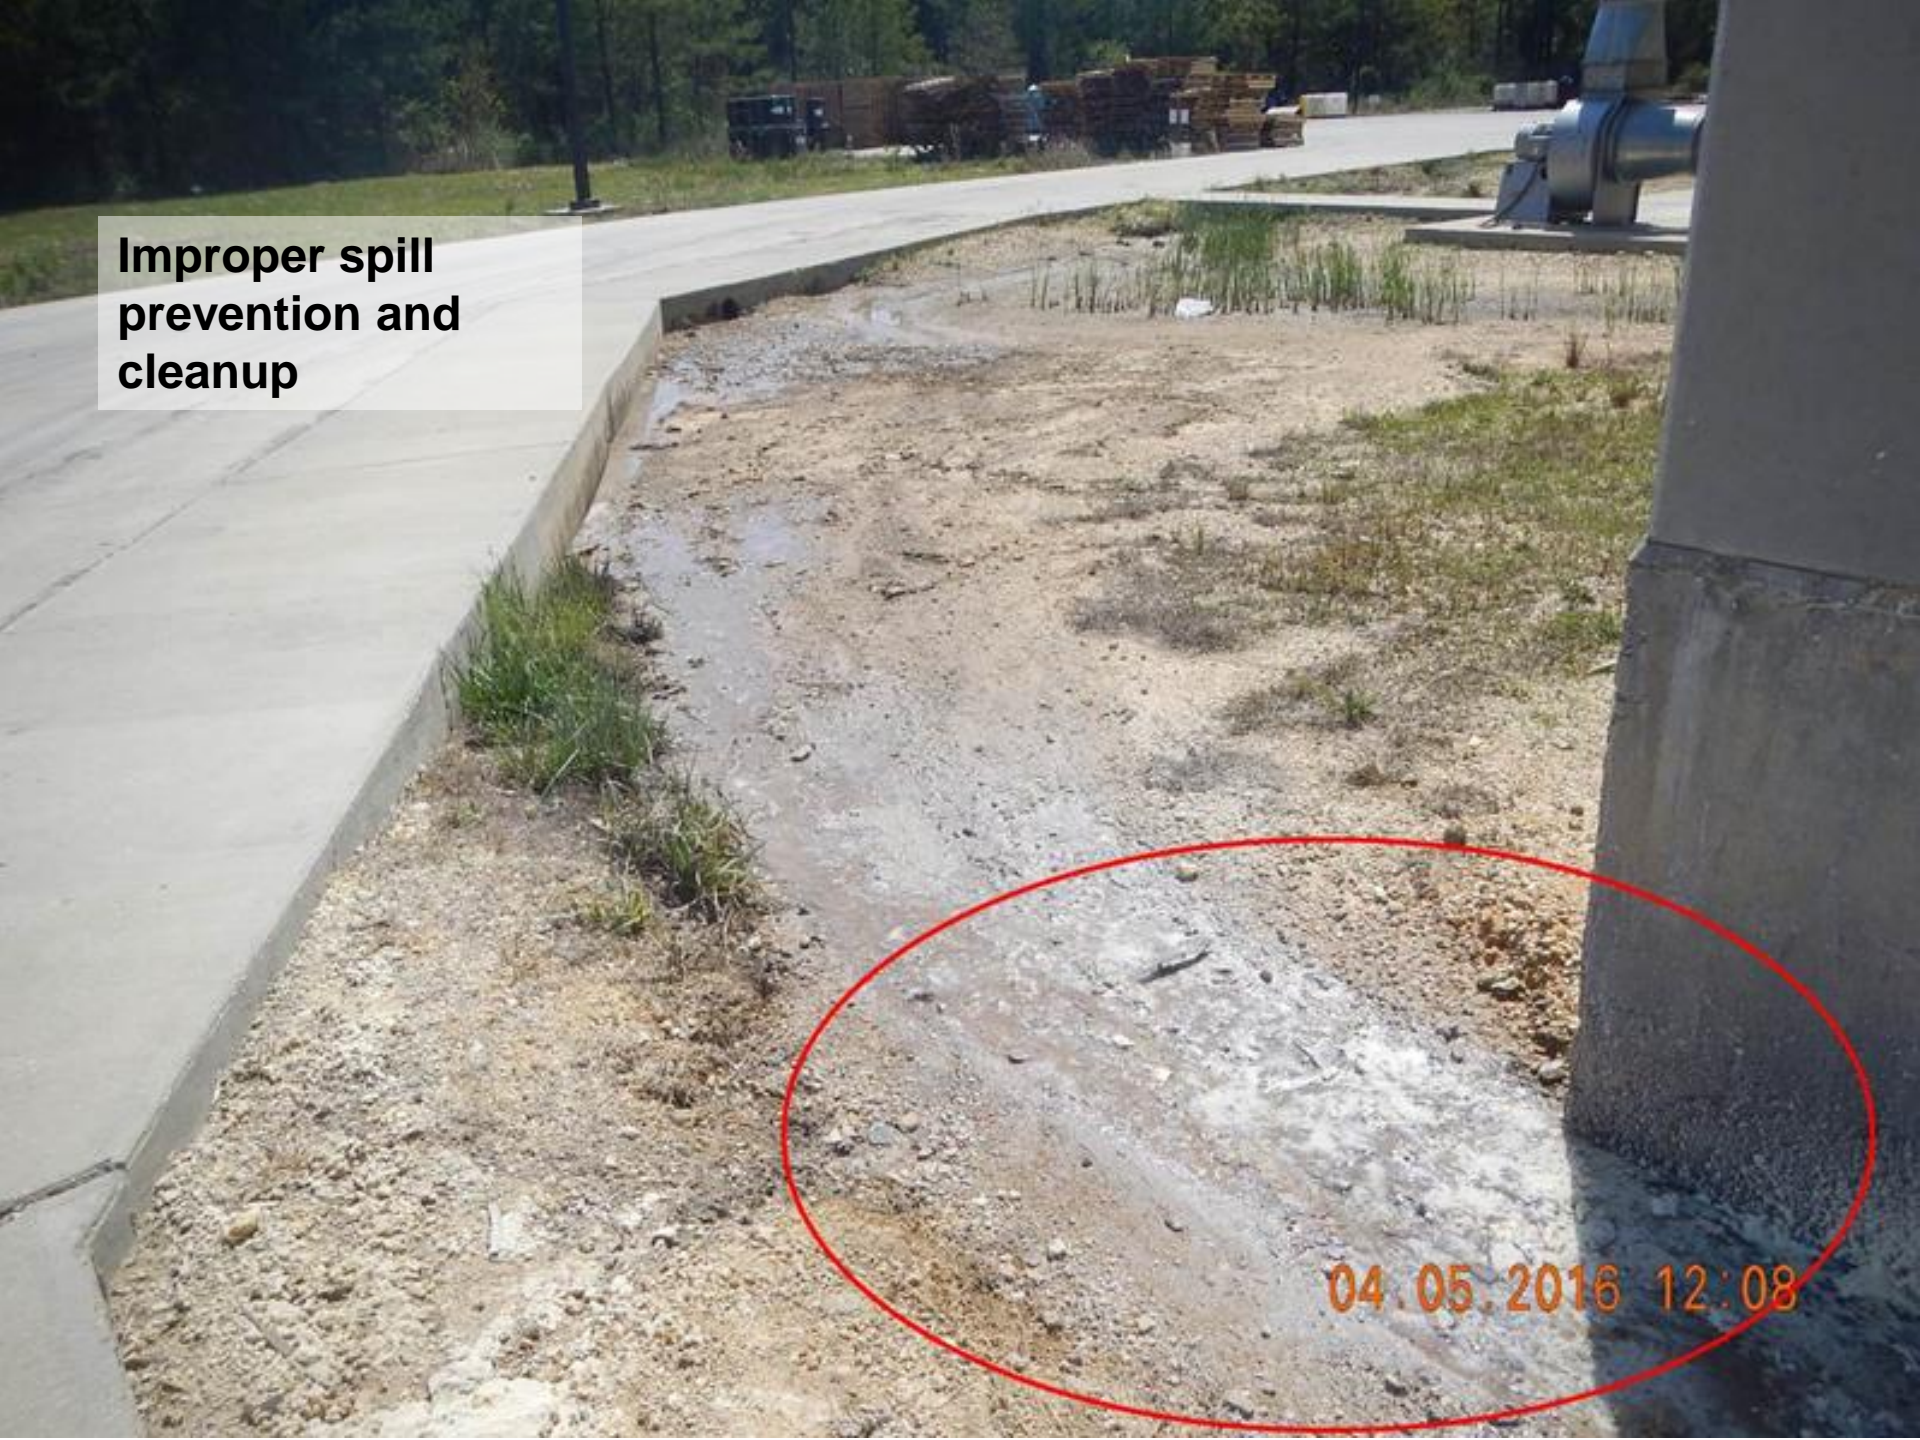
**Improper spill  
prevention and  
cleanup**

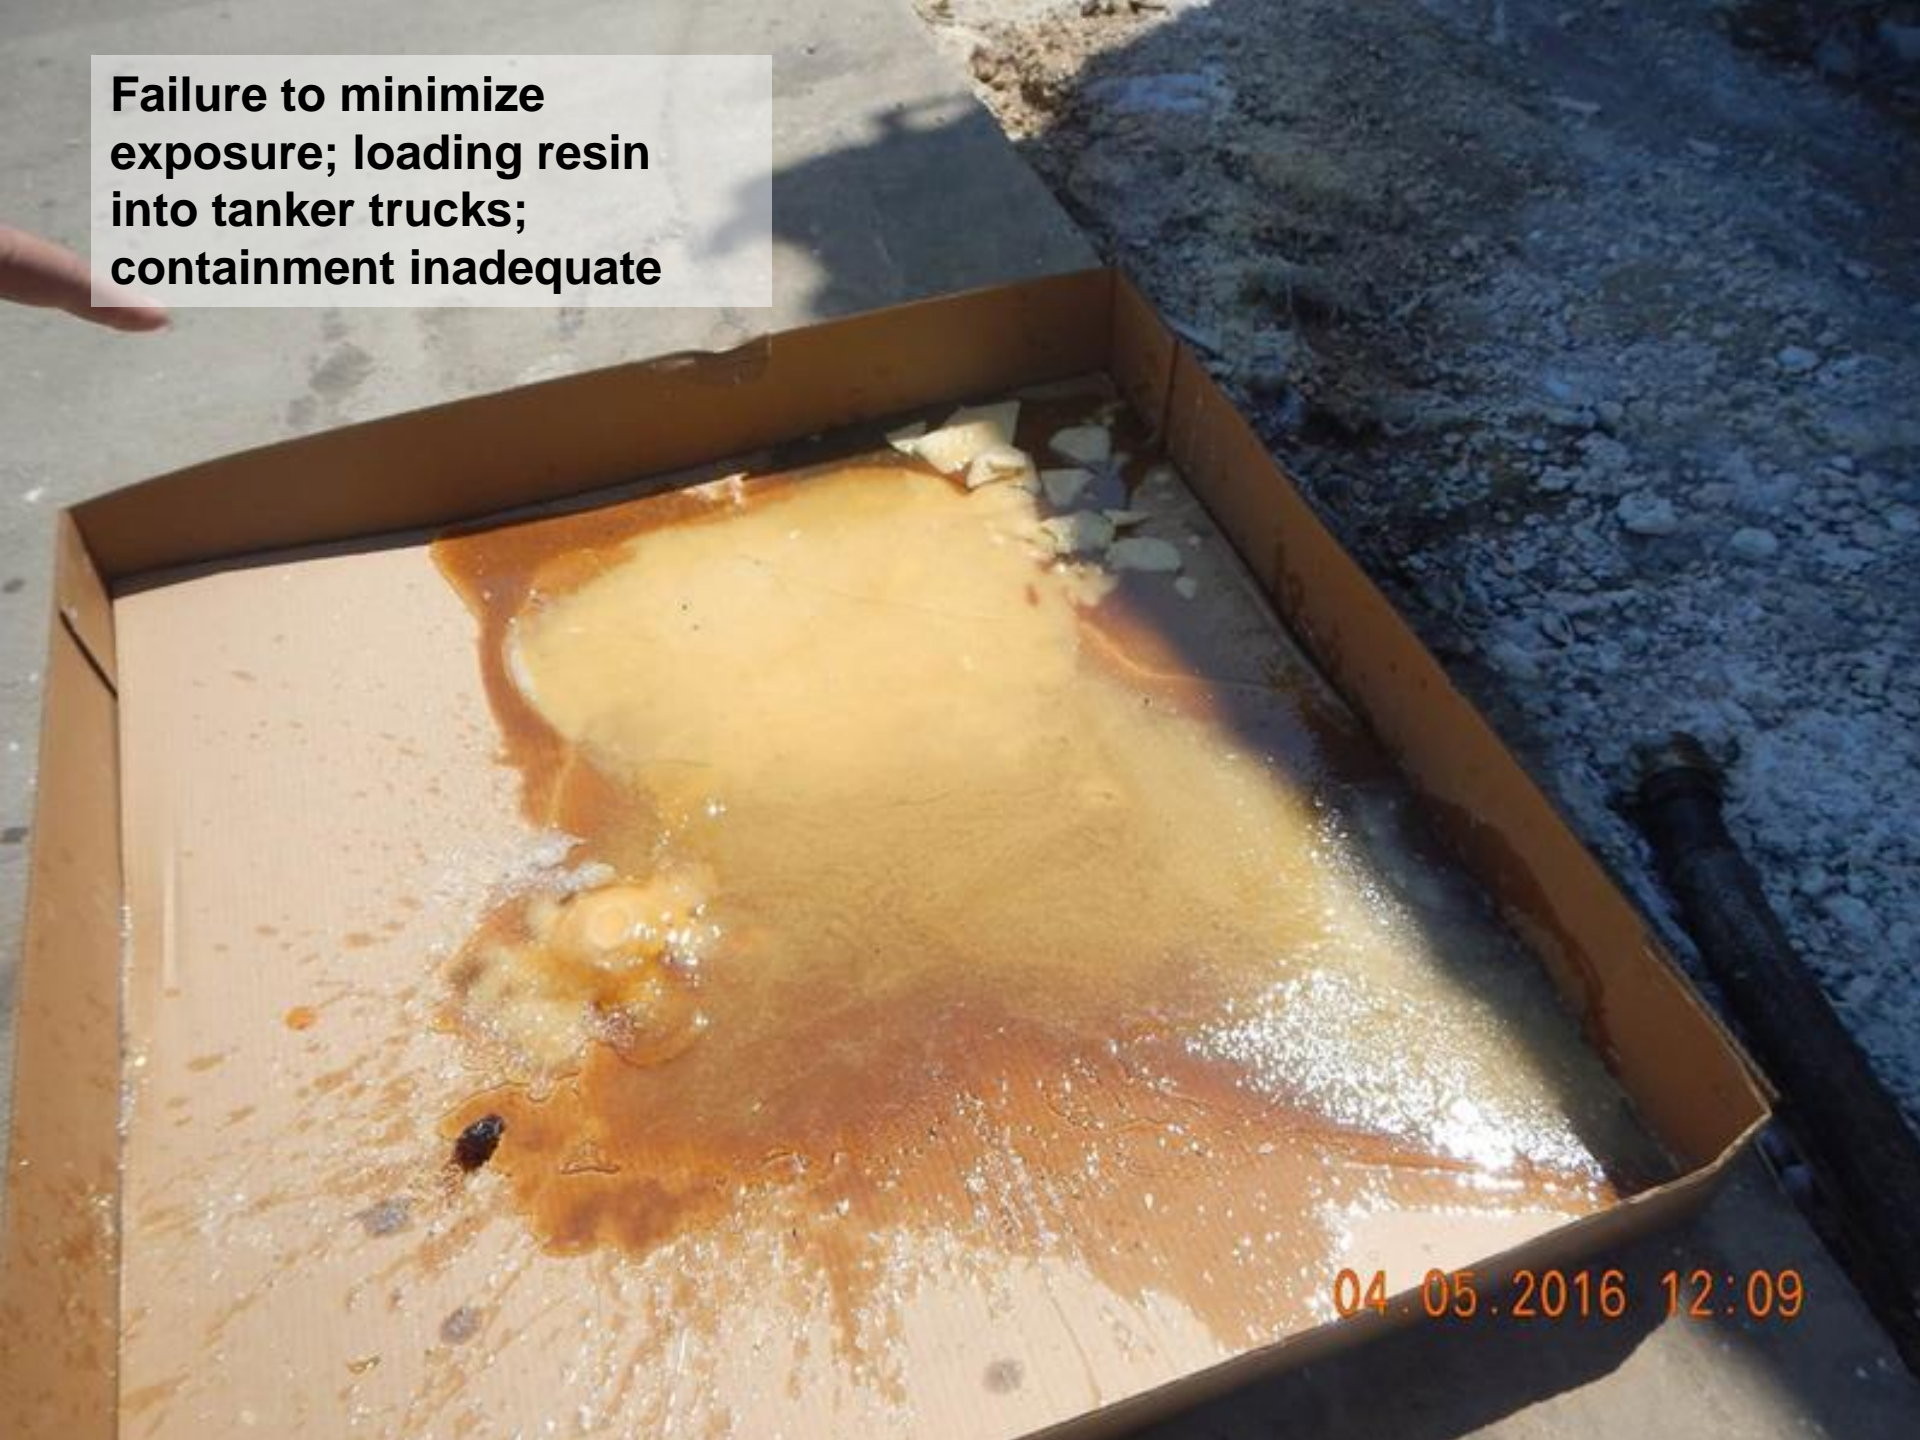
**Failure to minimize  
exposure; loading resin  
into tanker trucks;  
containment inadequate**

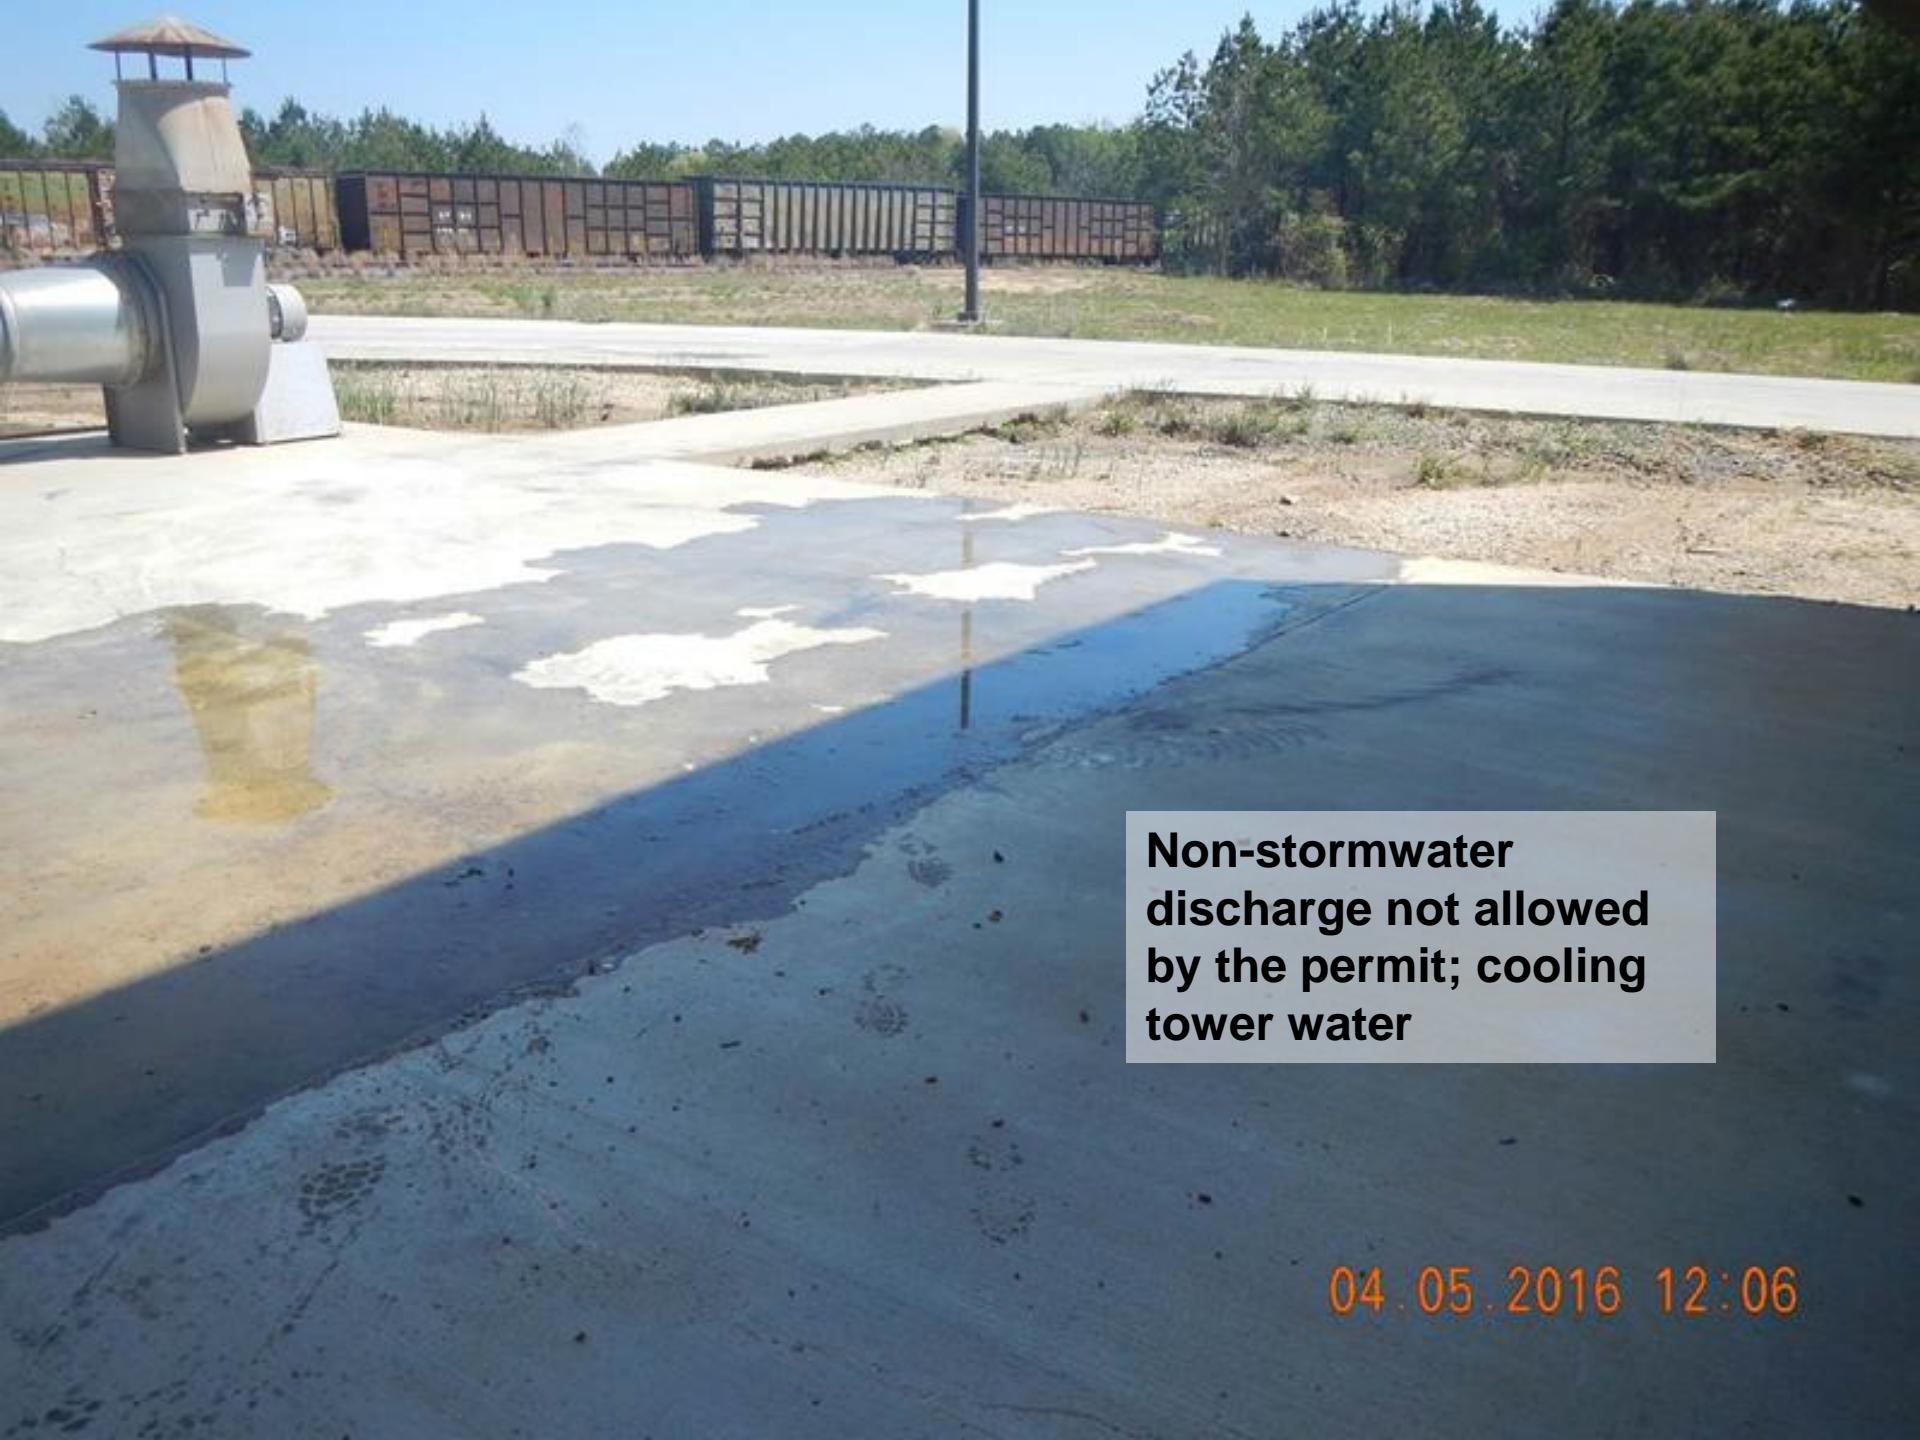
**Non-stormwater  
discharge not allowed  
by the permit; cooling  
tower water**

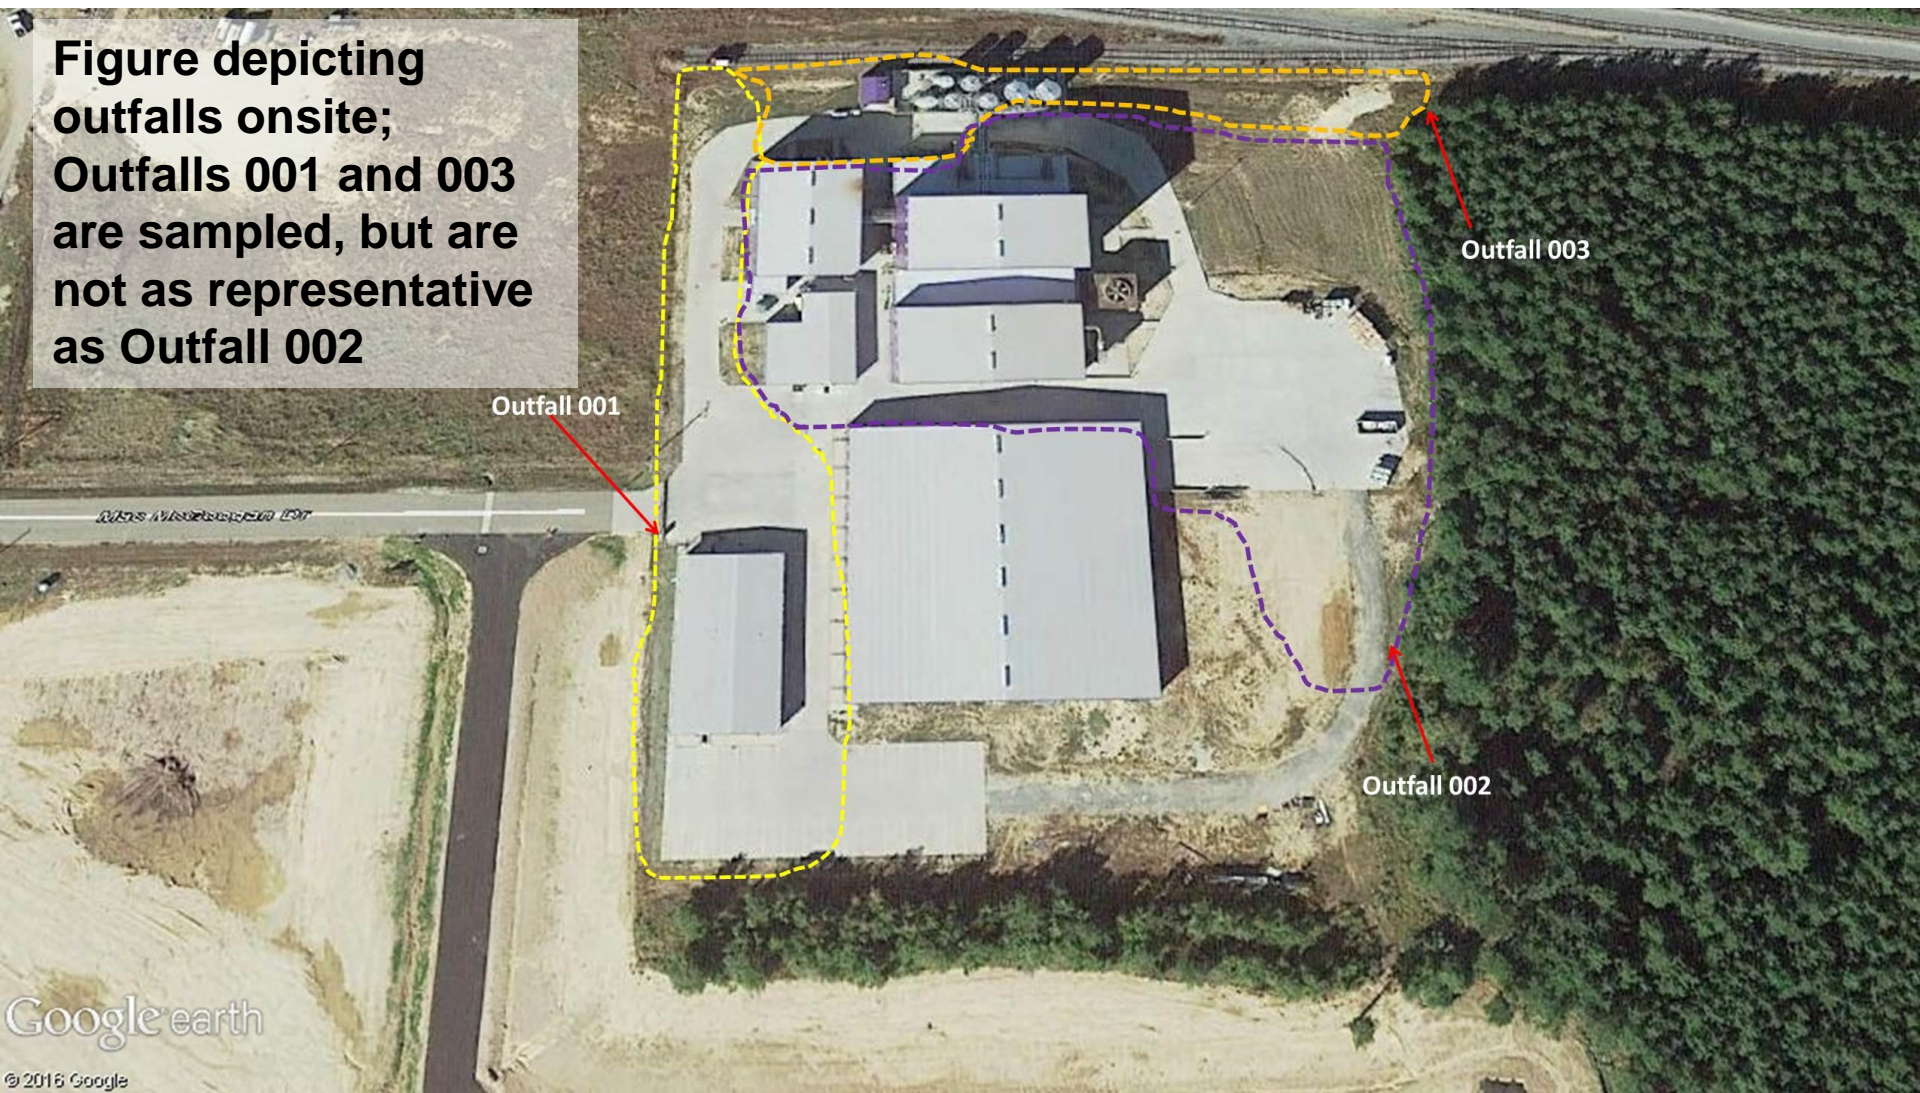
**Figure depicting  
outfalls onsite;  
Outfalls 001 and 003  
are sampled, but are  
not as representative  
as Outfall 002**

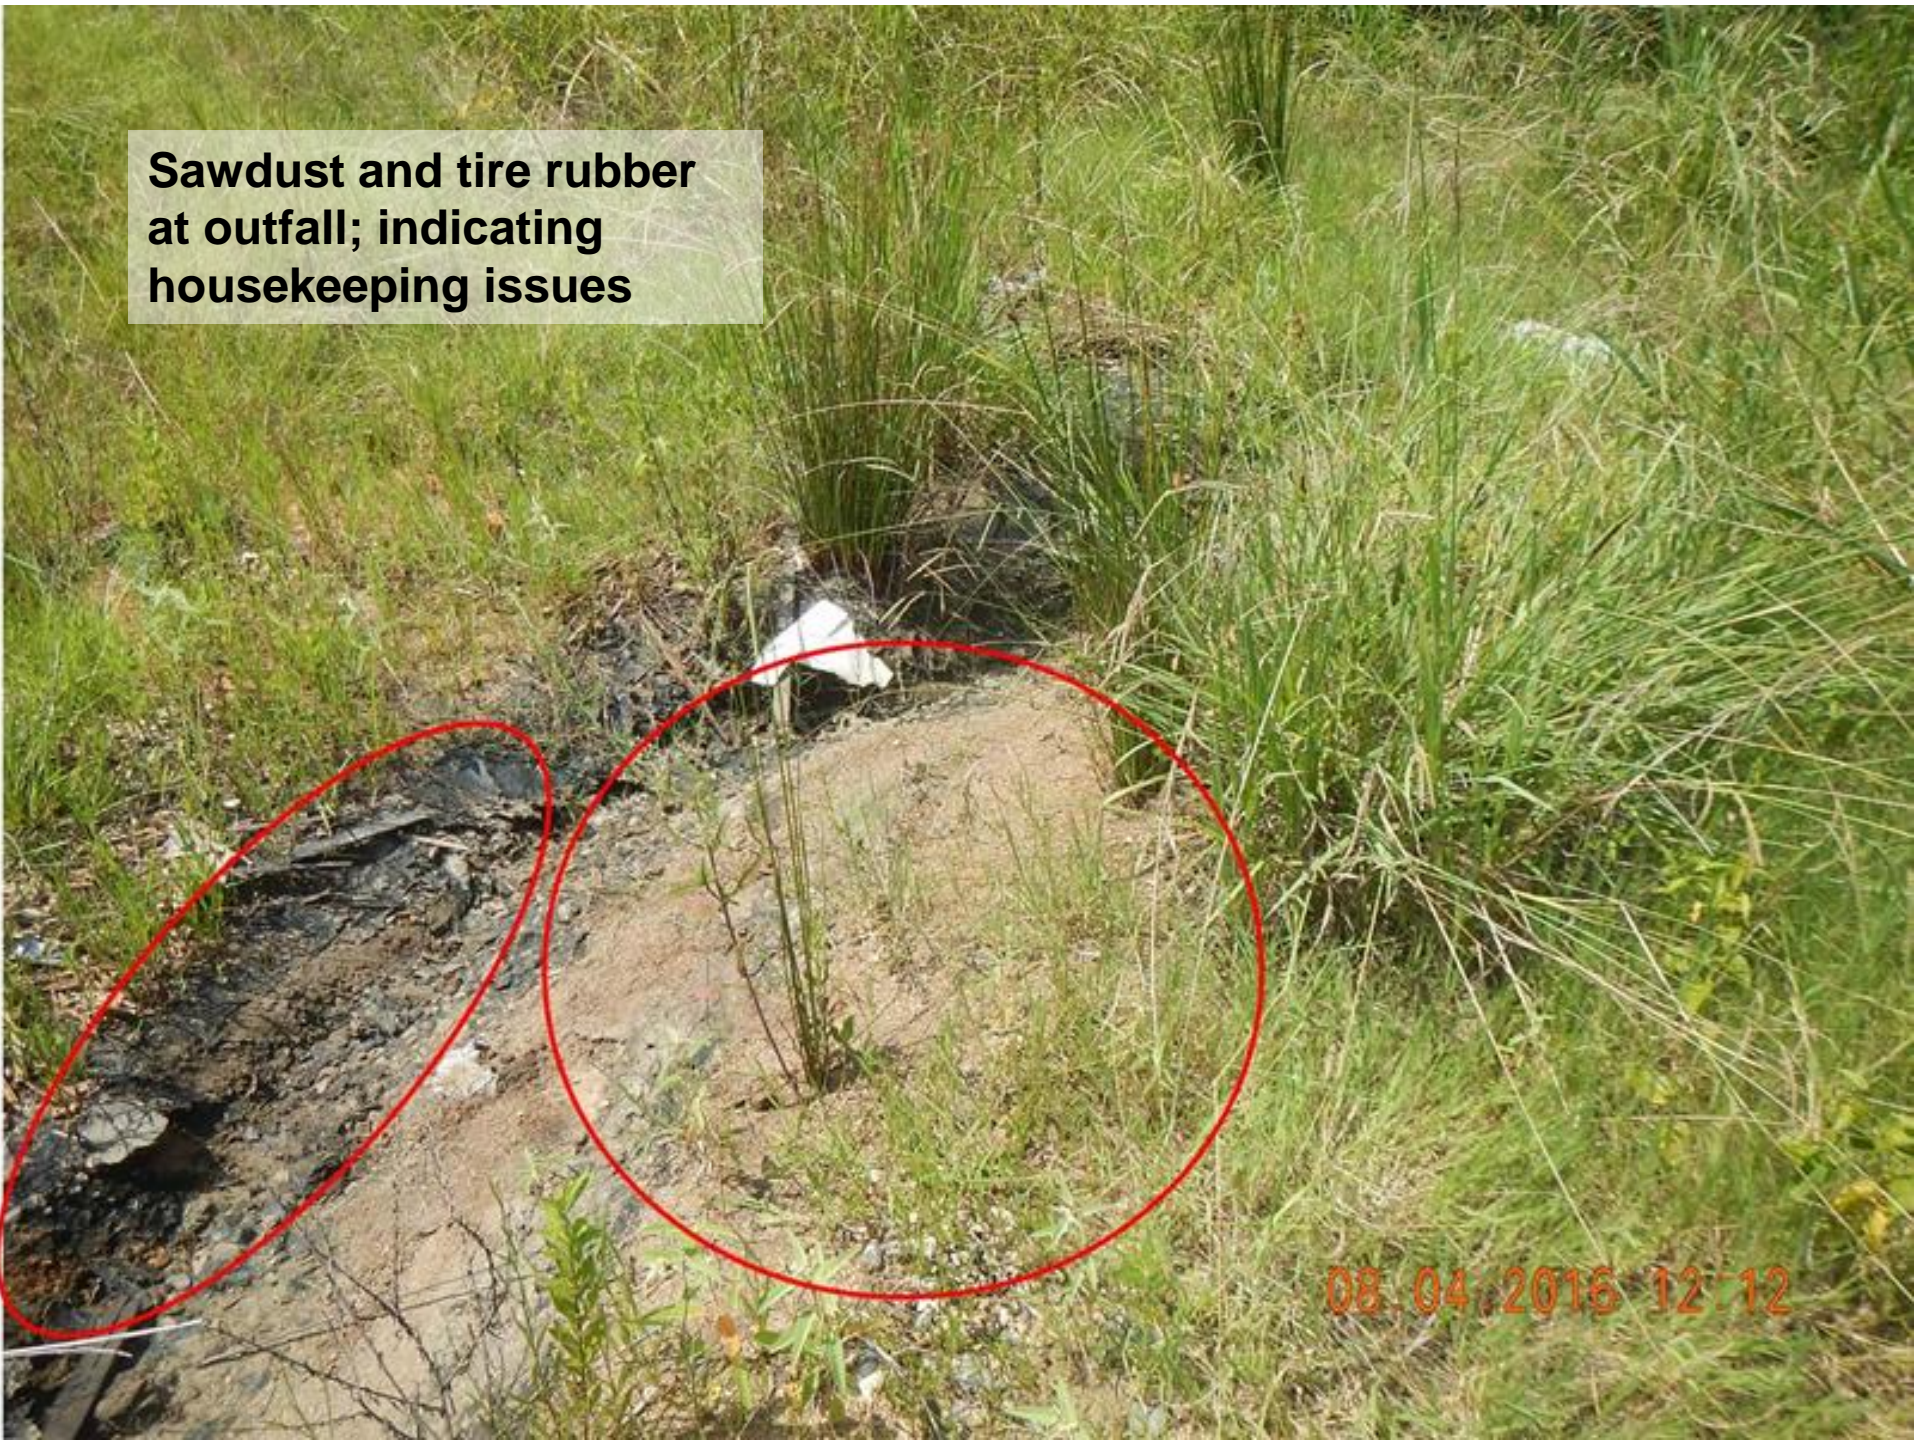
**Sawdust and tire rubber  
at outfall; indicating  
housekeeping issues**

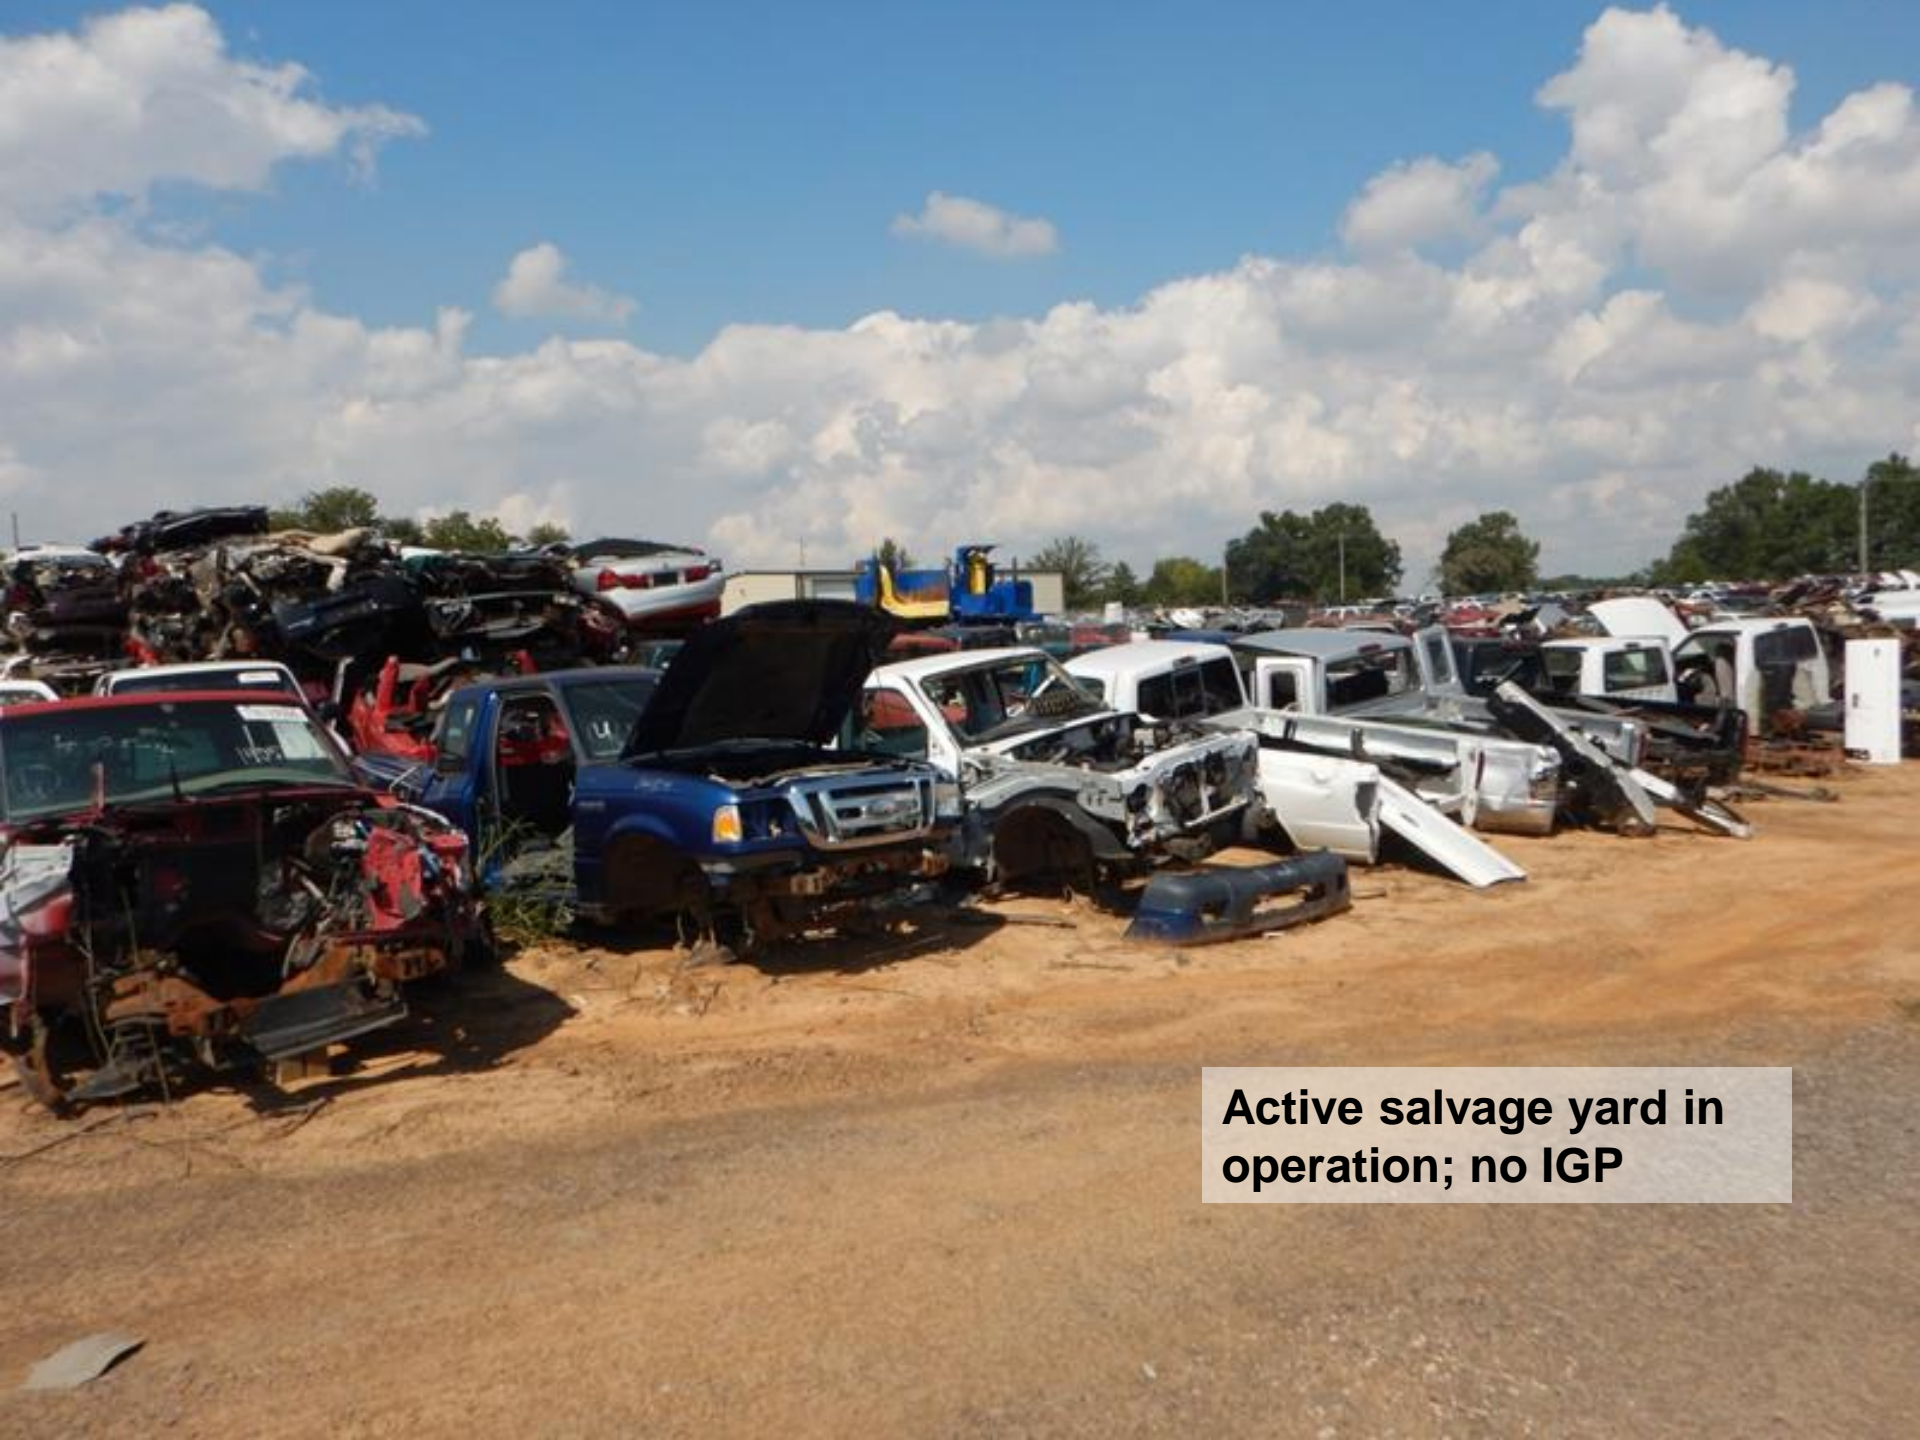
**Active salvage yard in  
operation; no IGP**

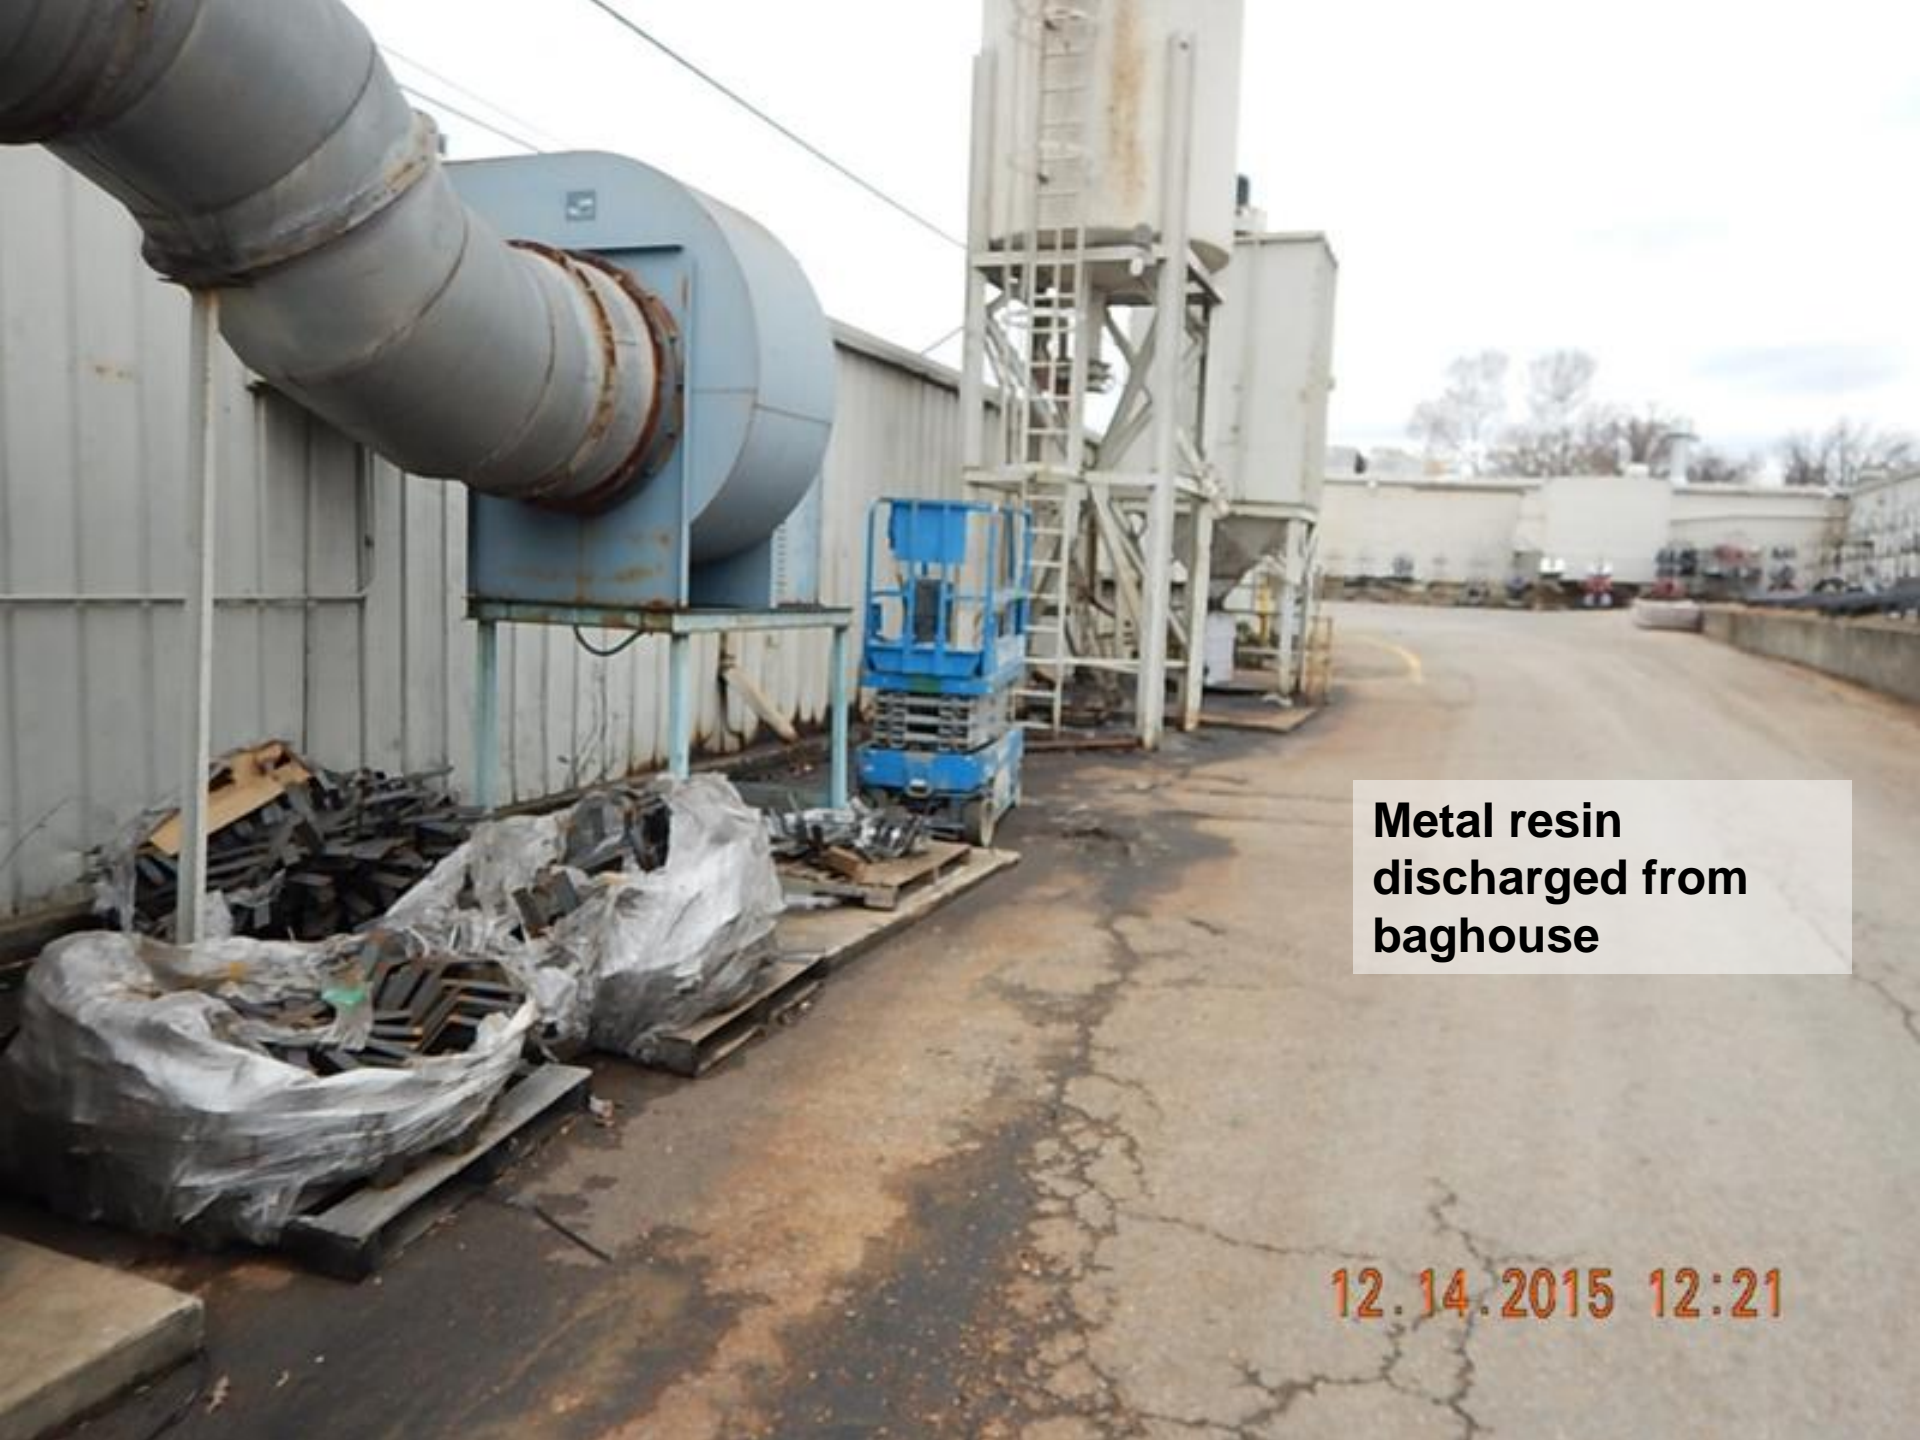
**Metal resin  
discharged from  
baghouse**

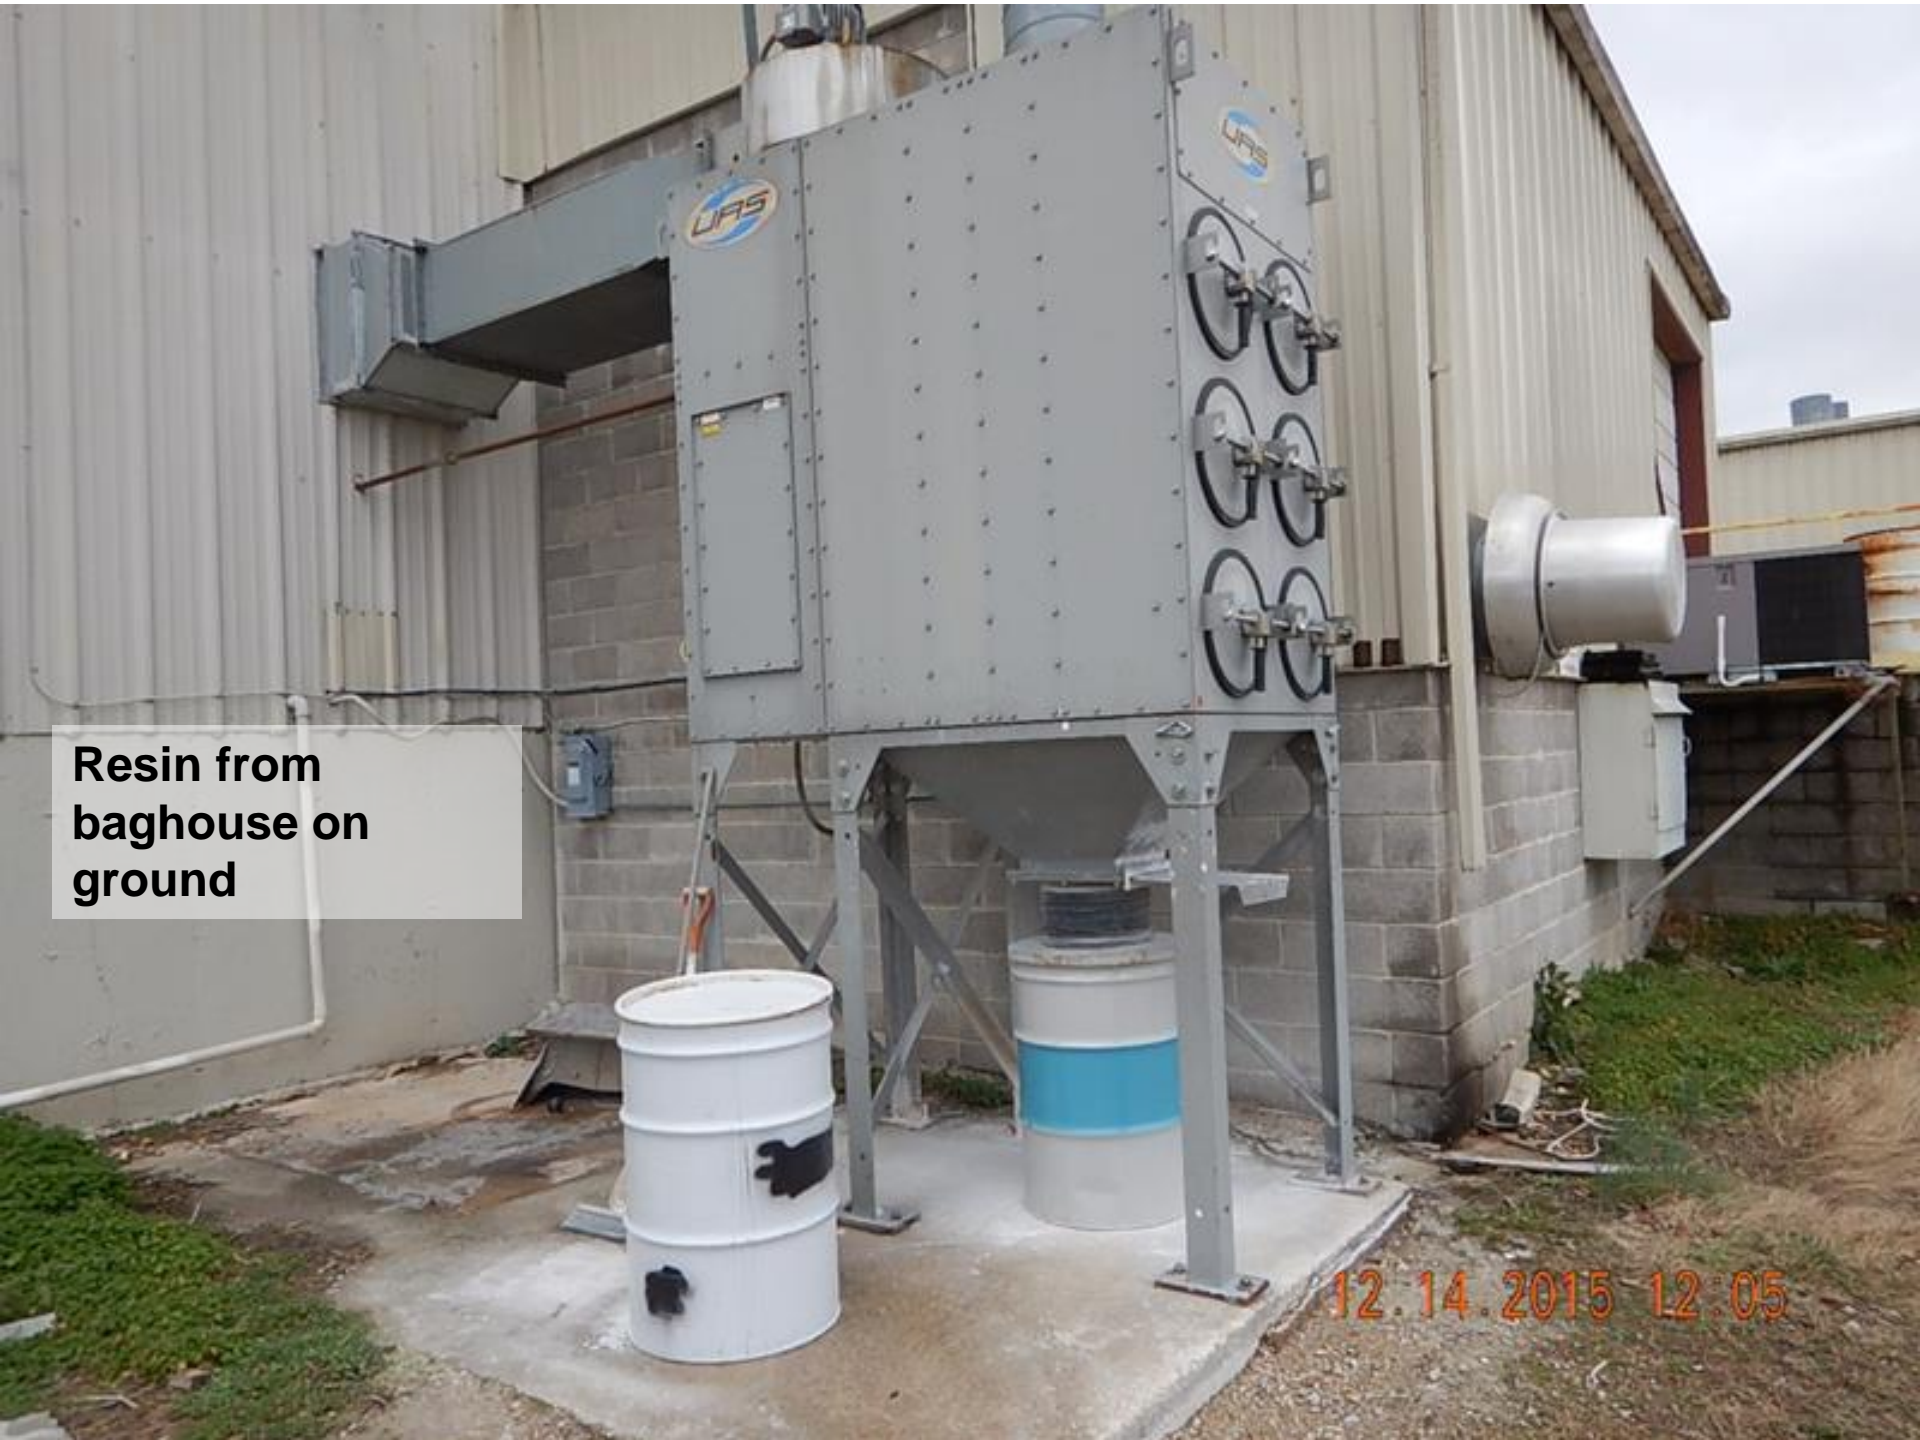
**Resin from  
baghouse on  
ground**
