# **Industrial Stormwater Success Stories: From Clueless to Superstars**

18<sup>th</sup> Annual USEPA Region 6 SW/MS4 Conference

Kerri McCabe, Inspector Supervisor

ADEQ – Office of Water Quality

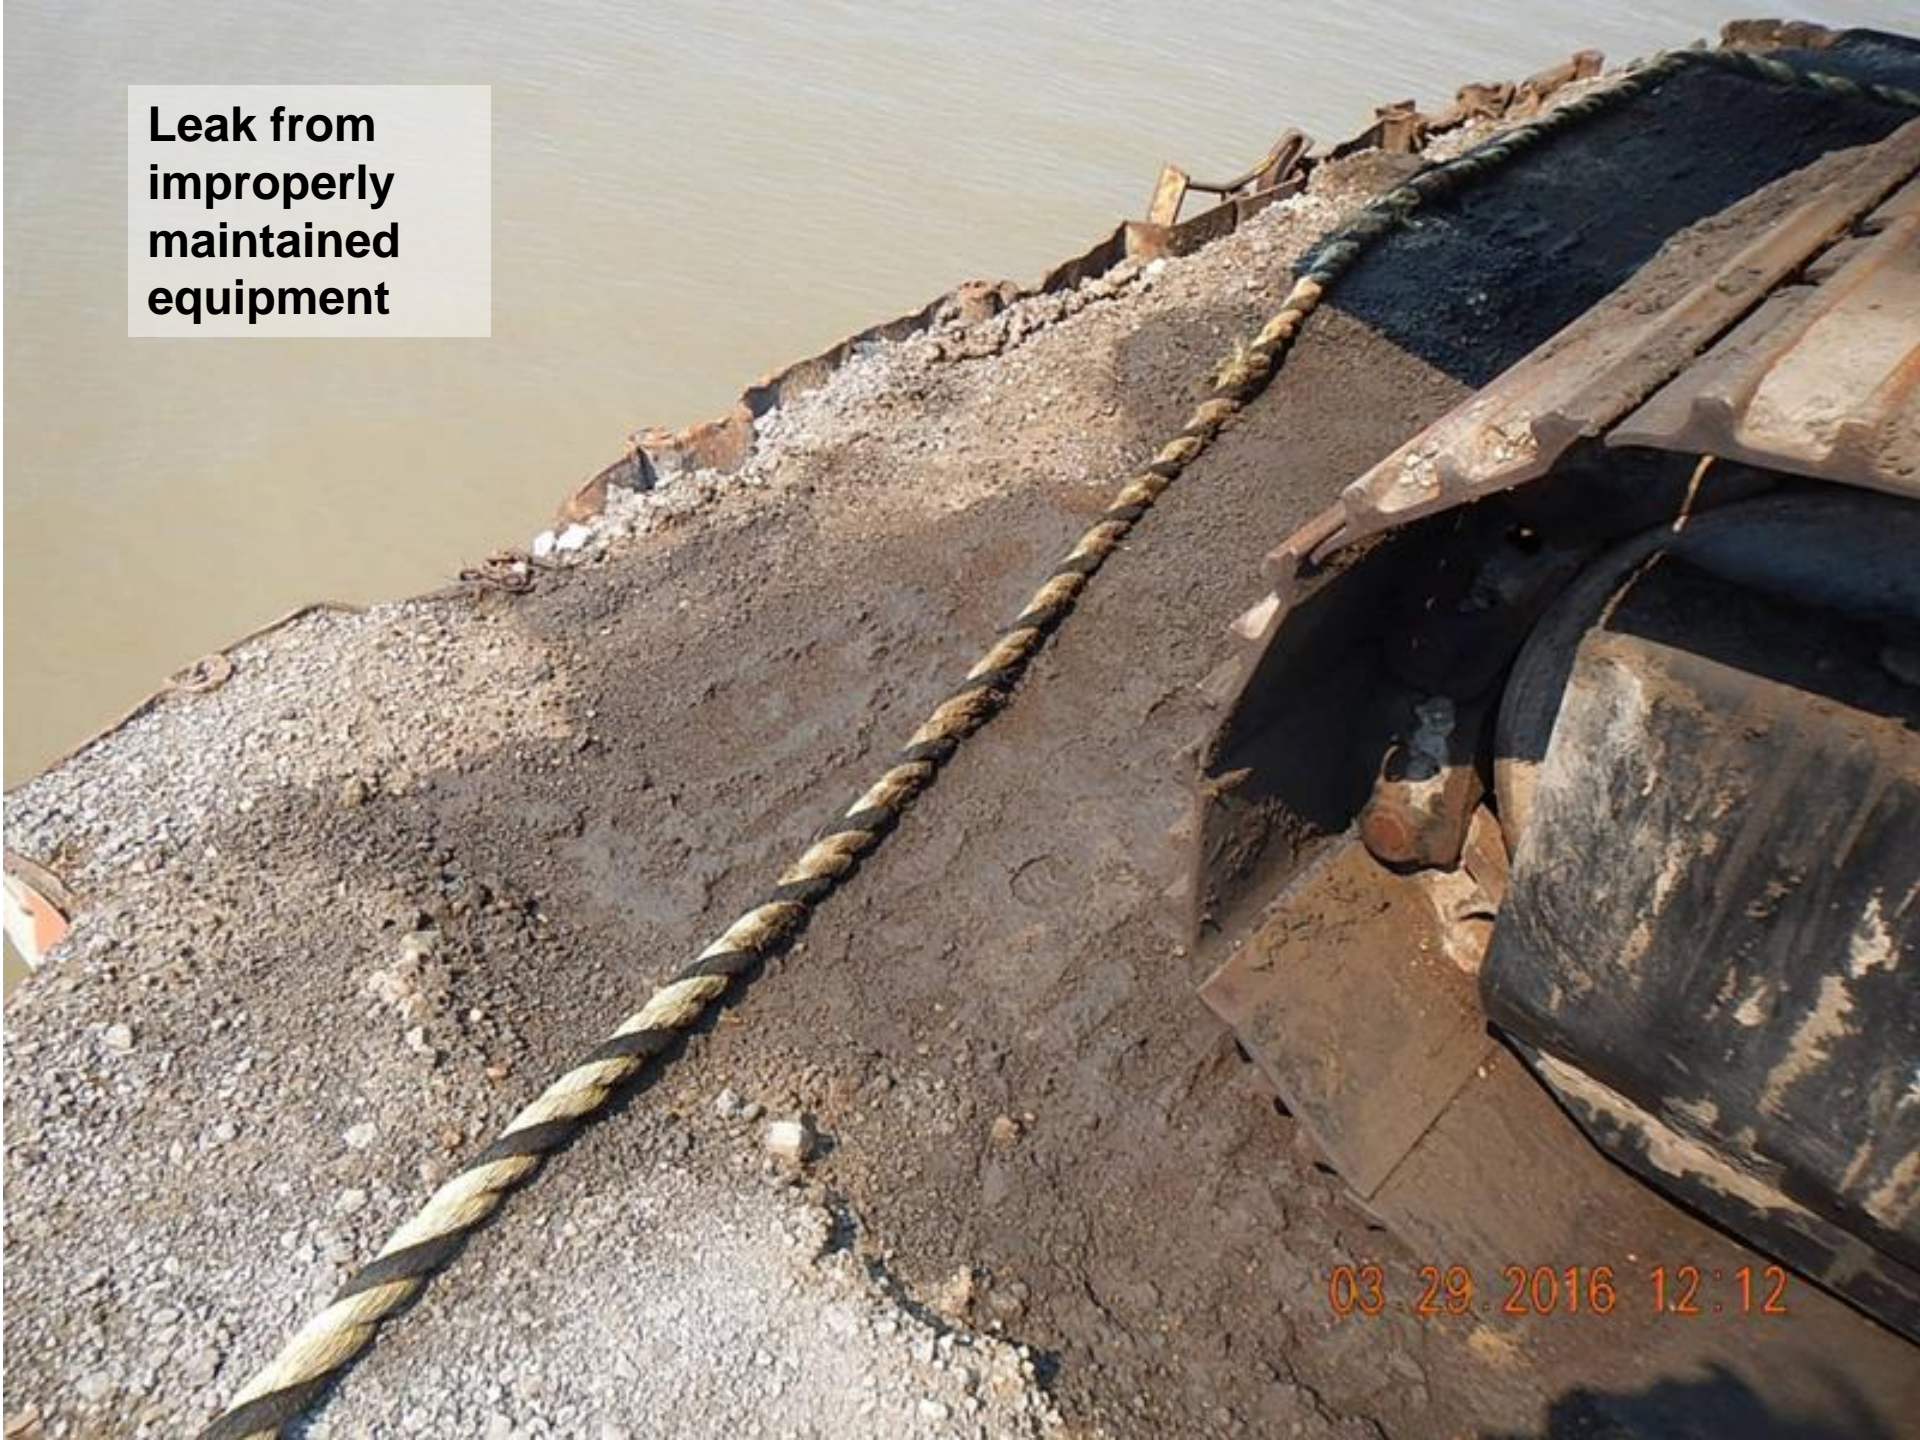
**Leak from  
improperly  
maintained  
equipment**

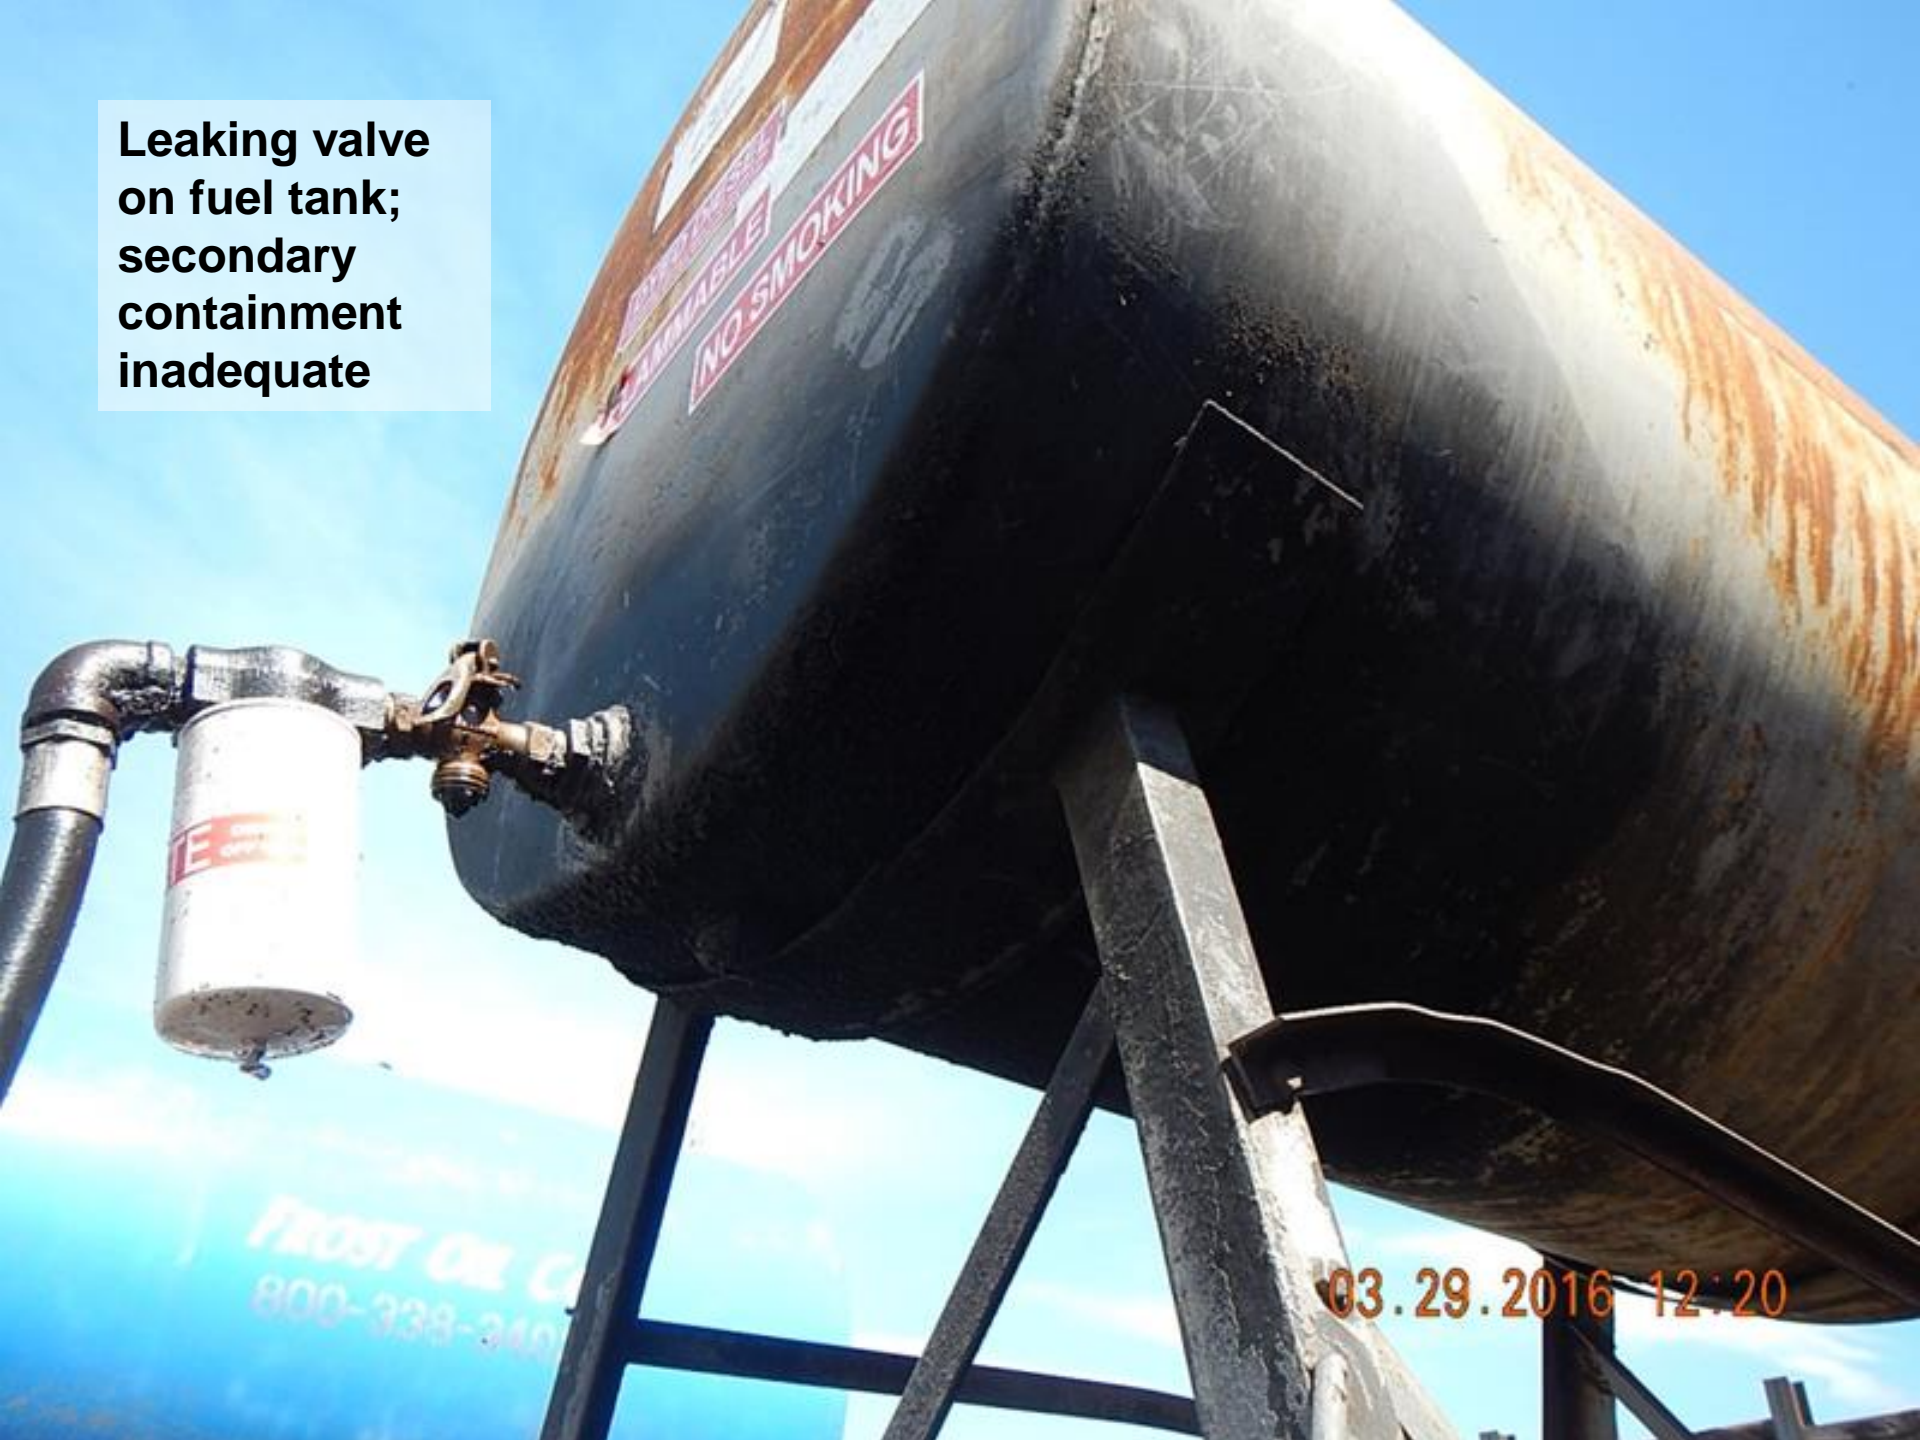
Leaking valve  
on fuel tank;  
secondary  
containment  
inadequate

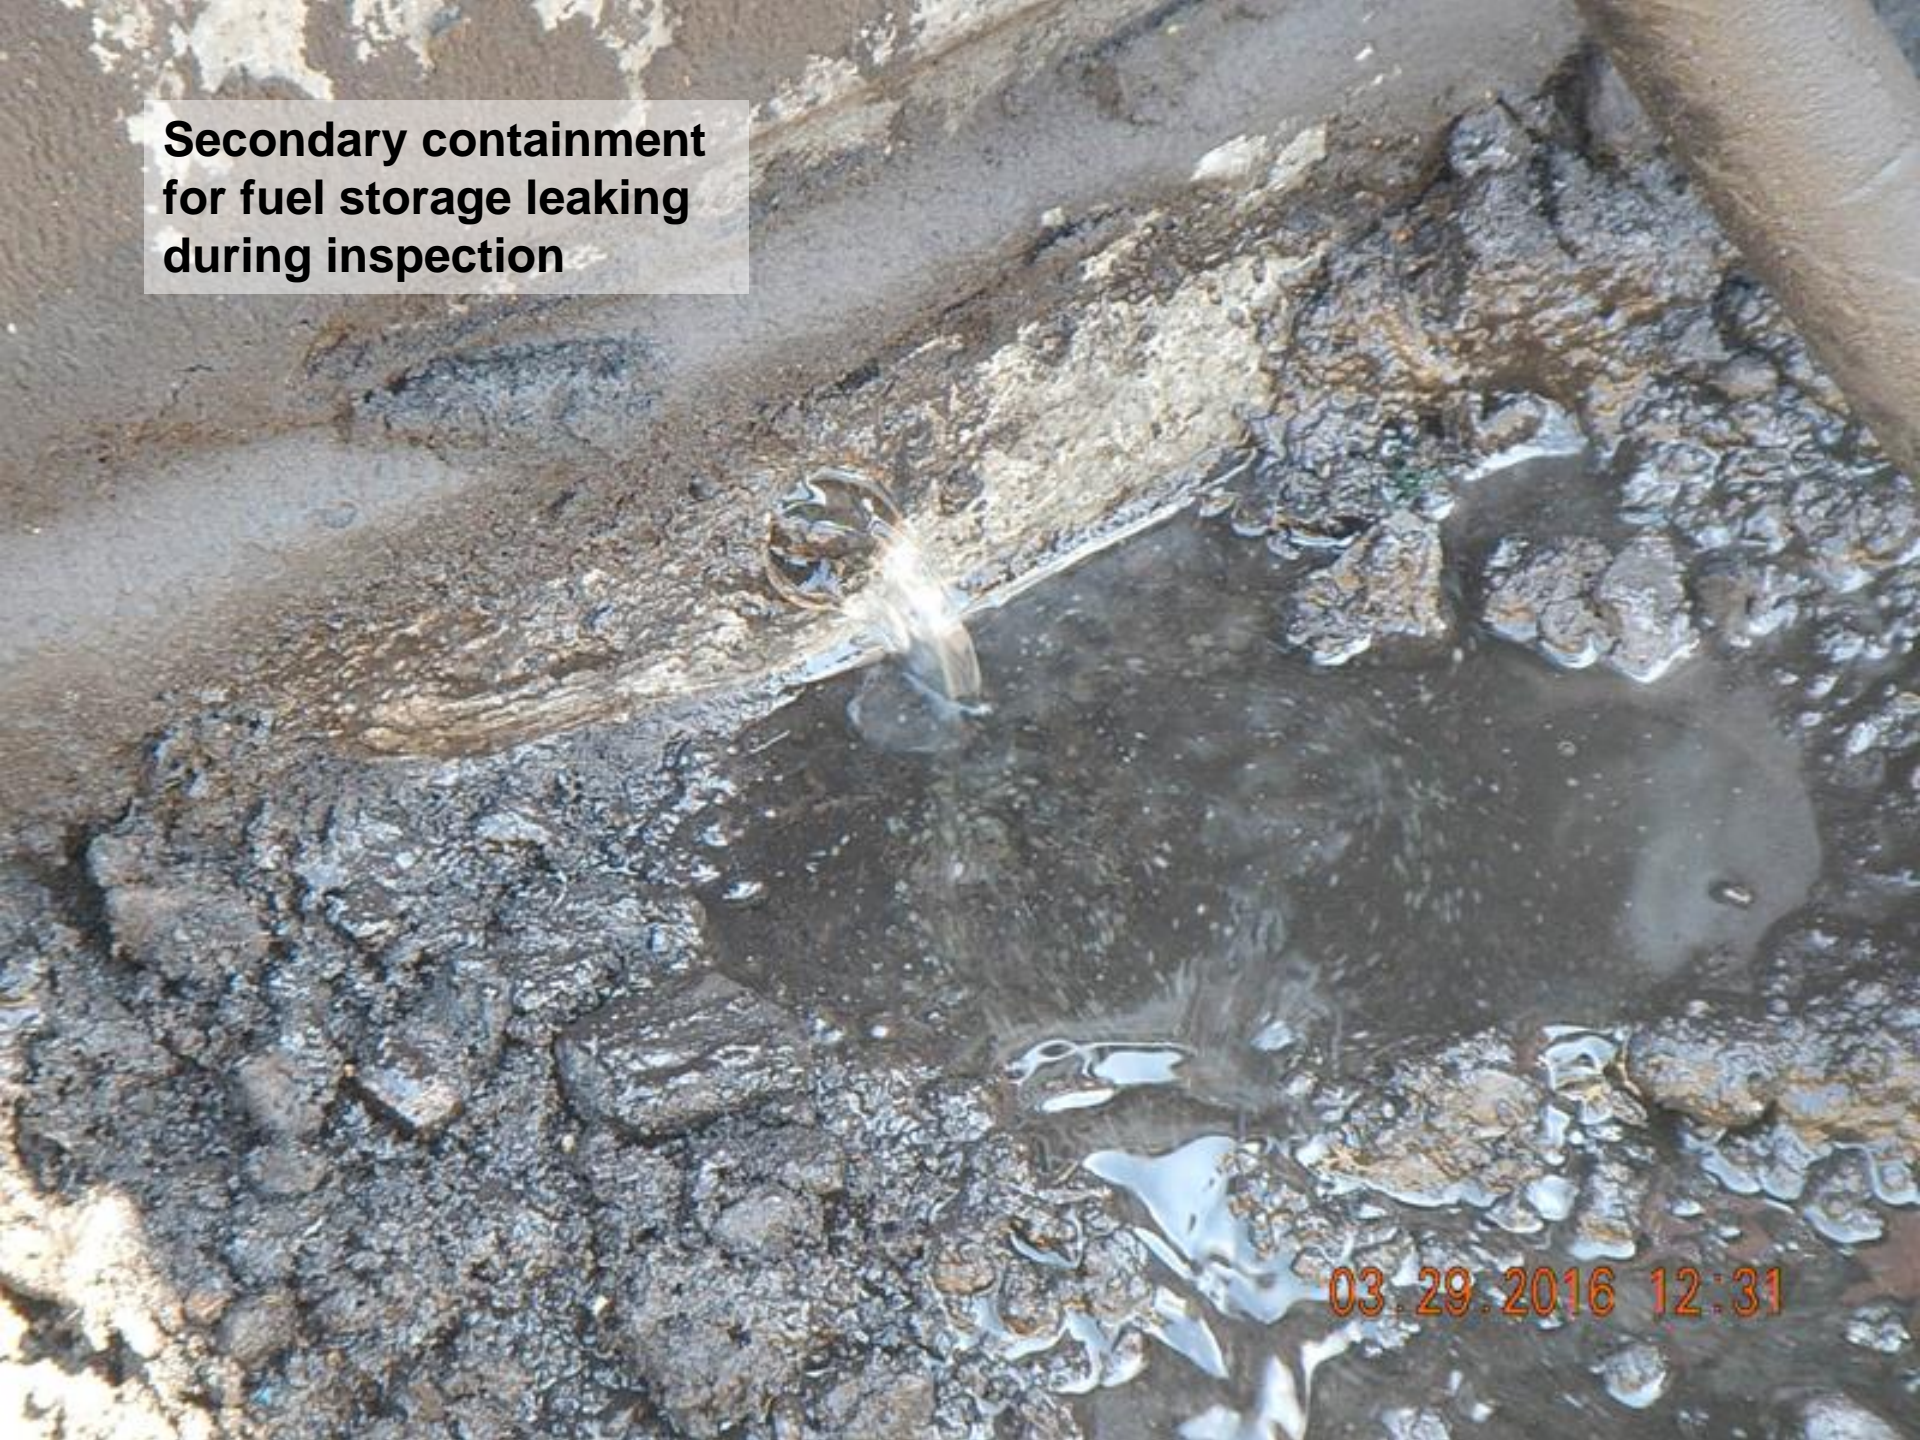
**Secondary containment  
for fuel storage leaking  
during inspection**

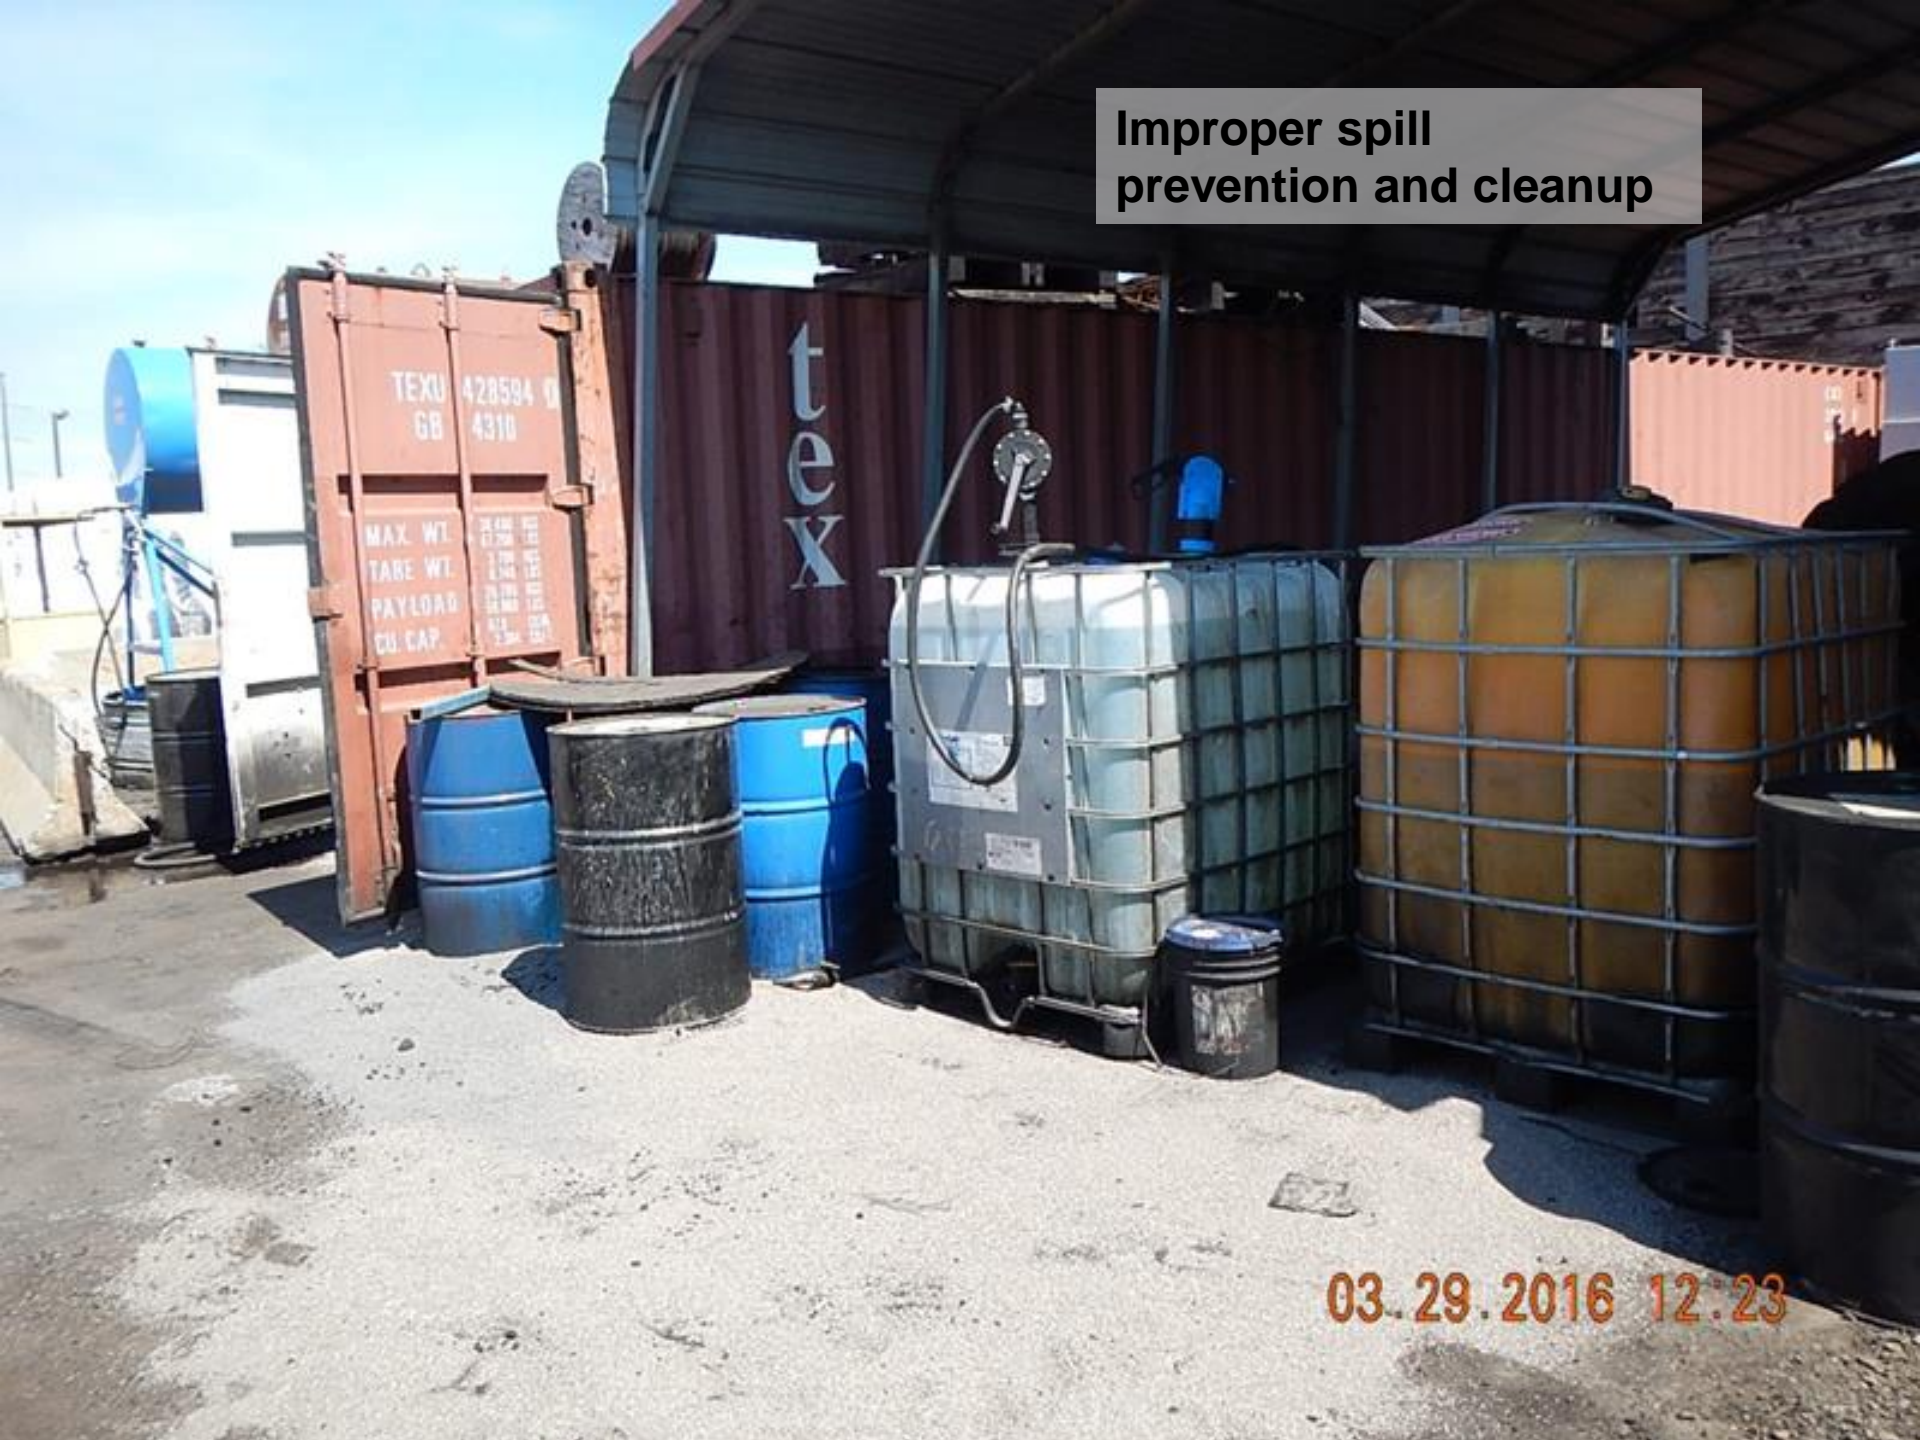
**Improper spill  
prevention and cleanup**

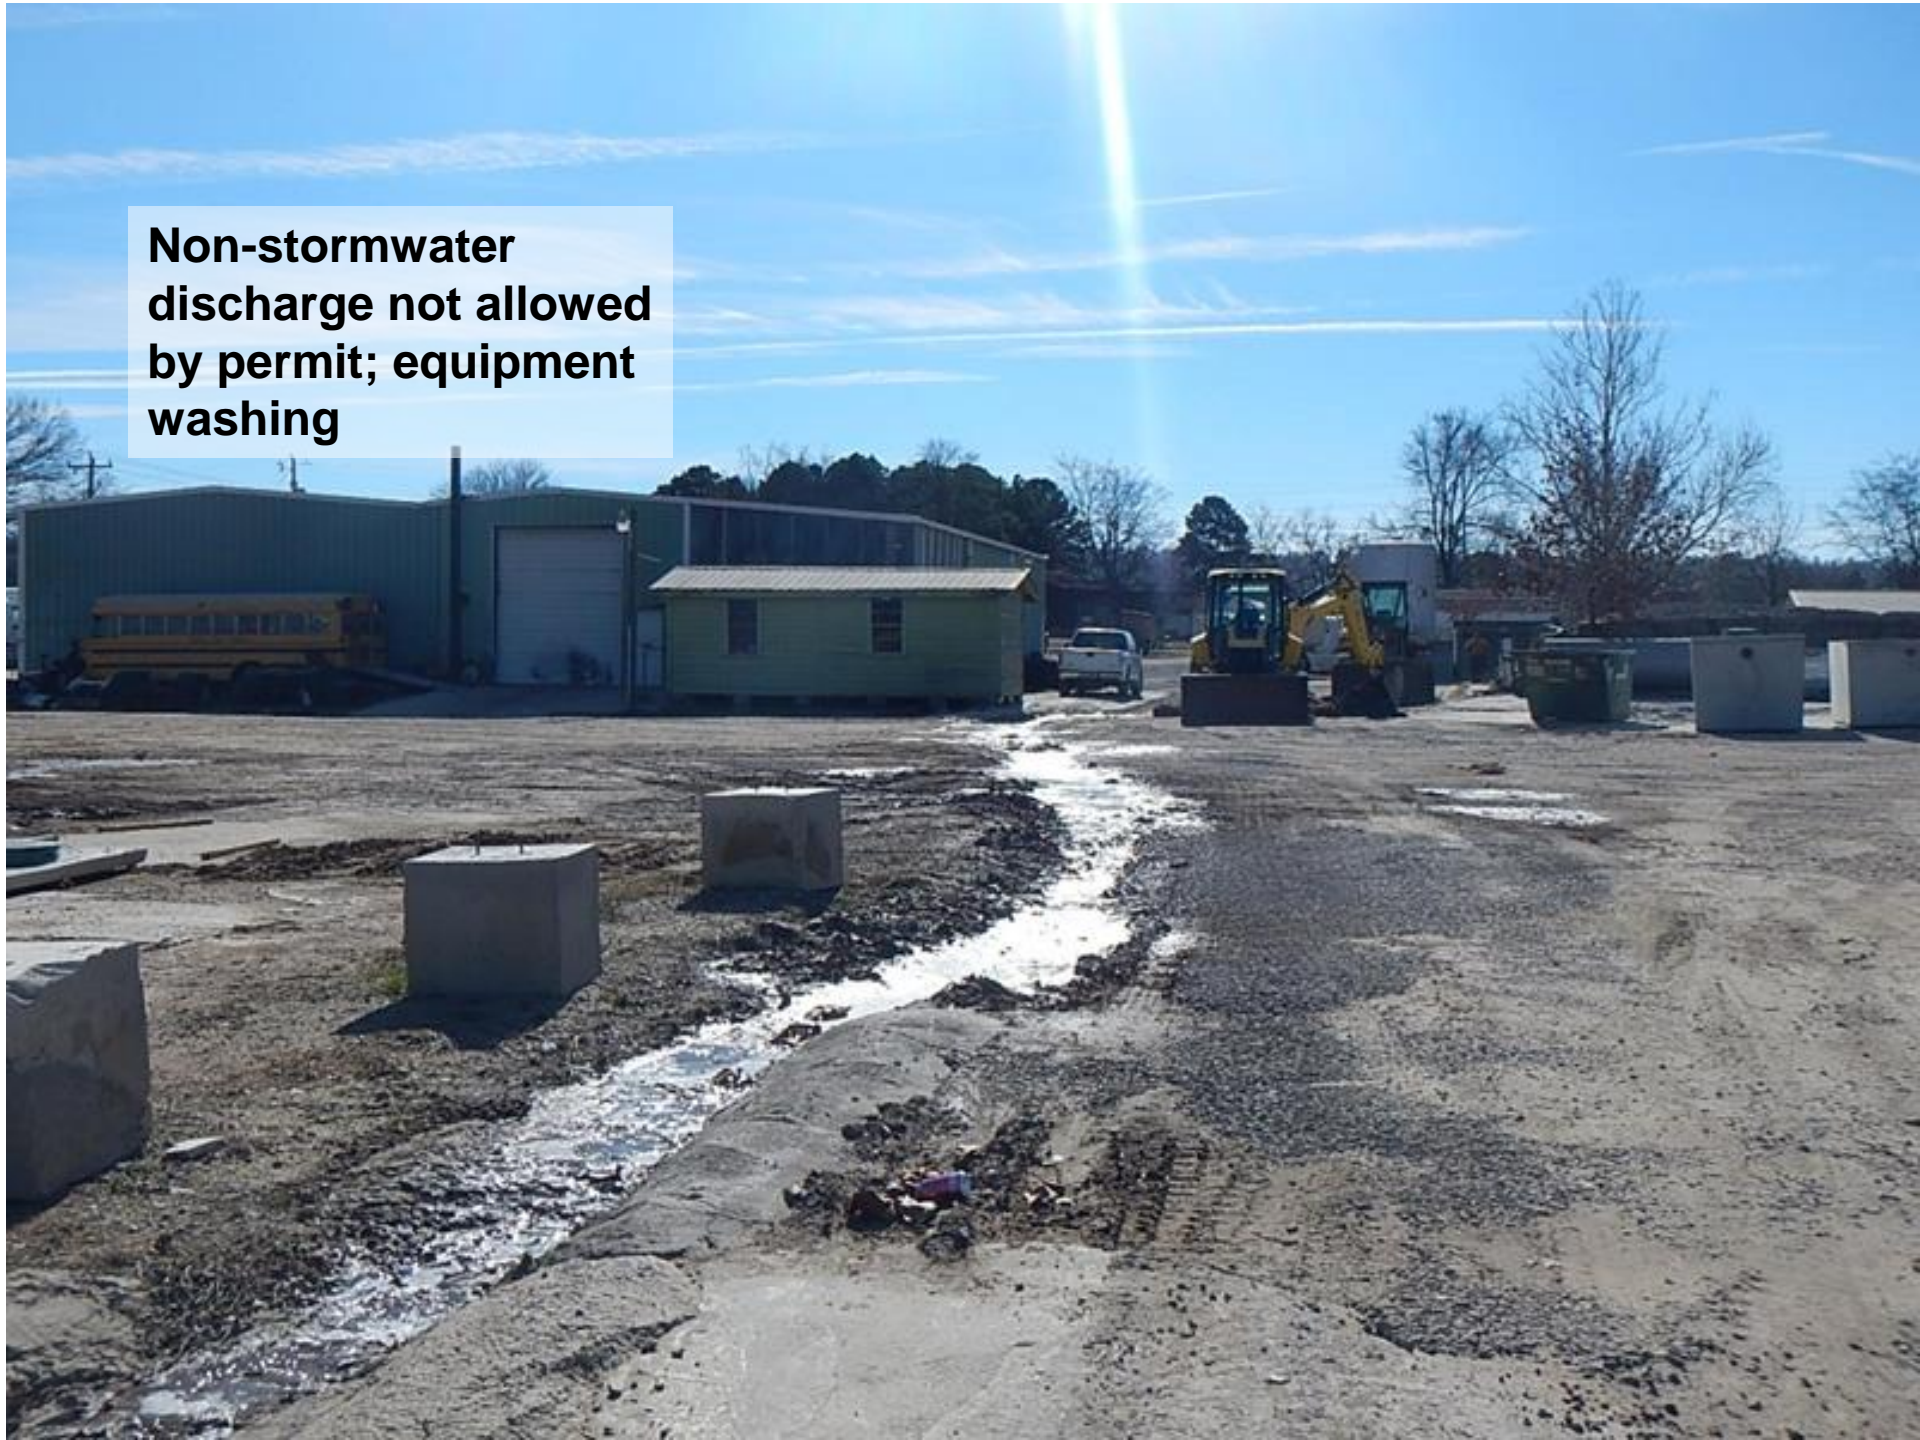
**Non-stormwater  
discharge not allowed  
by permit; equipment  
washing**

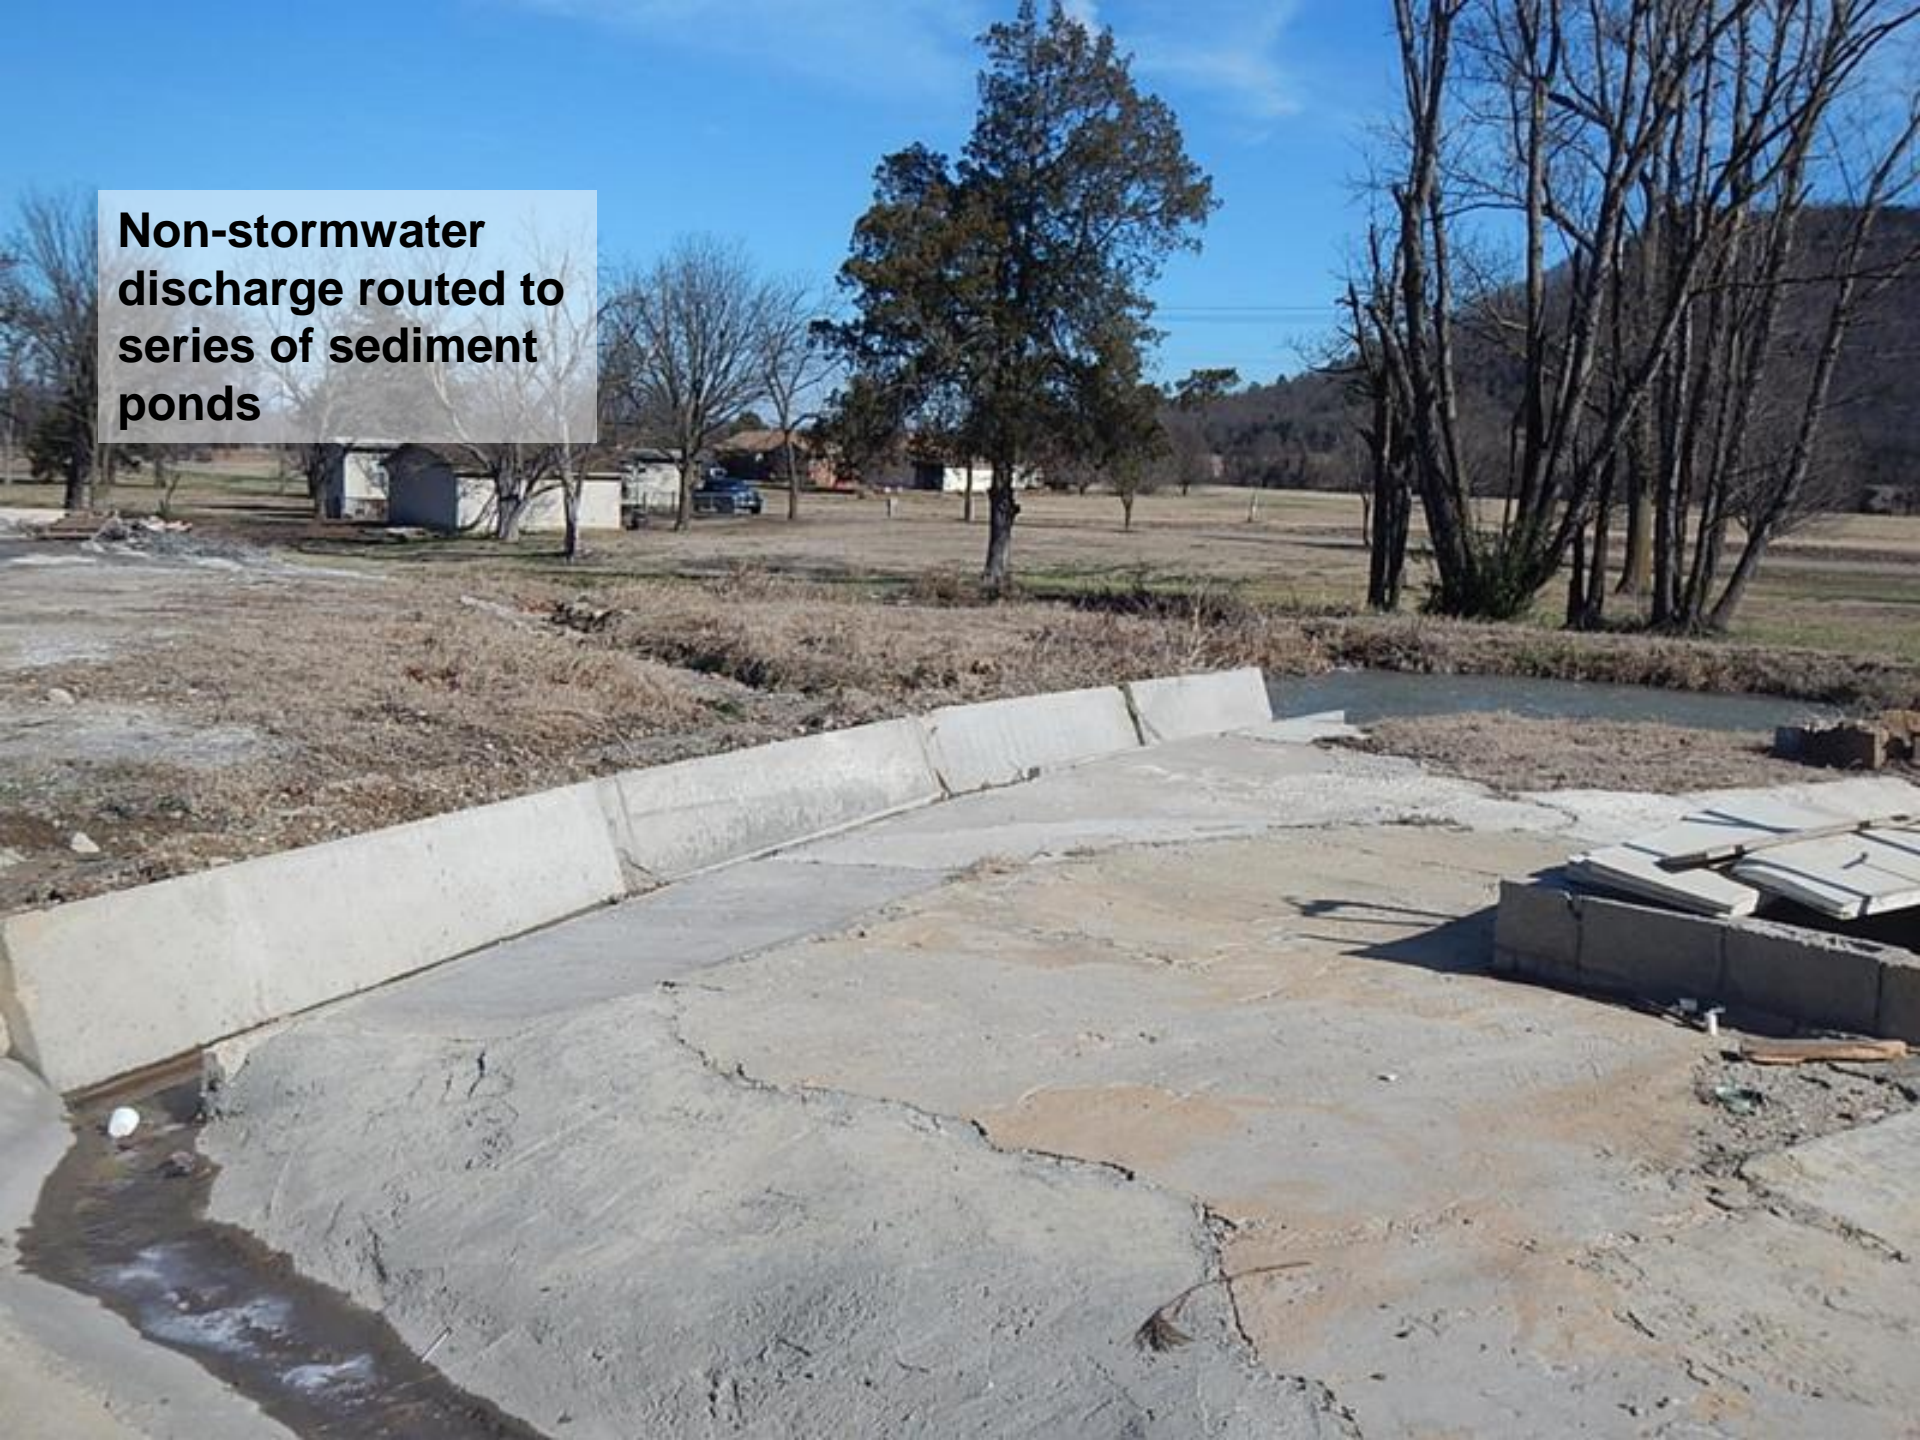
**Non-stormwater  
discharge routed to  
series of sediment  
ponds**

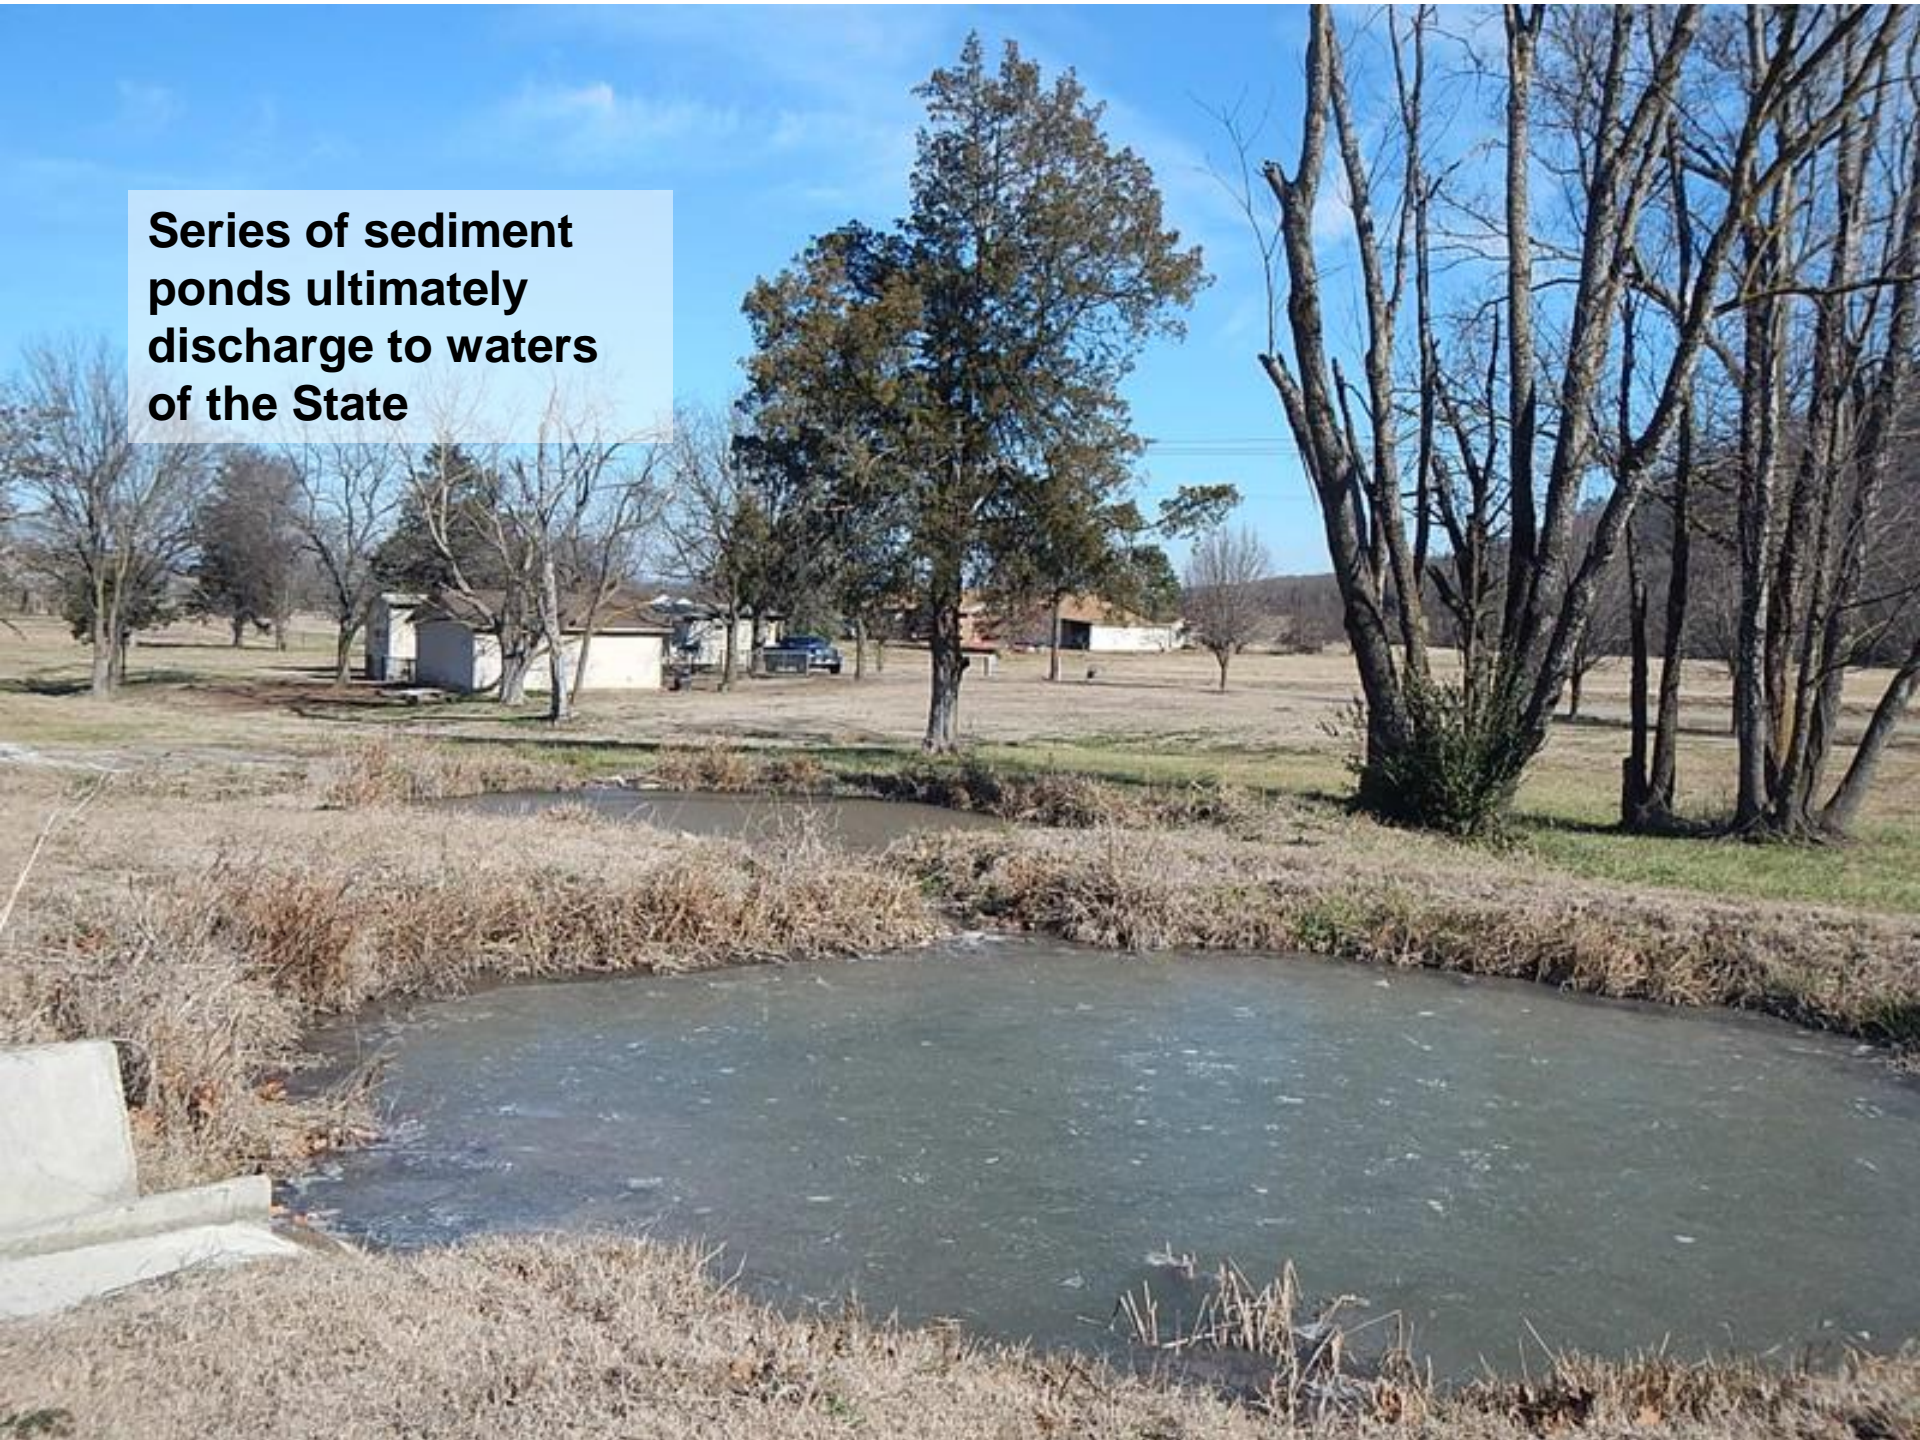
**Series of sediment  
ponds ultimately  
discharge to waters  
of the State**

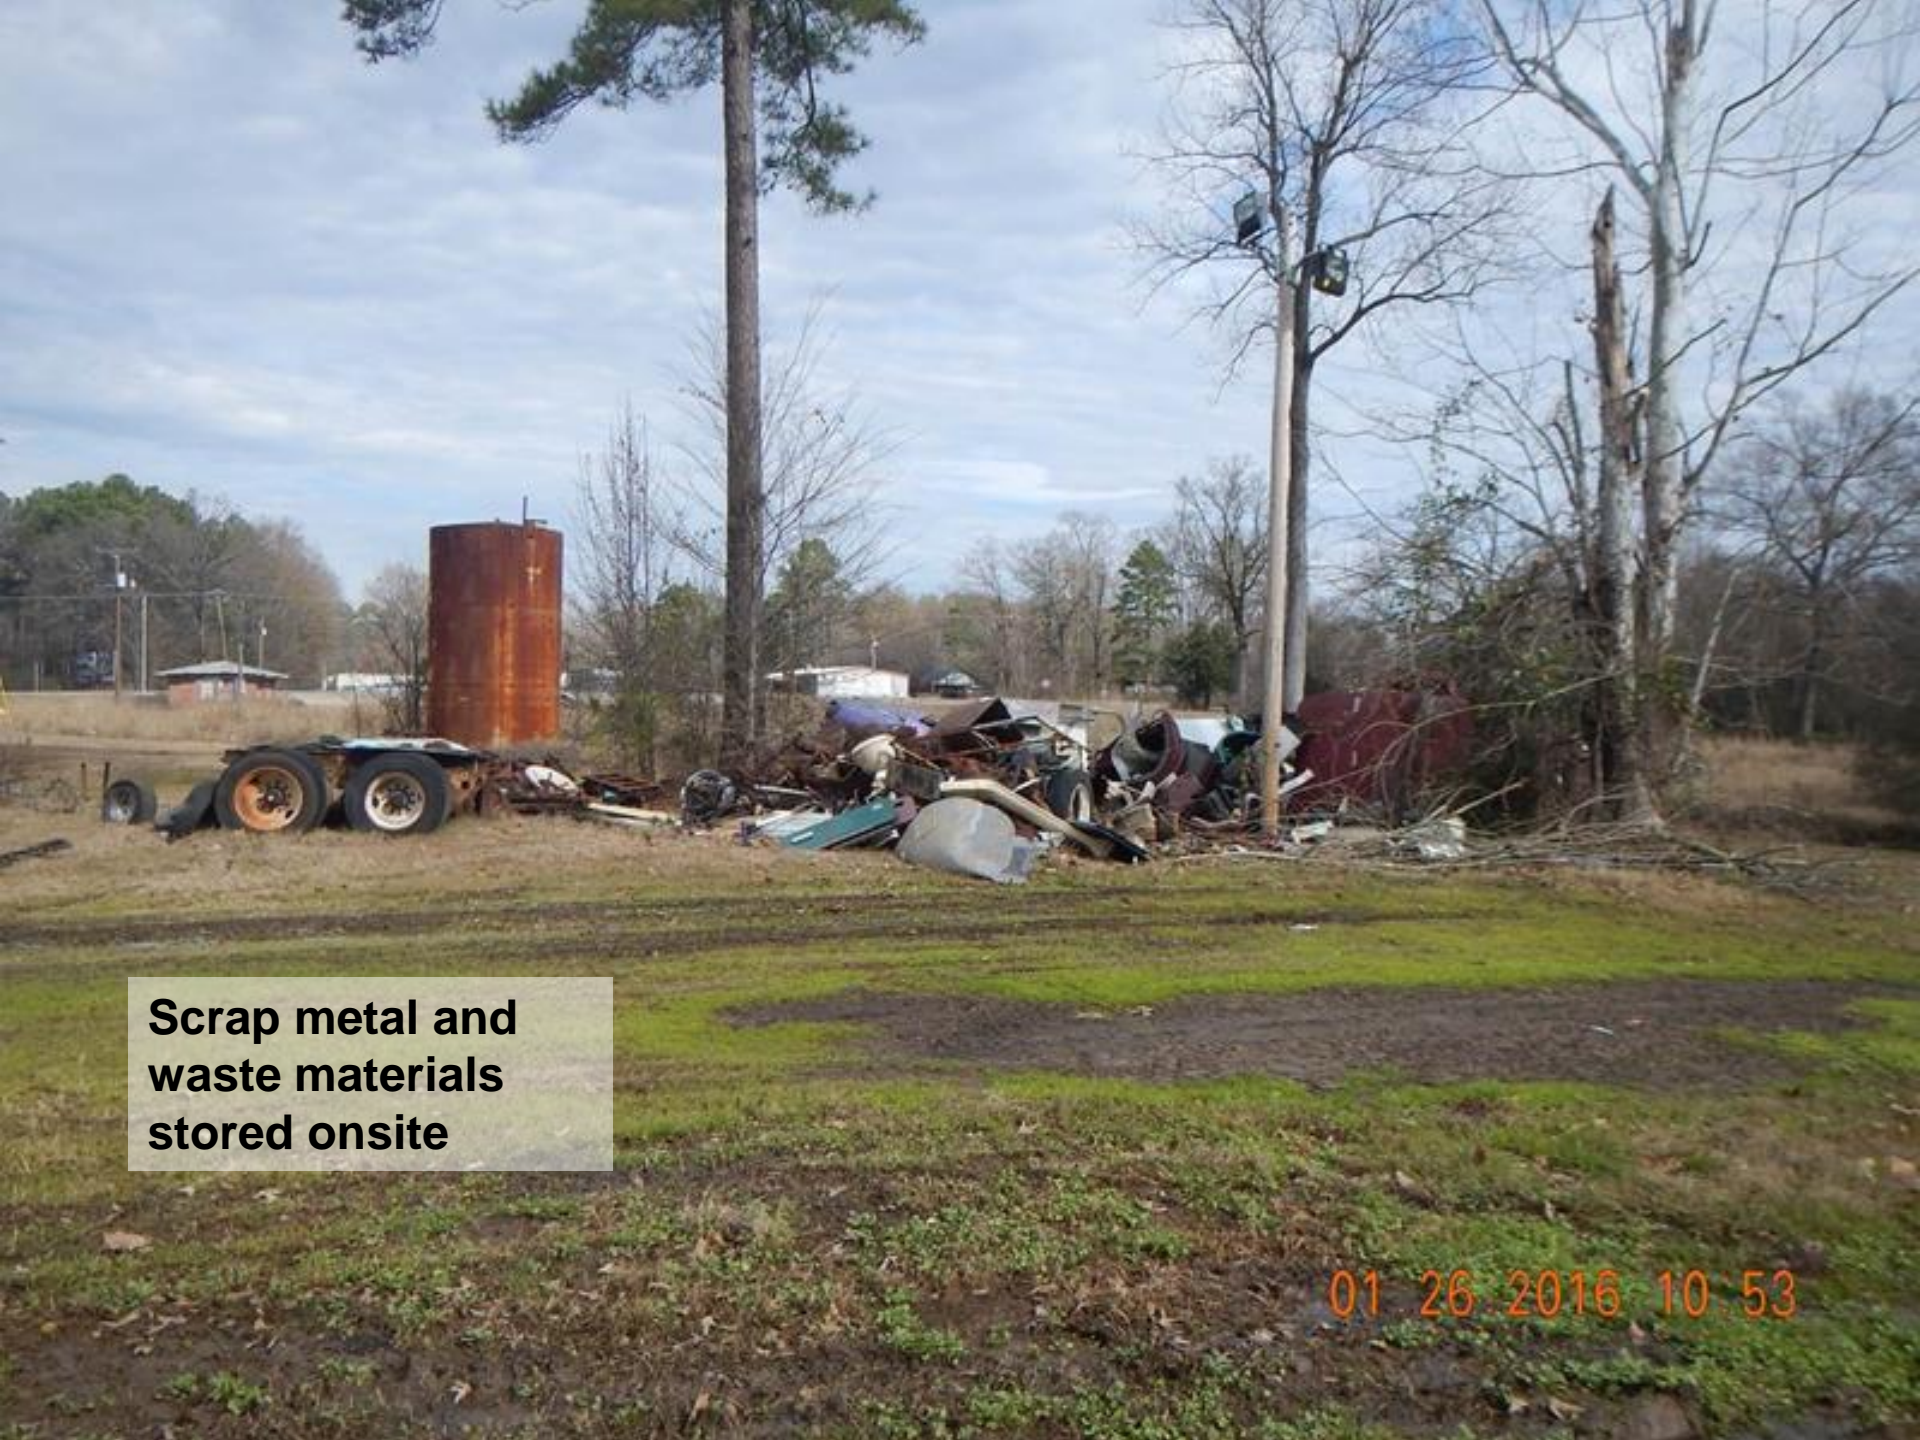
**Scrap metal and  
waste materials  
stored onsite**
