# **Industrial Stormwater Success Stories: From Clueless to Superstars**

18<sup>th</sup> Annual USEPA Region 6 SW/MS4 Conference

Kerri McCabe, Inspector Supervisor

ADEQ – Office of Water Quality

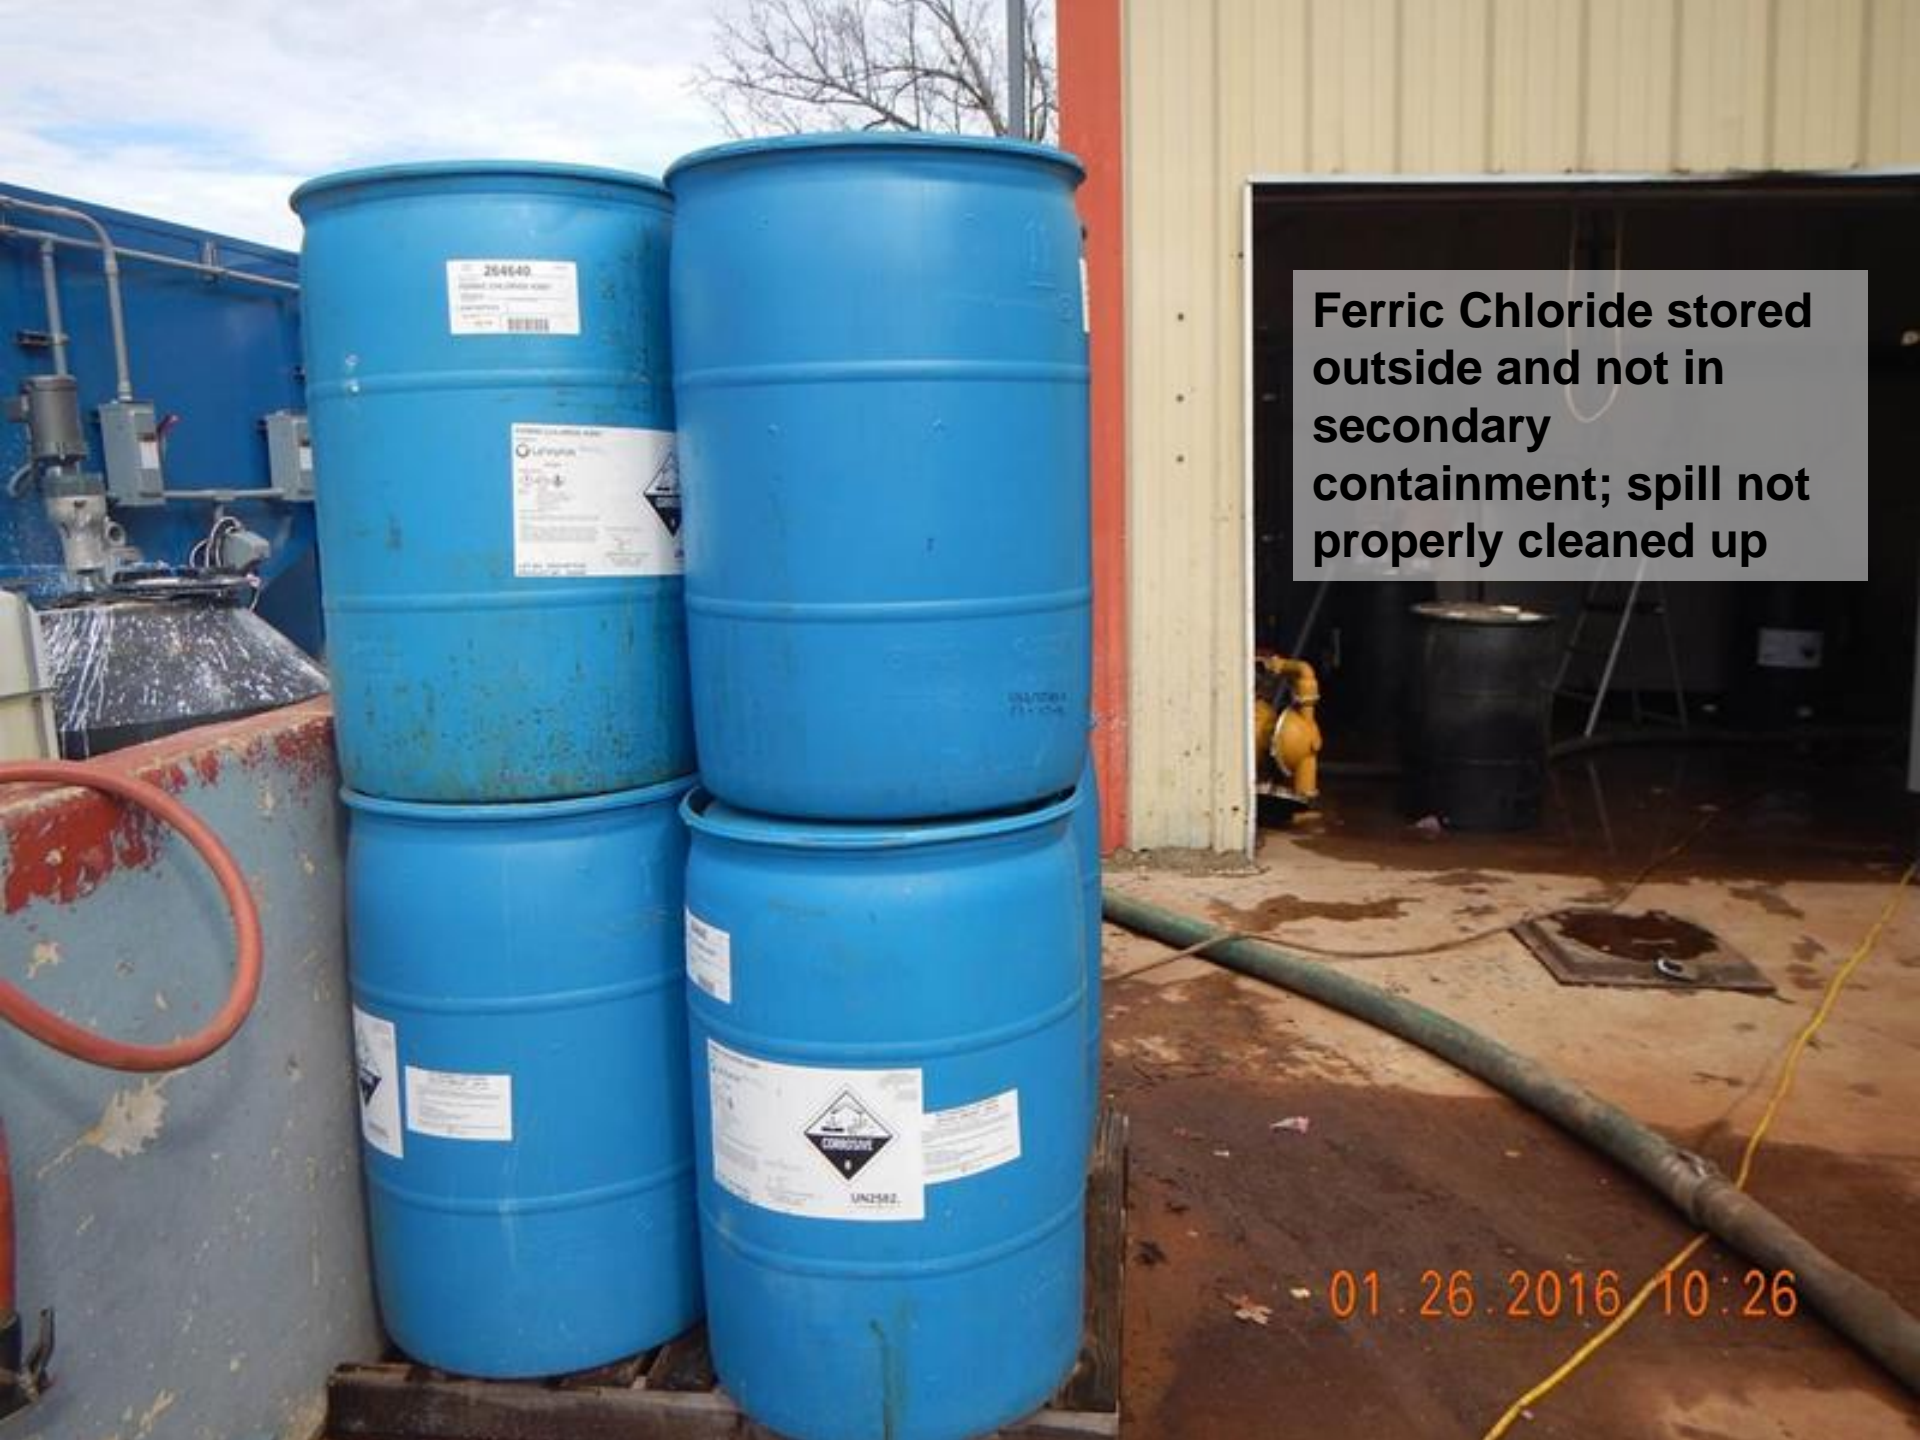
**Ferric Chloride stored outside and not in secondary containment; spill not properly cleaned up**

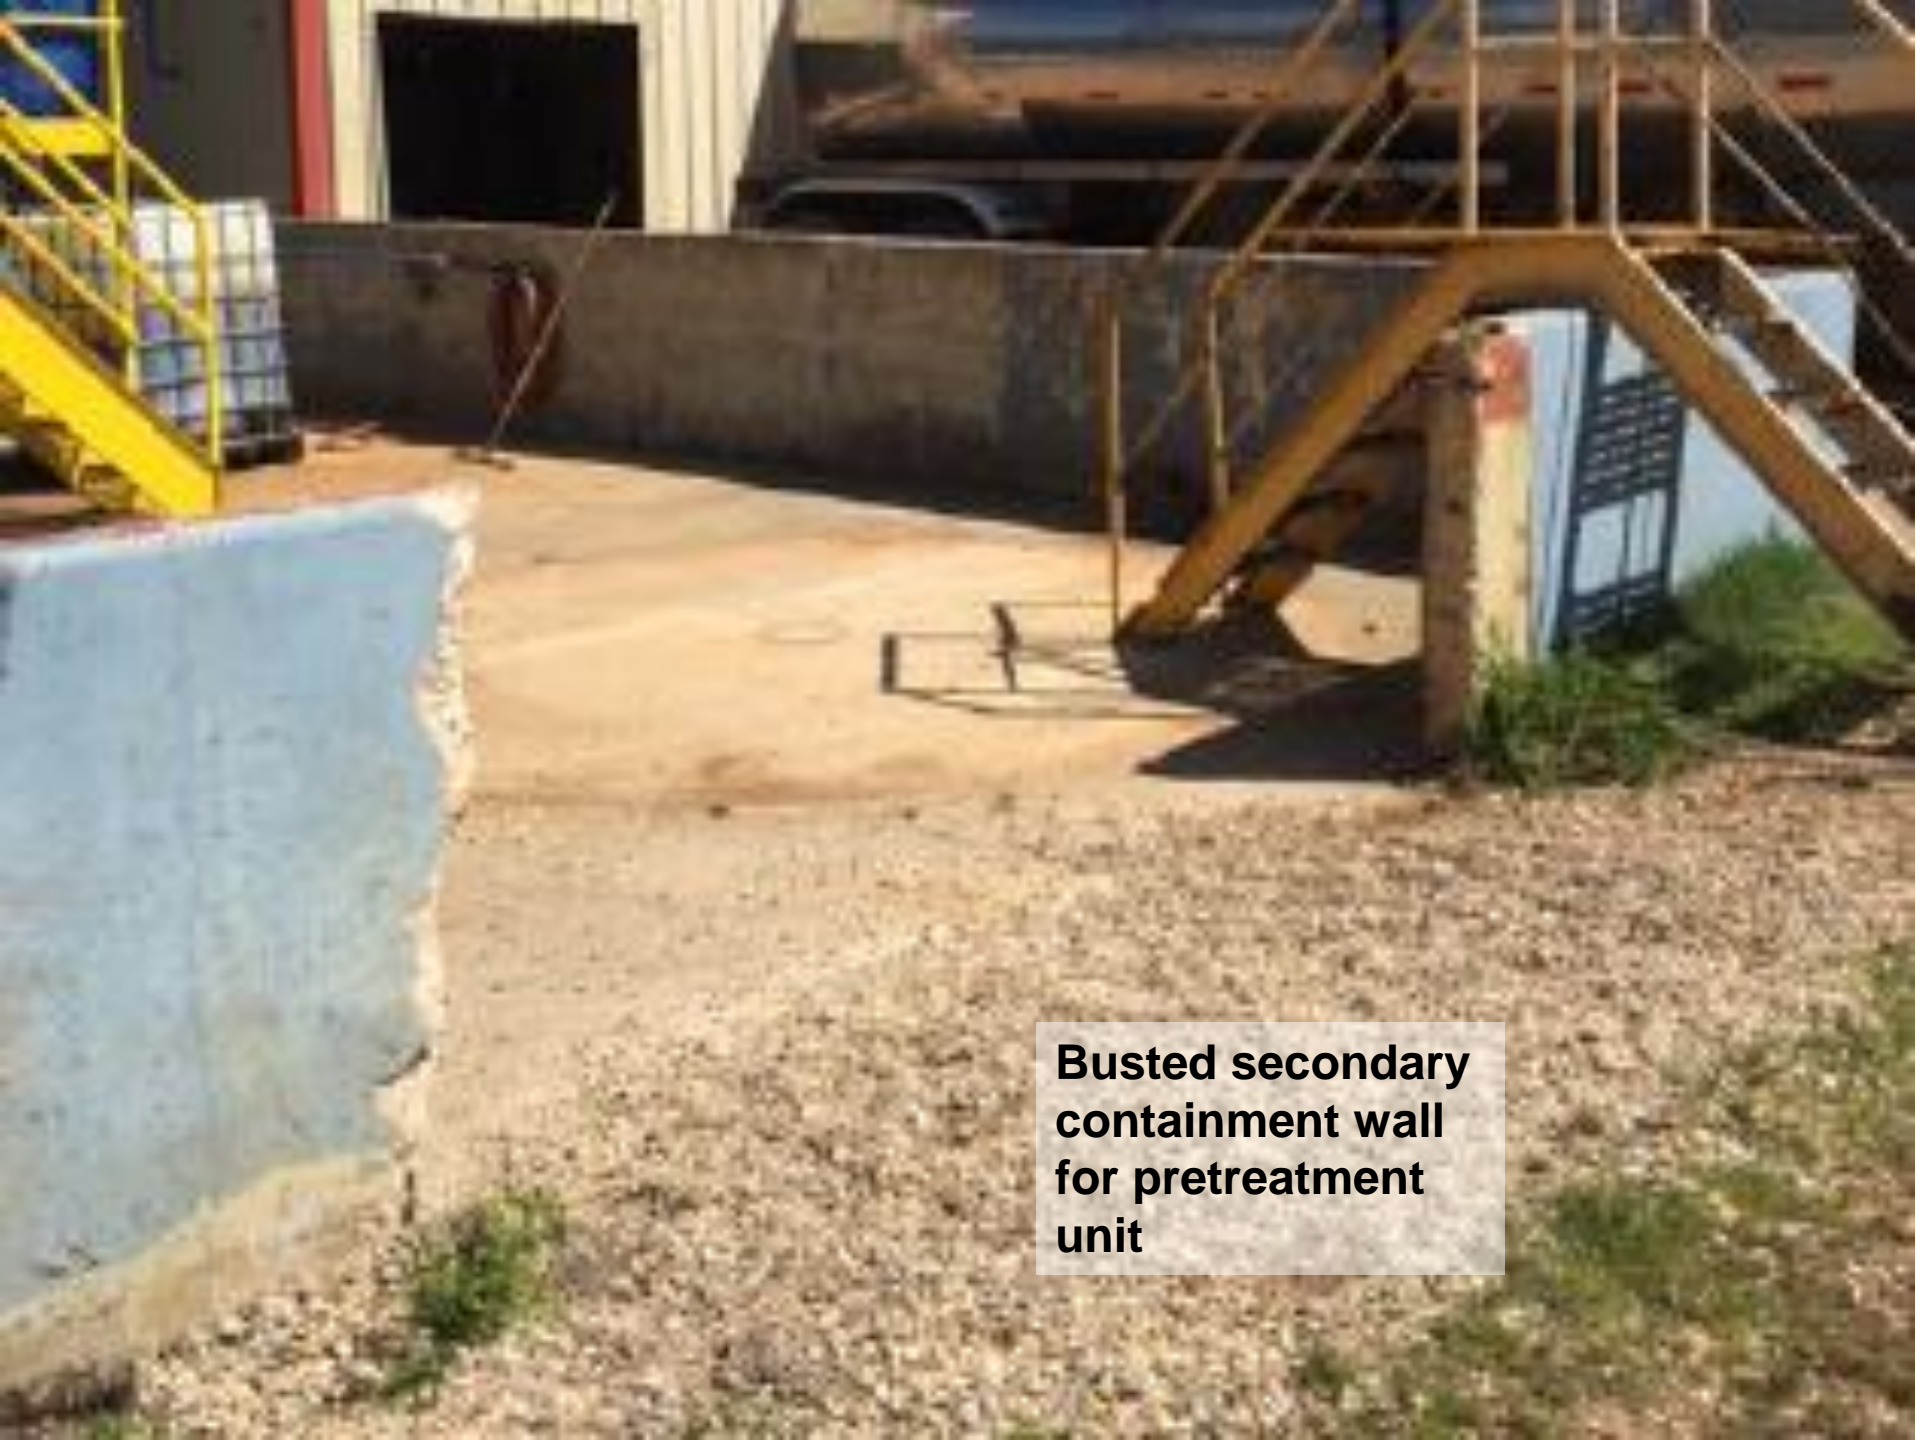
**Busted secondary  
containment wall  
for pretreatment  
unit**

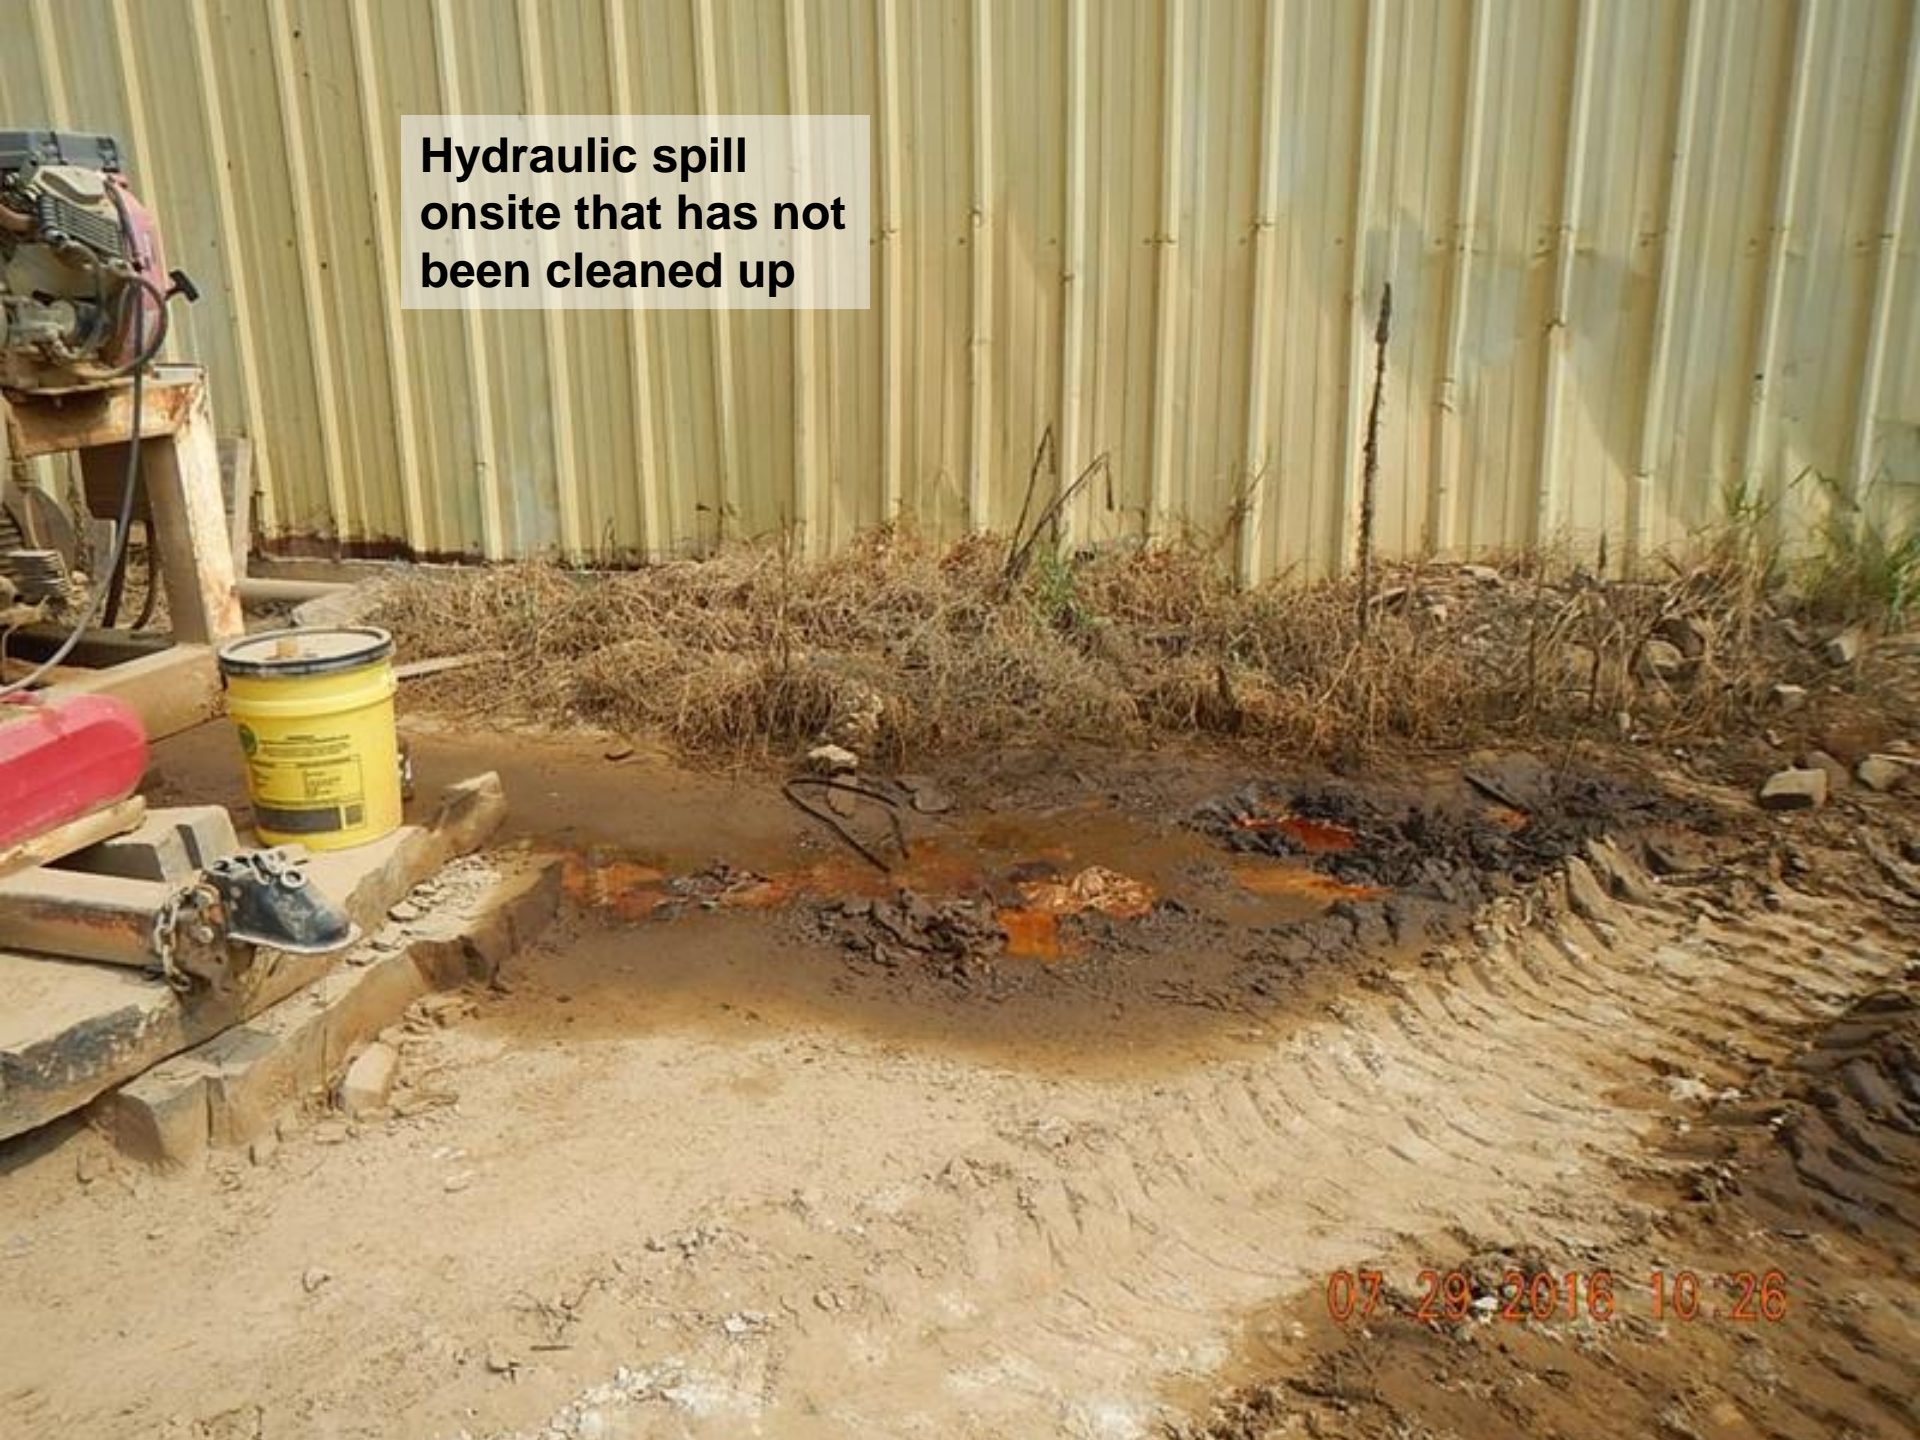
**Hydraulic spill  
onsite that has not  
been cleaned up**

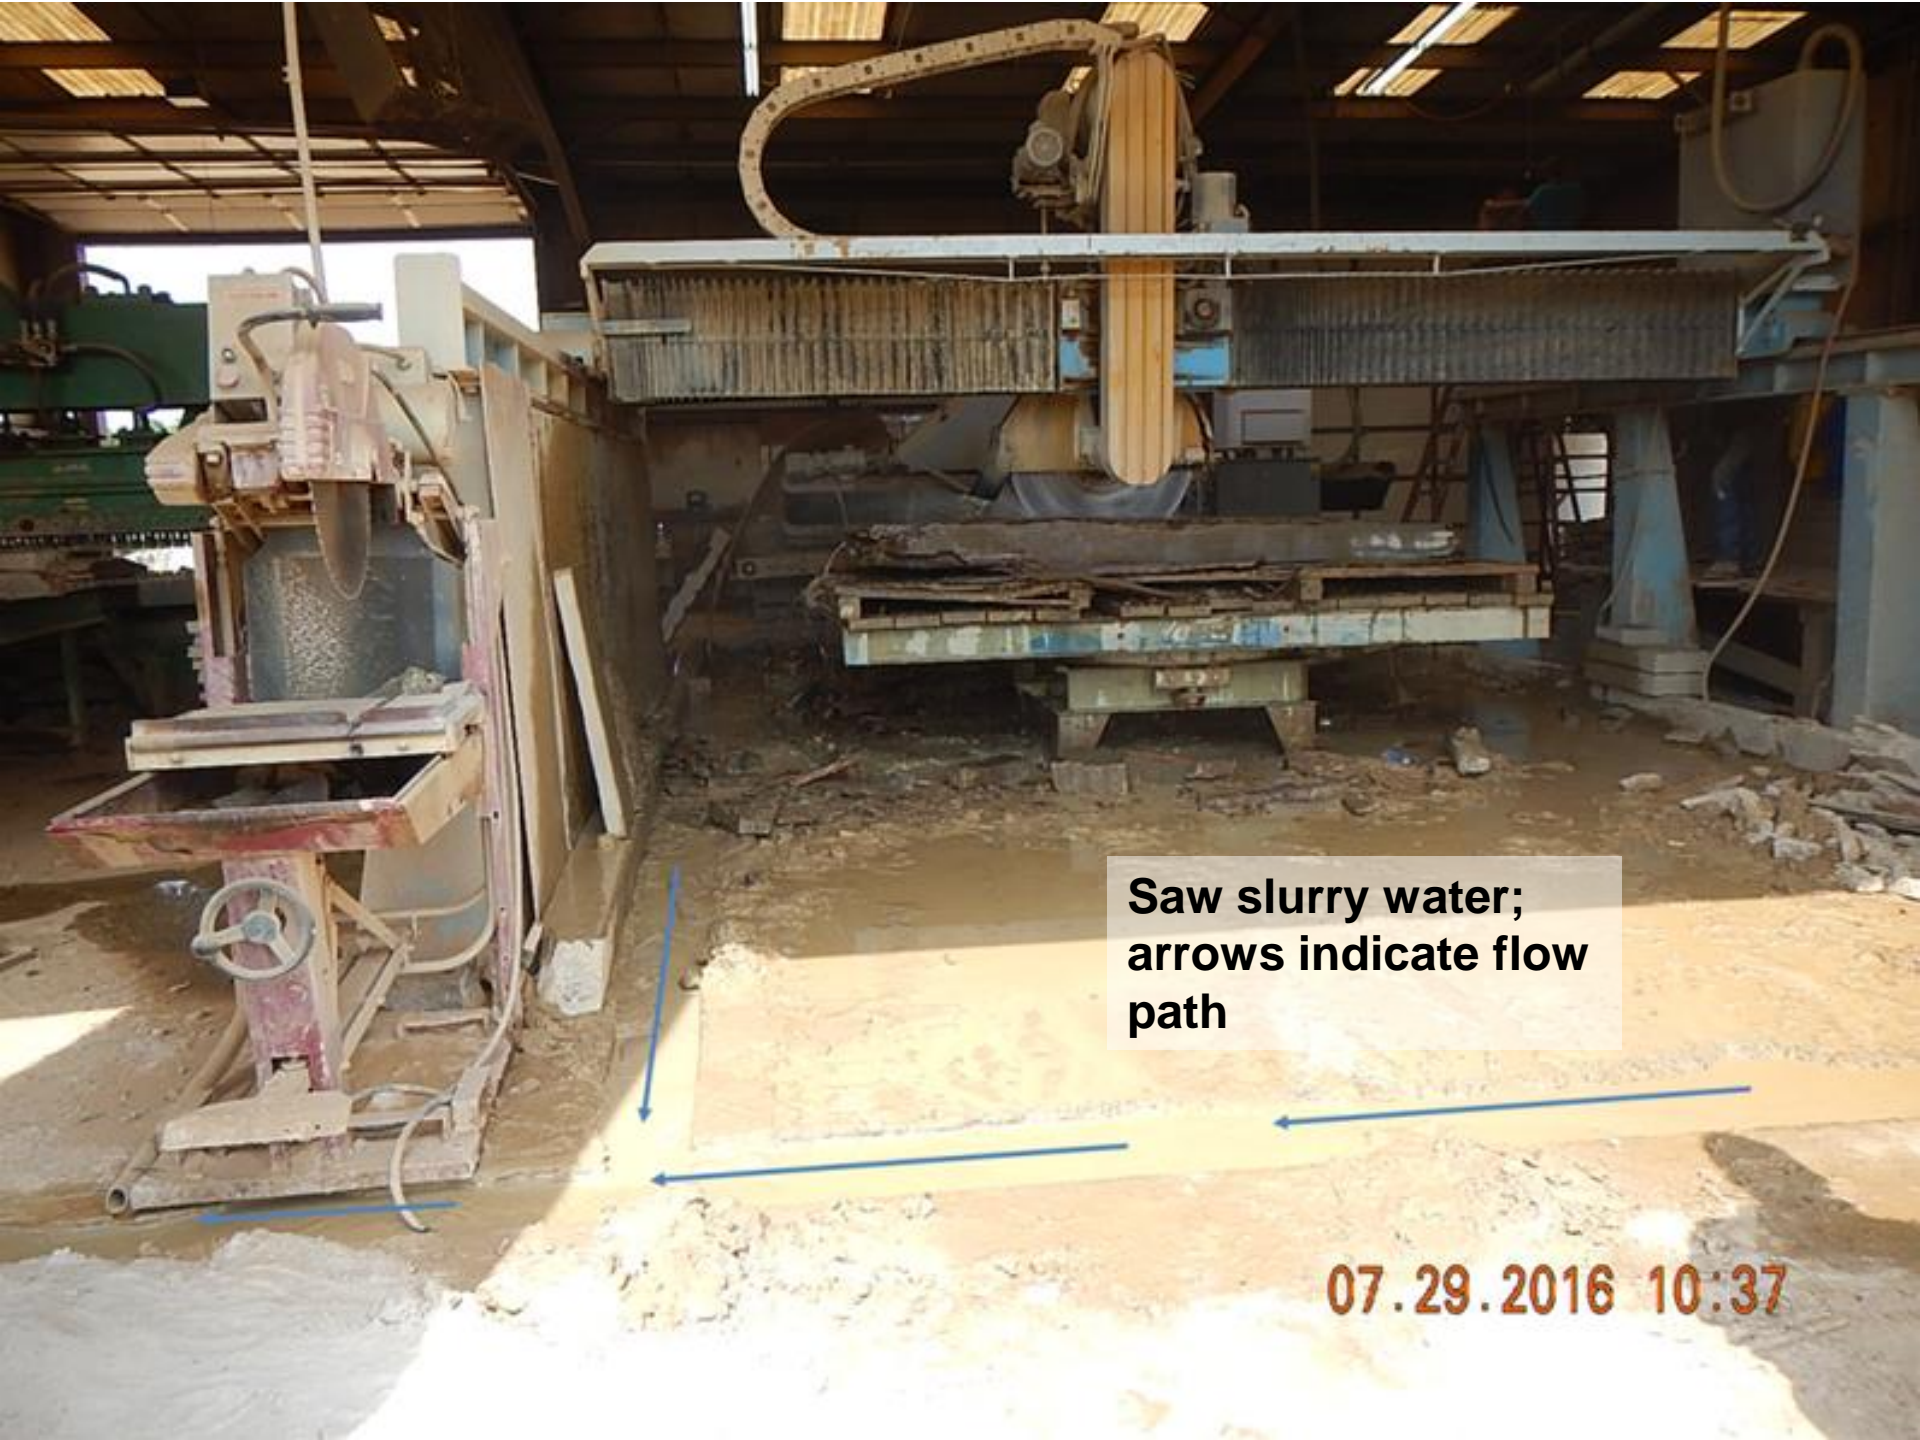
**Saw slurry water;  
arrows indicate flow  
path**

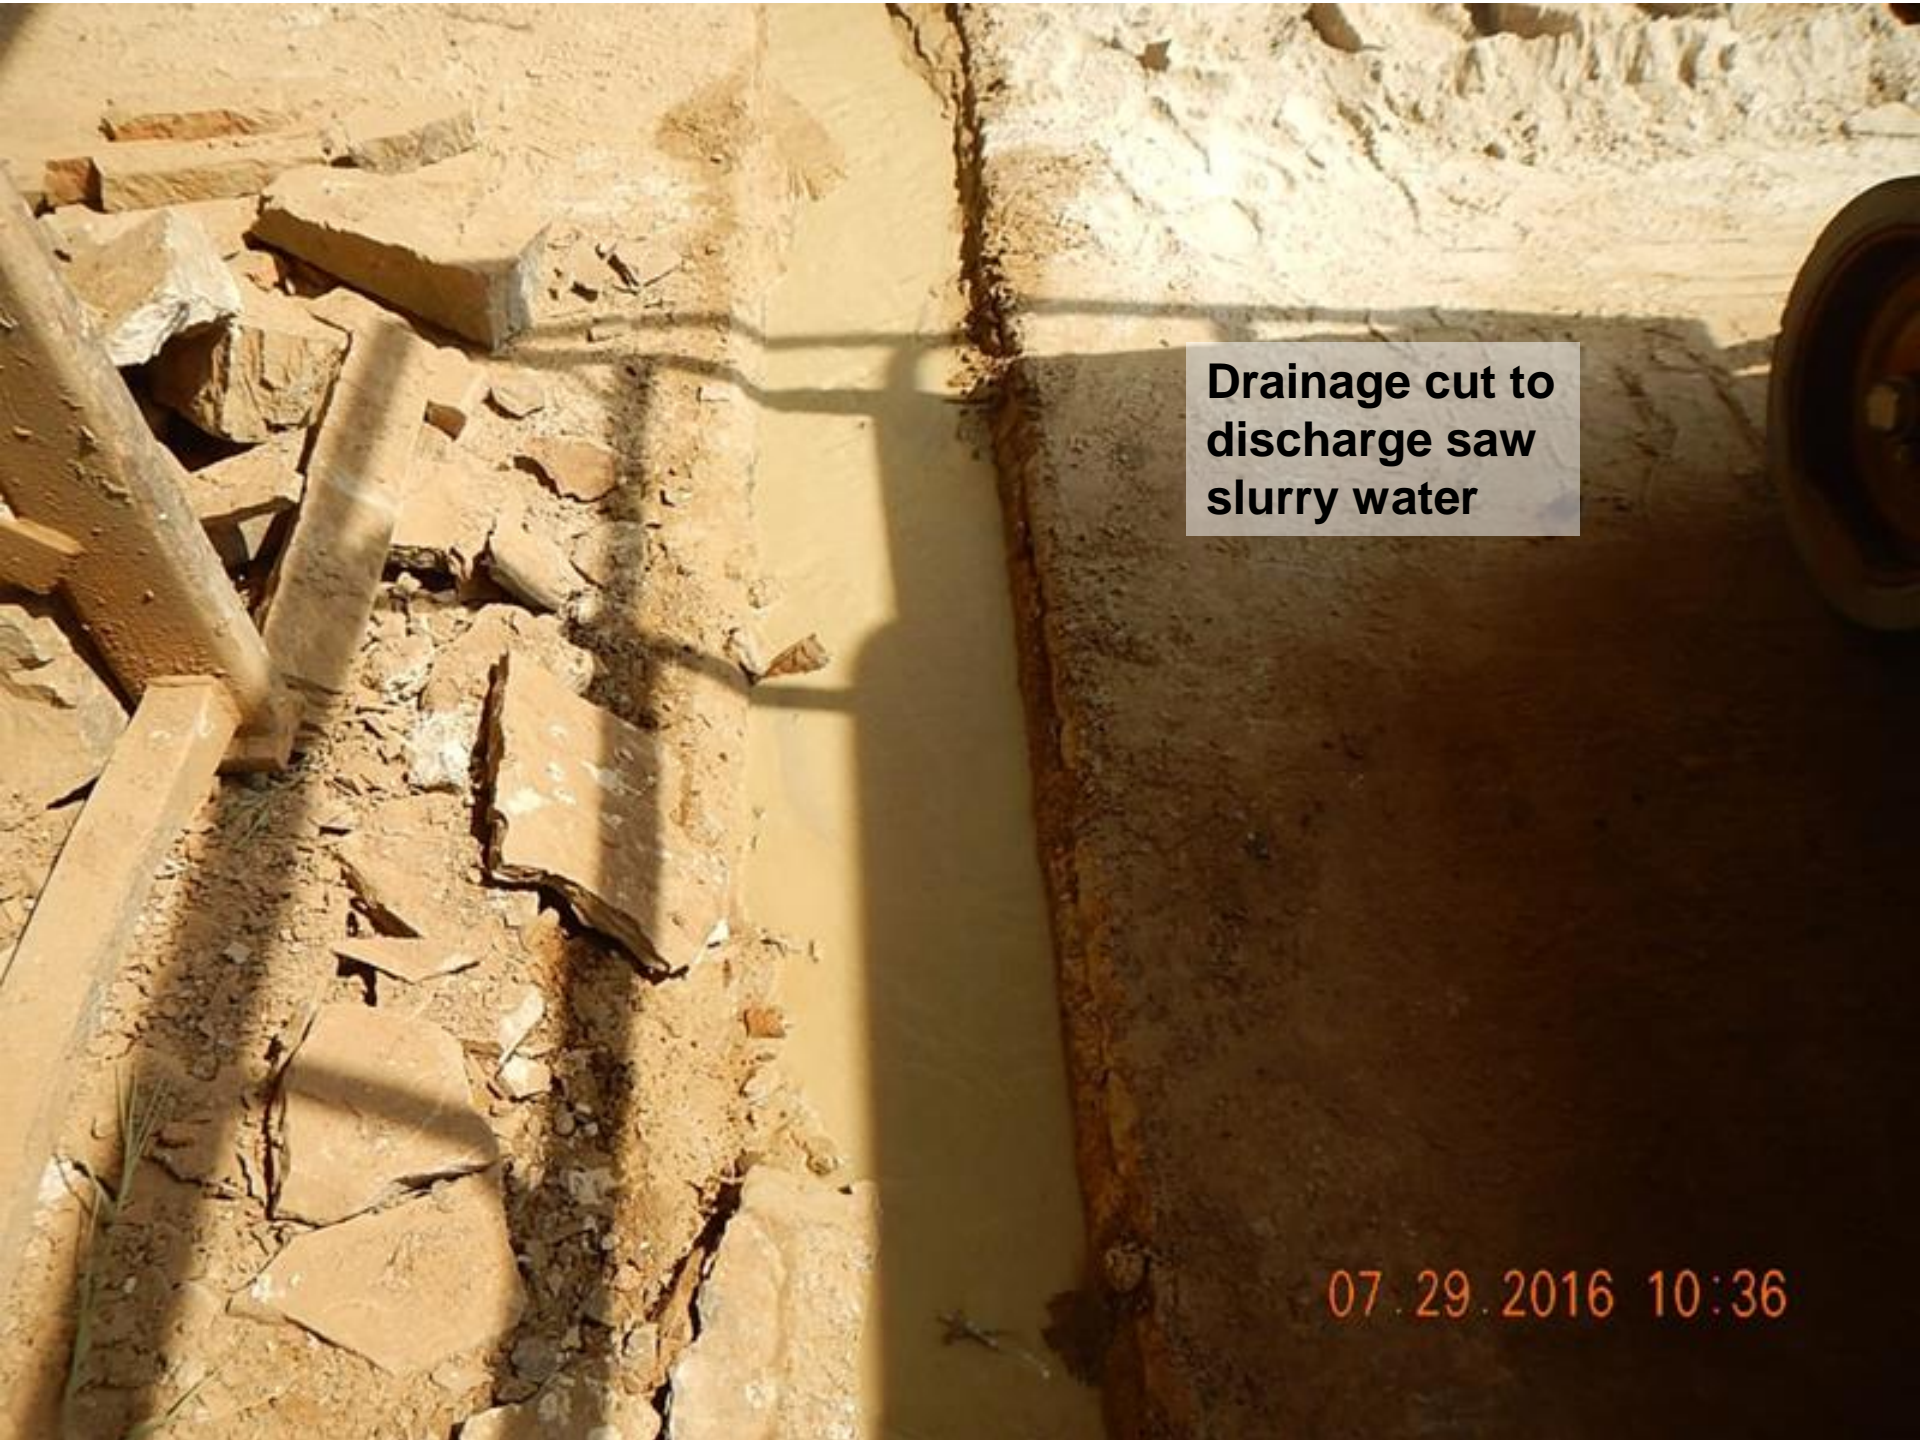
**Drainage cut to  
discharge saw  
slurry water**

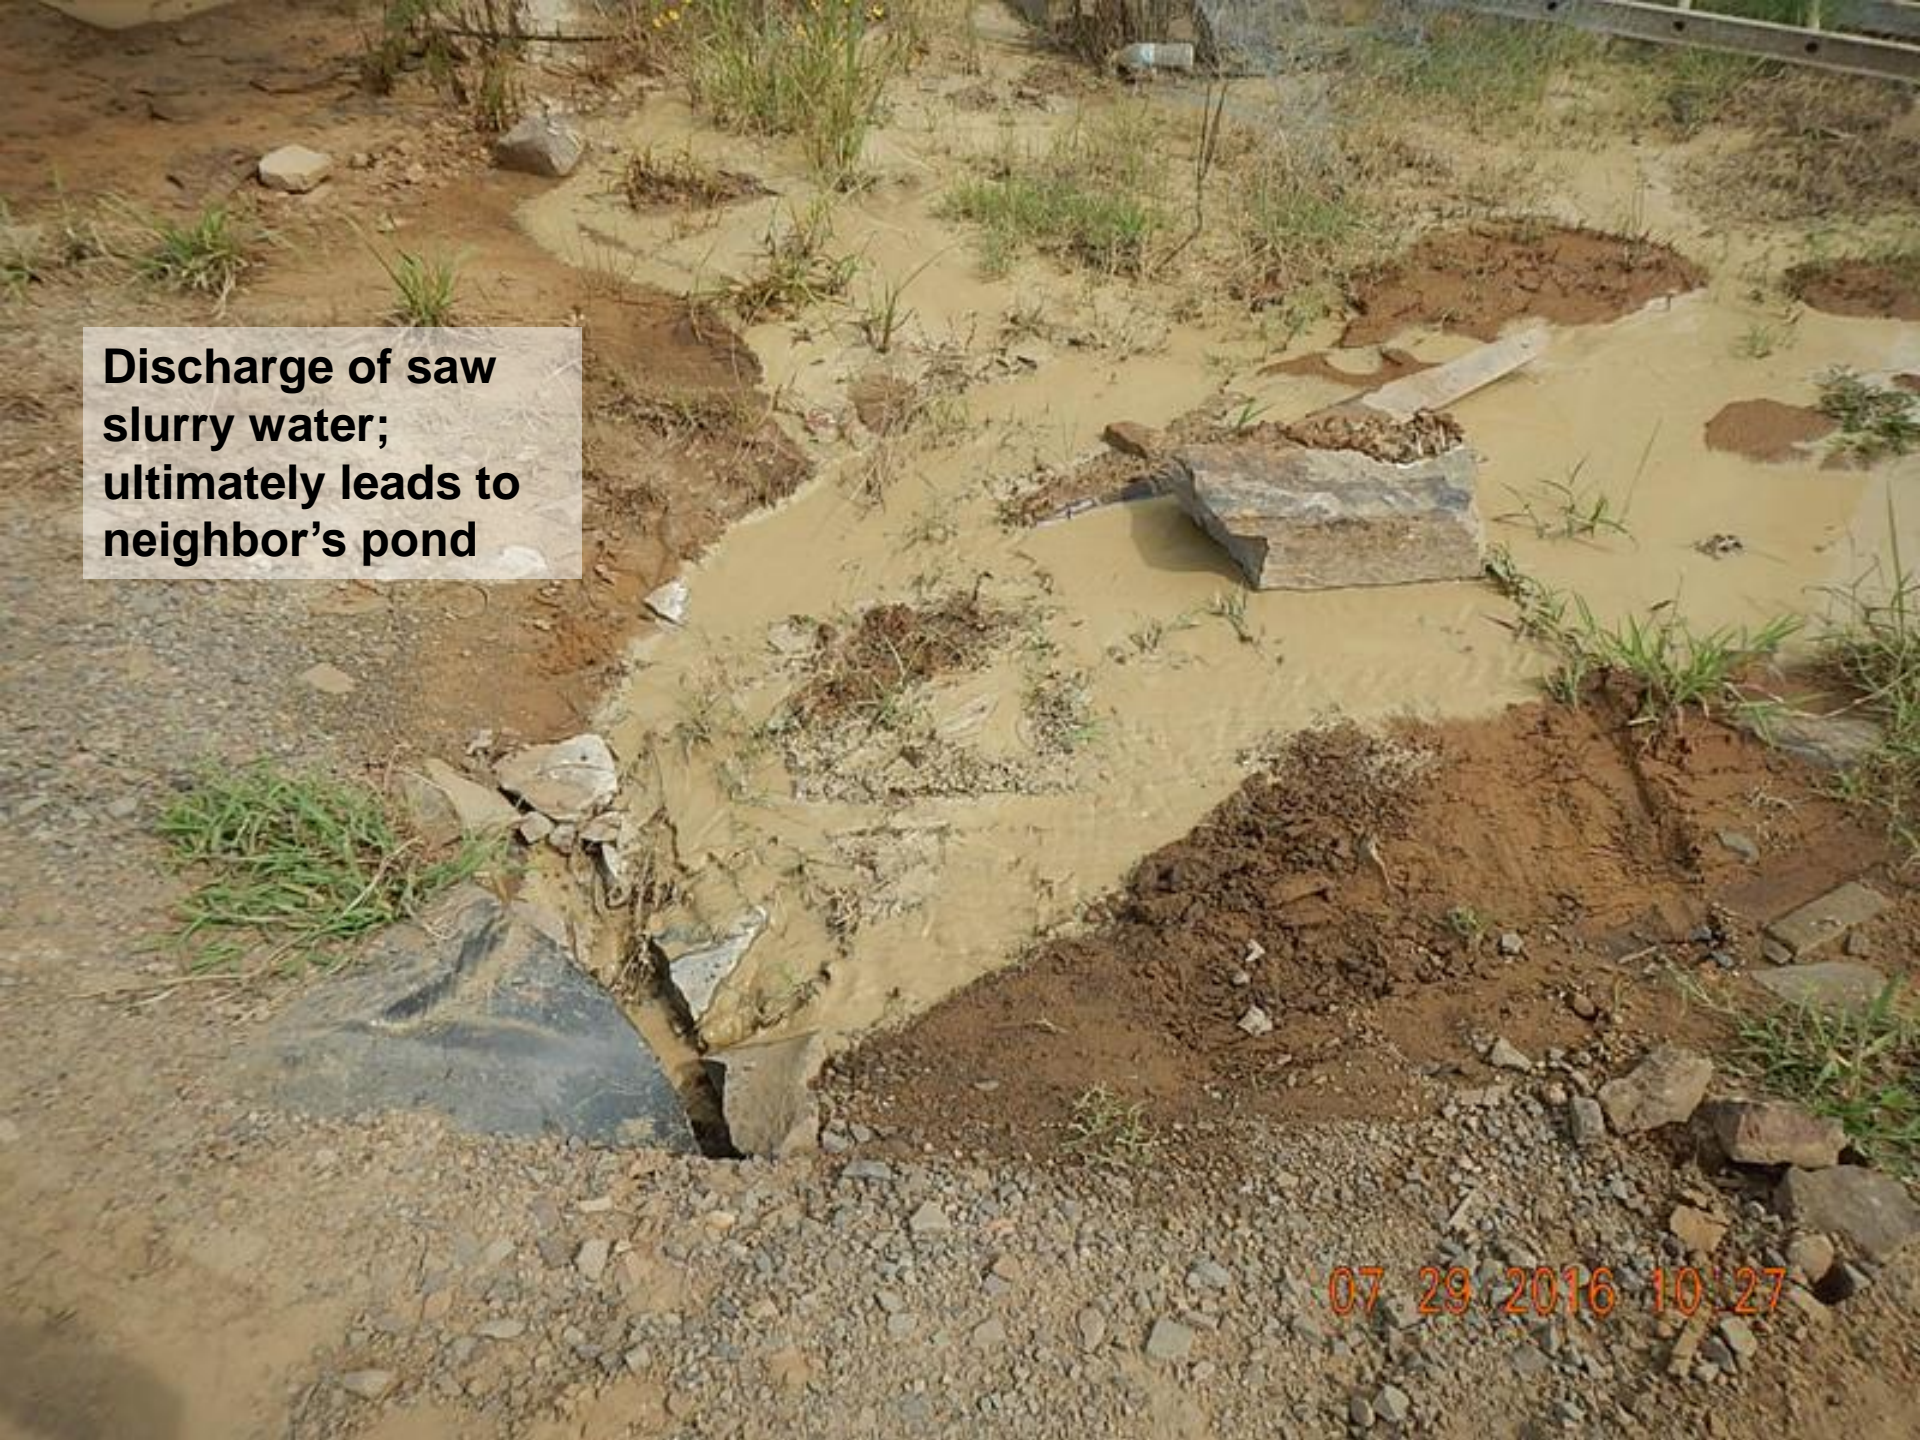
**Discharge of saw  
slurry water;  
ultimately leads to  
neighbor's pond**
