Northern & Central Watershed Protection Plan Project

Ahmed Mahmoud, Ph.D.
Civil Engineering Department
University of Texas Rio Grande Valley

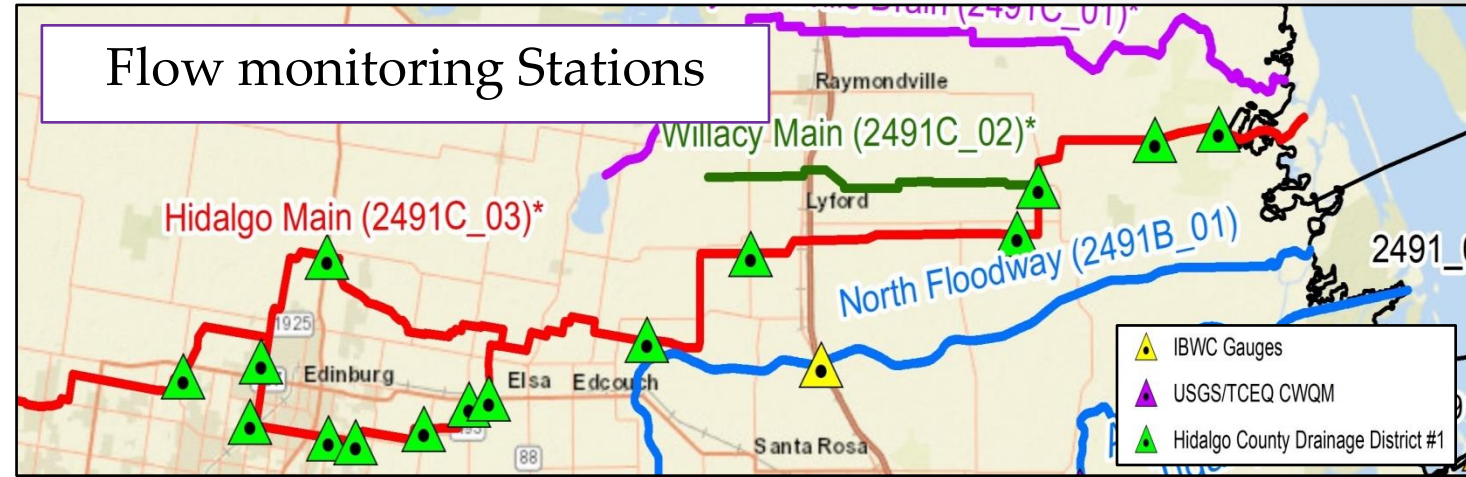
Monitoring Stations

16 Flow monitoring
Hidalgo County Drainage
District #1

Only **one** TCEQ water
quality monitoring station
(ID 22003)

New site started in 2018

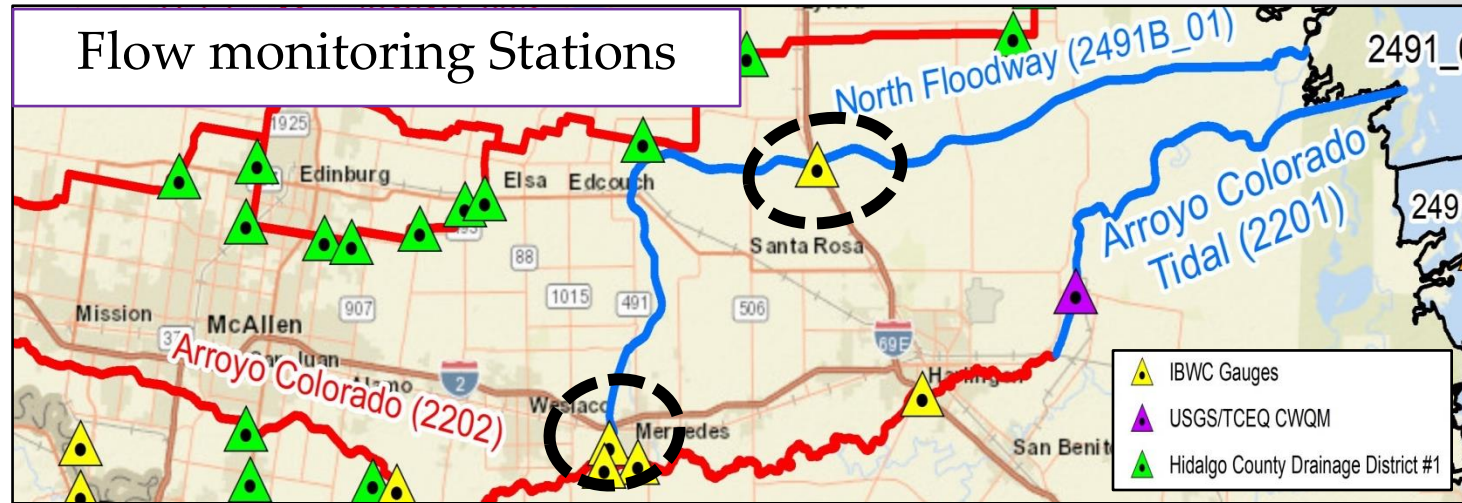
USIBWC North Floodway

2 Flow monitoring IBWC
(Since 2012)

Only **one** TCEQ water
quality monitoring station
(ID 20930)
