Lower Laguna Madre/ Brownsville Ship Channel Watershed Characterization 2018

Prepared by:

University of Texas –Rio Grande Valley, Brownsville

TCEQ Contract 582-14-41167

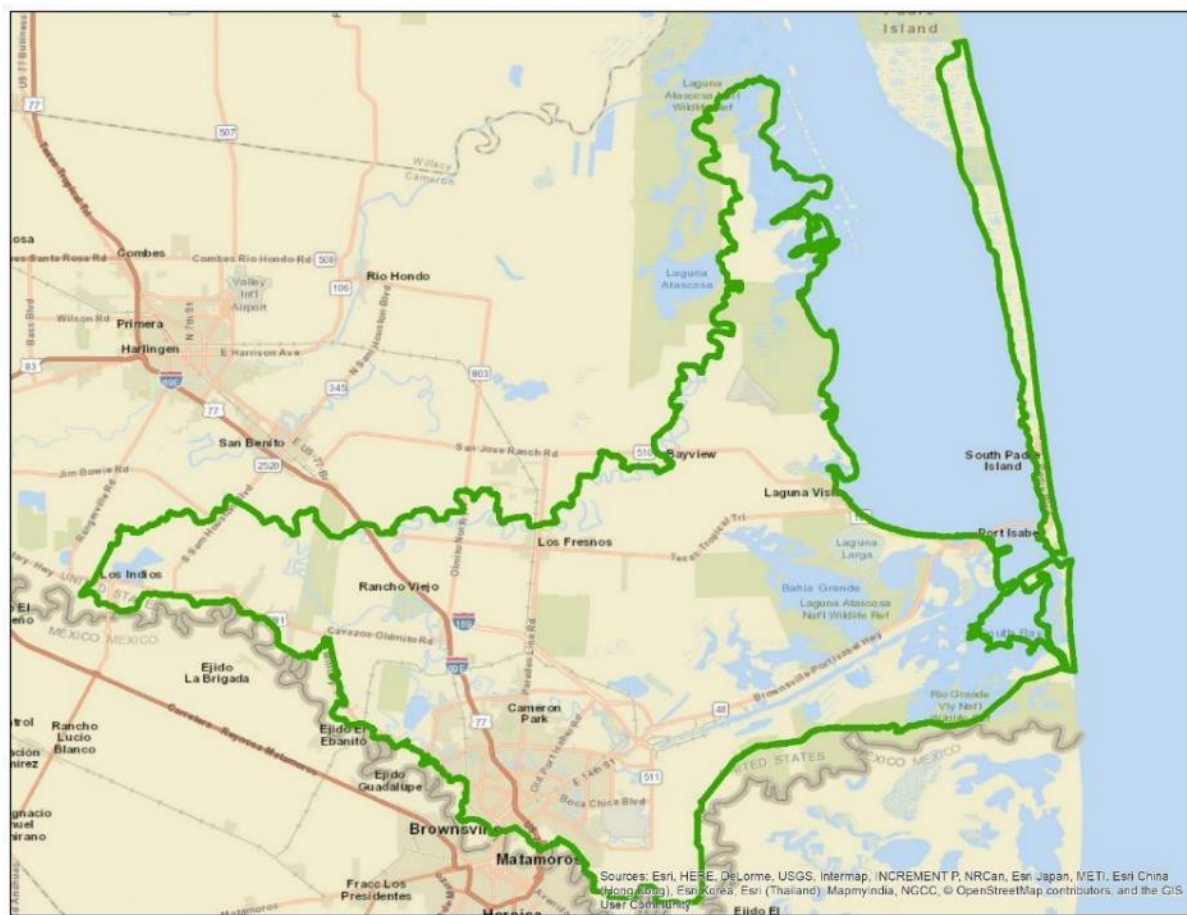
Figure 1-2. Boundary of the Lower Laguna Madre / Brownsville Ship Channel watershed.

Located entirely within Cameron County, Texas, the LLM/BSC watershed drains the southeastern-most landscape in the state (Figure 1-2). Low relief, sandy-clayey soils, hot summers and ample year-round sunshine strongly define this coastal sub-tropical region. The average annual precipitation is slightly more than 27 in. and over a third of it (10 in.) usually arrives during mid-August through October, when water temperatures in the Gulf of Mexico are peaked and tropical storms are more common (Figure 1-3). Evapotranspiration rates are typically 2 – 3 times greater than precipitation.
