# **Real-Time Hydrological Monitoring to Estimate Flow and Pollutant Loads in Brownsville Ship Channel, South Texas**

Iván René Santos Chávez, Ahmed Mahmoud, Ph.D.; and Abdoul Oubeidillah, Ph.D.; Andrew Ernest, Ph.D., PE  
Civil Engineering Department, University of Texas Rio Grande Valley, Edinburg, TX 78539

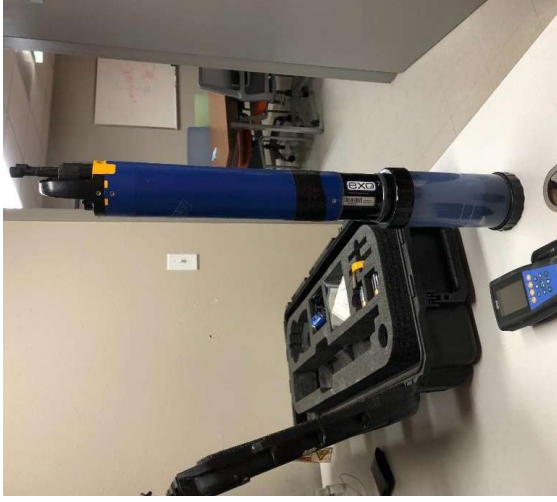
**Figure 3**  
EXO2 Multiparameter Sonde

- EXO2 Multiparameter Sonde
- ADCP: Acoustic Doppler Current Profiler
- Samples for Lab

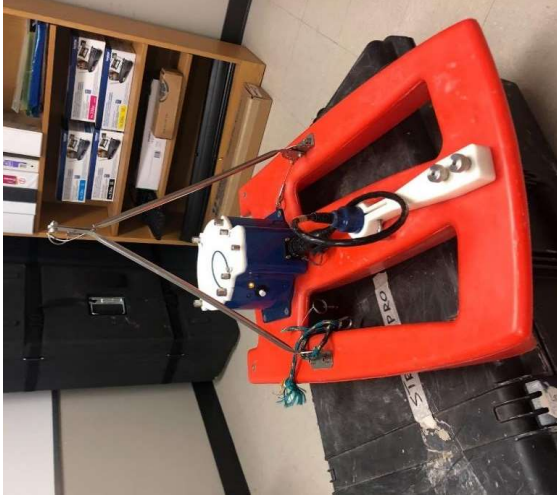
**Figure 4**  
ADCP

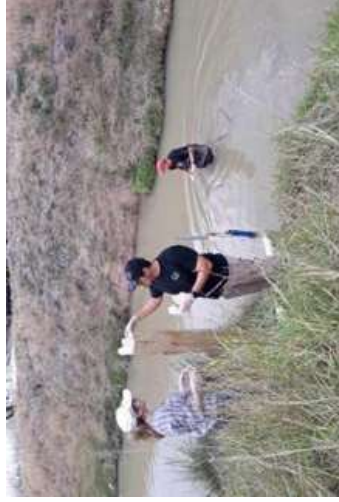
**Figure 5**  
Samples for Lab and Sonde EXO2 measurements

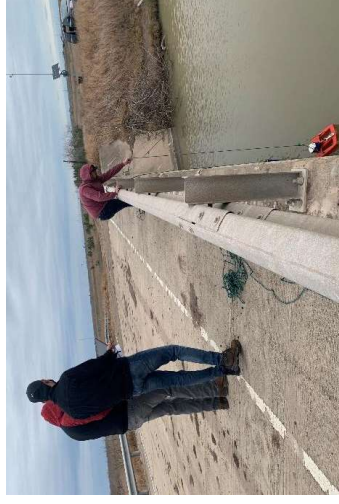
**Figure 5**  
ADCP measurements
