## Development of Cyberinfrastructure for Assessment of the Lower Rio Grande Valley North and Central Watersheds Characteristics

Linda Navarro  
April 20, 2020

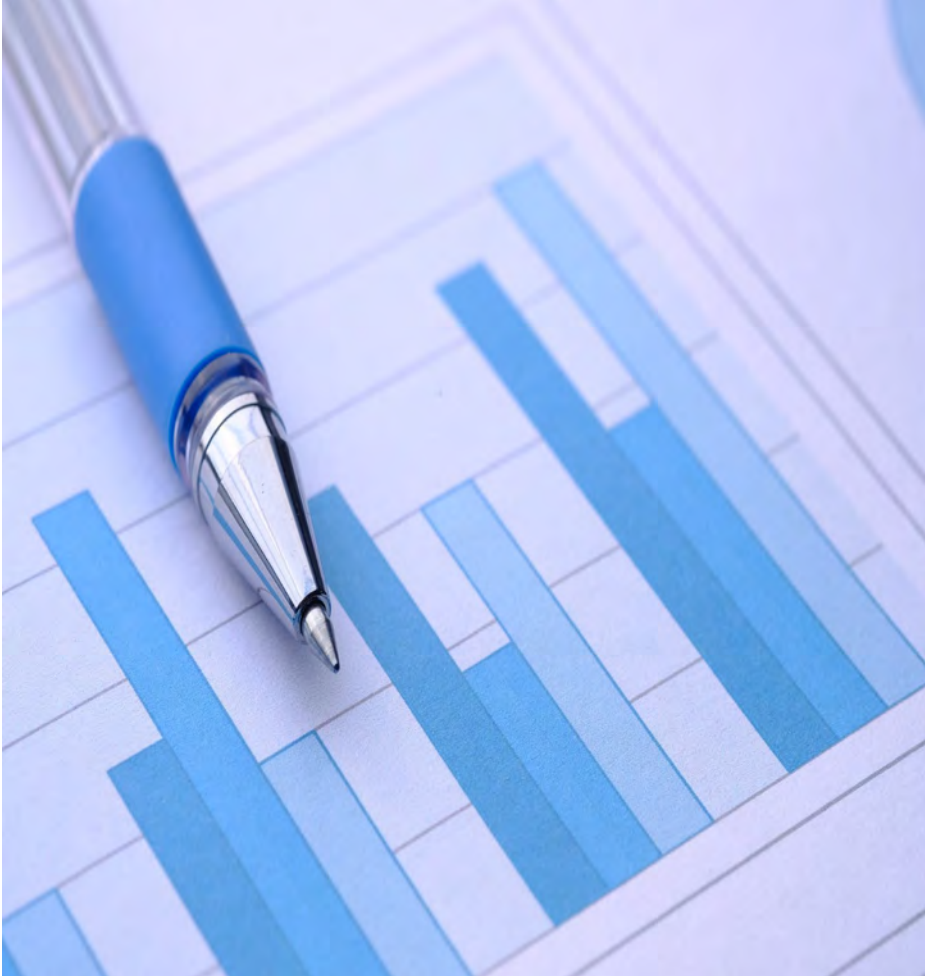
# Loading Concentrations

## Water Quality + Flow Data

### Hidalgo Willacy Main Drain

- Clean Rivers Program
- 8 Samples
- 2017-2019
