Best Management Practices (BMPs) and Water Quality Parameters of Selected Farms Located in the Arroyo Colorado Watershed

Texas Water Resources Institute EM-113

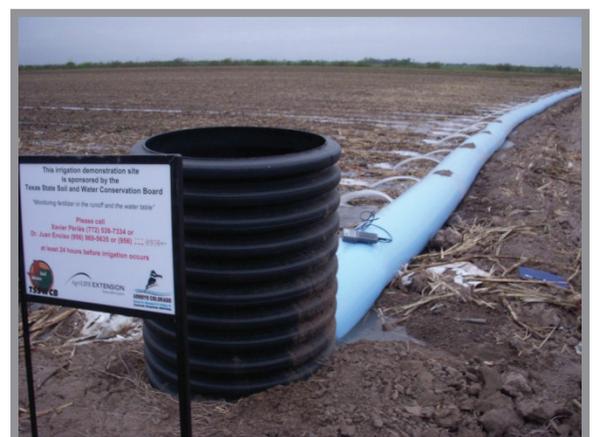
Figure 1: Irrigation poly pipe utilized during an irrigation event

Producers can implement multiple BMPs to protect the water quality of the Arroyo Colorado. The combination of multiple practices can create a greater impact of nutrient reductions to the Arroyo Colorado. Some practices such as land leveling with some grade and the use of poly-pipe facilitate irrigation management and thus, have an impact on improving yields and profits. The two BMPs that reduced nutrient runoff the most were nutrient management and irrigation management. Nutrient management typically consists of applying fertilizer at a specific rate according to a soil analysis test. Irrigation management includes controlling the total amount of water applied to the land focusing on using non-erosive flow-rates, thereby reducing runoff.

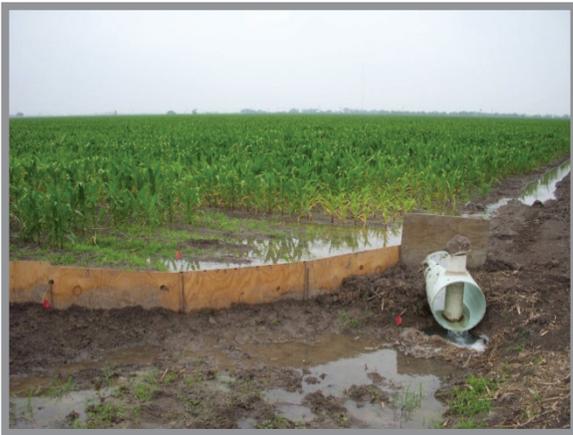
Figure 2: Runoff resulting from an irrigation event being measured.

2. The gains of nitrates, nitrites and total Kjeldahl nitrogen loadings from the fields were small. The activity that resulted in the highest influence on nutrient loadings was the amount of runoff. This could be reduced through improved irrigation management.
