# **Industrial Stormwater Success Stories: From Clueless to Superstars**

18<sup>th</sup> Annual USEPA Region 6 SW/MS4 Conference

Kerri McCabe, Inspector Supervisor

ADEQ – Office of Water Quality

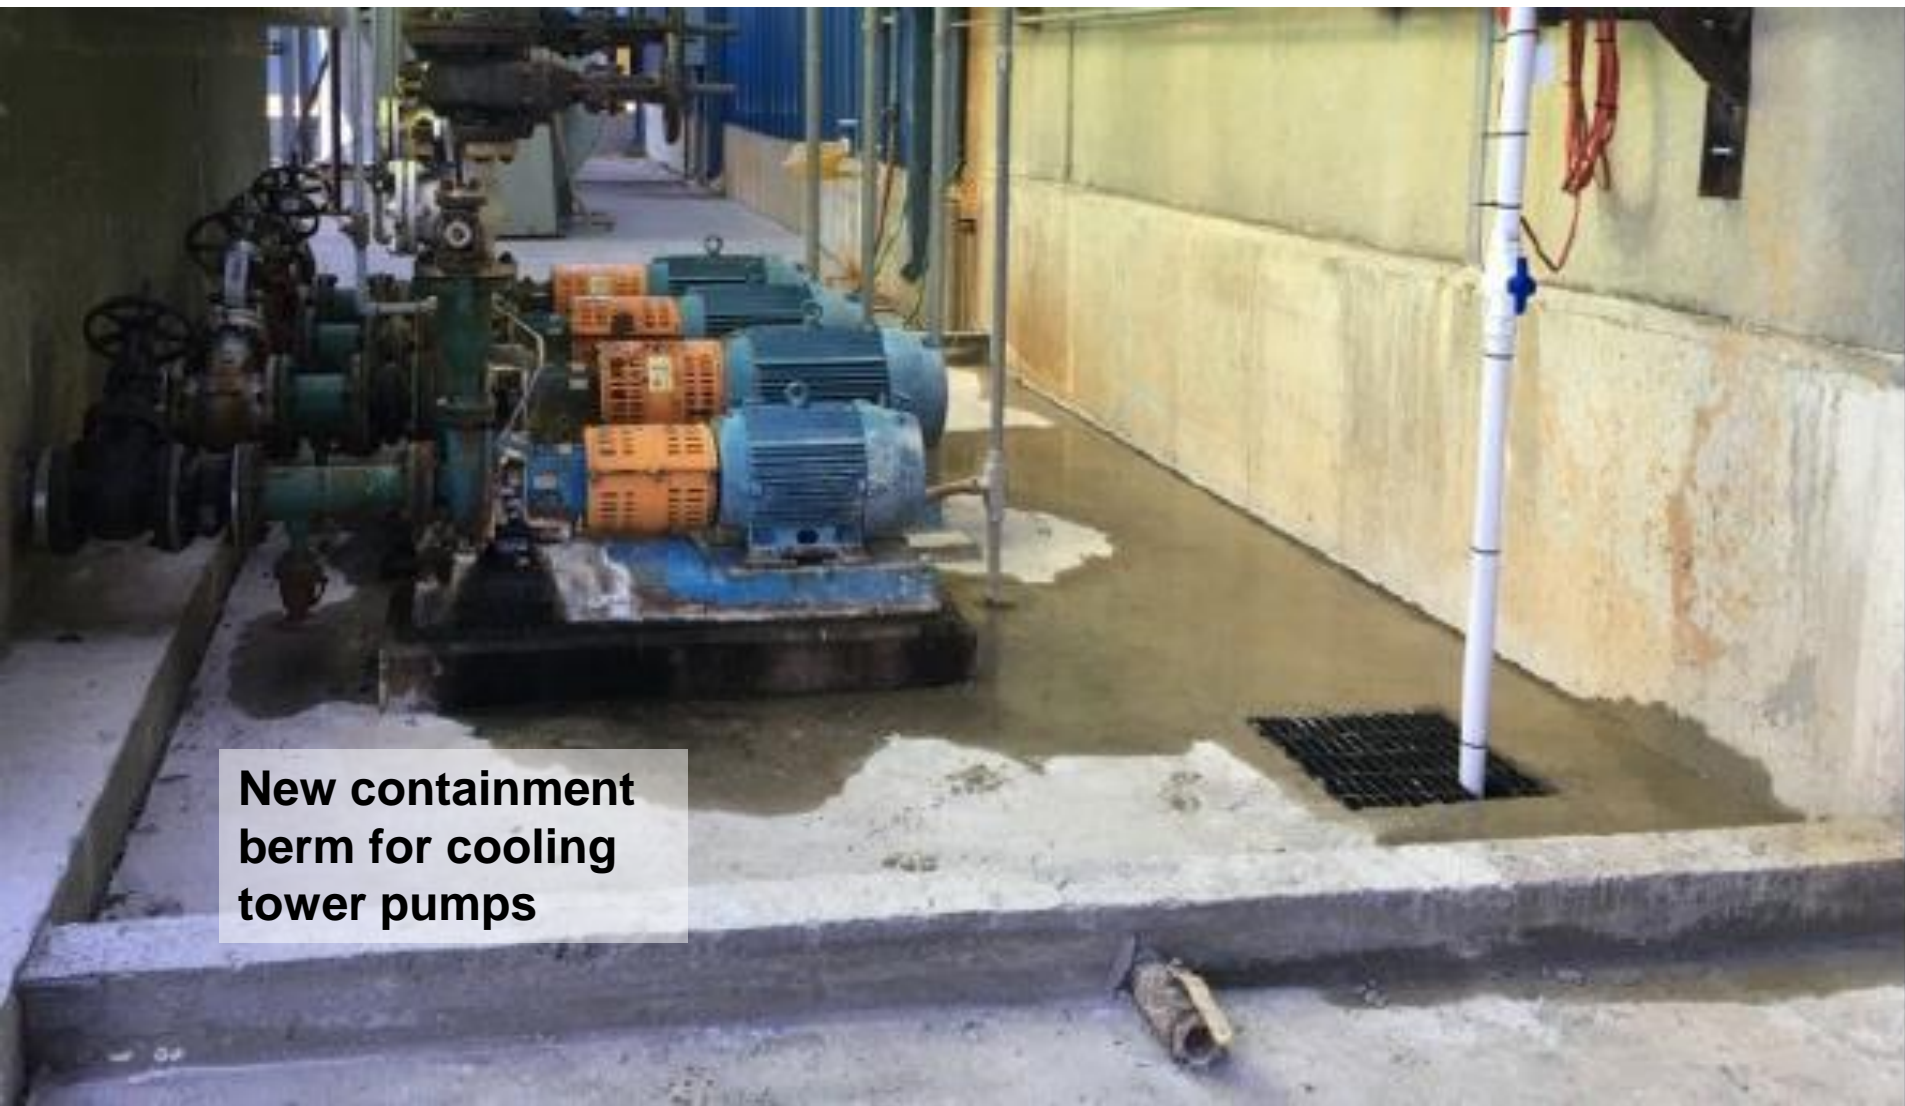
**New containment  
berm for cooling  
tower pumps**

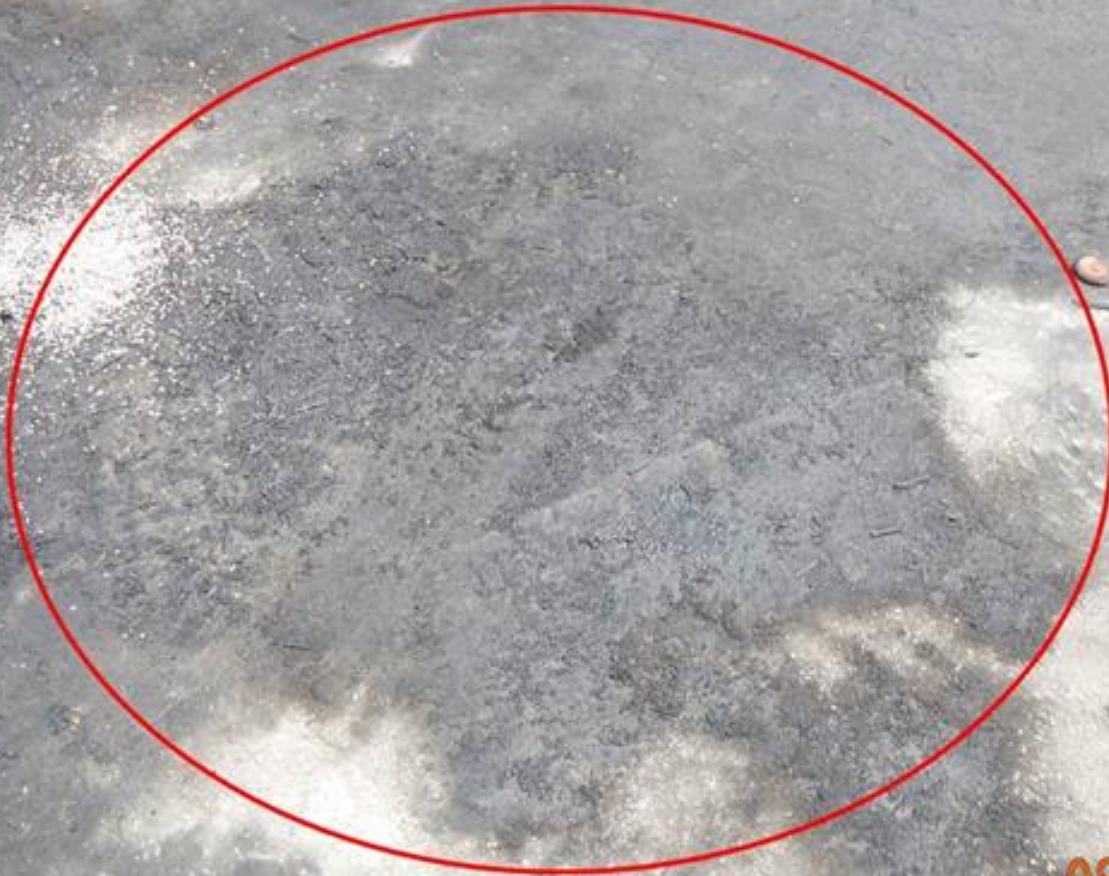
08.04.2016 12:13

**Spill that is not  
properly cleaned**

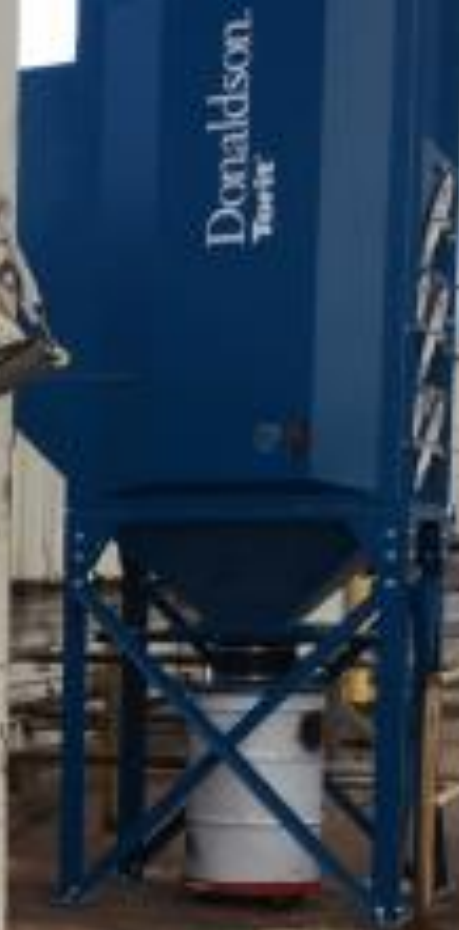
**Residuals  
cleaned from  
baghouse**

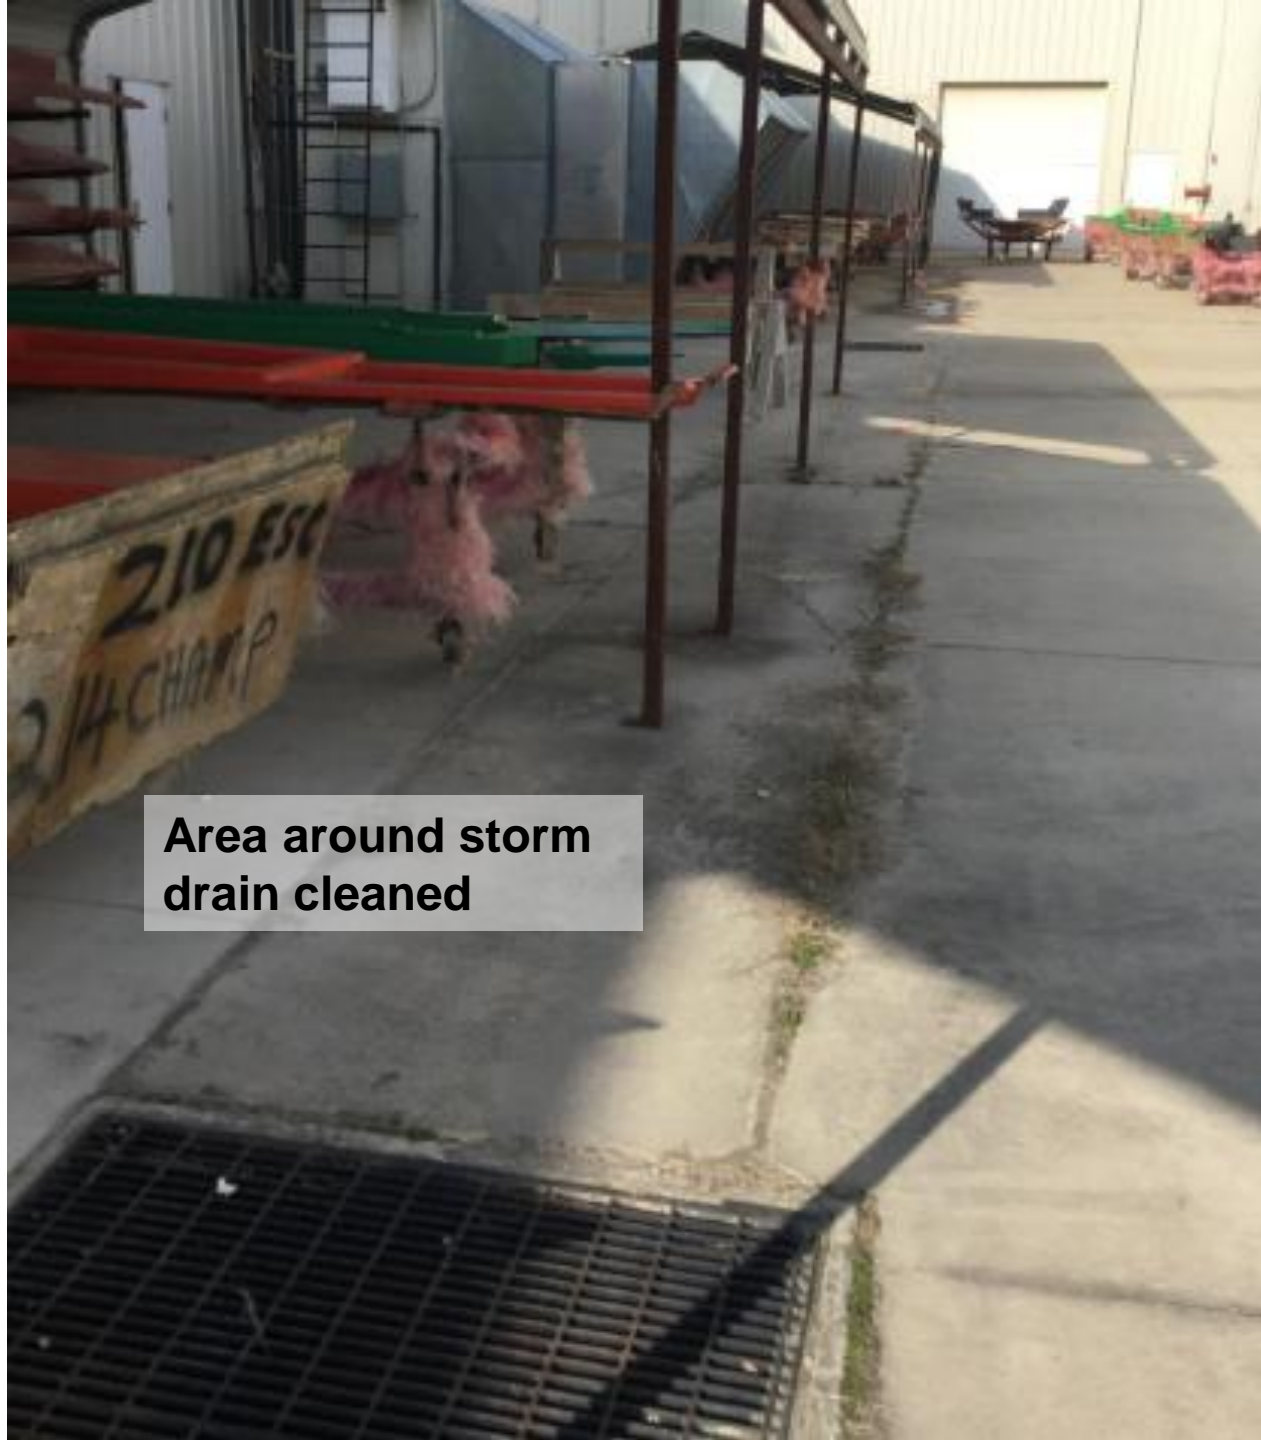
**Area around storm  
drain cleaned**

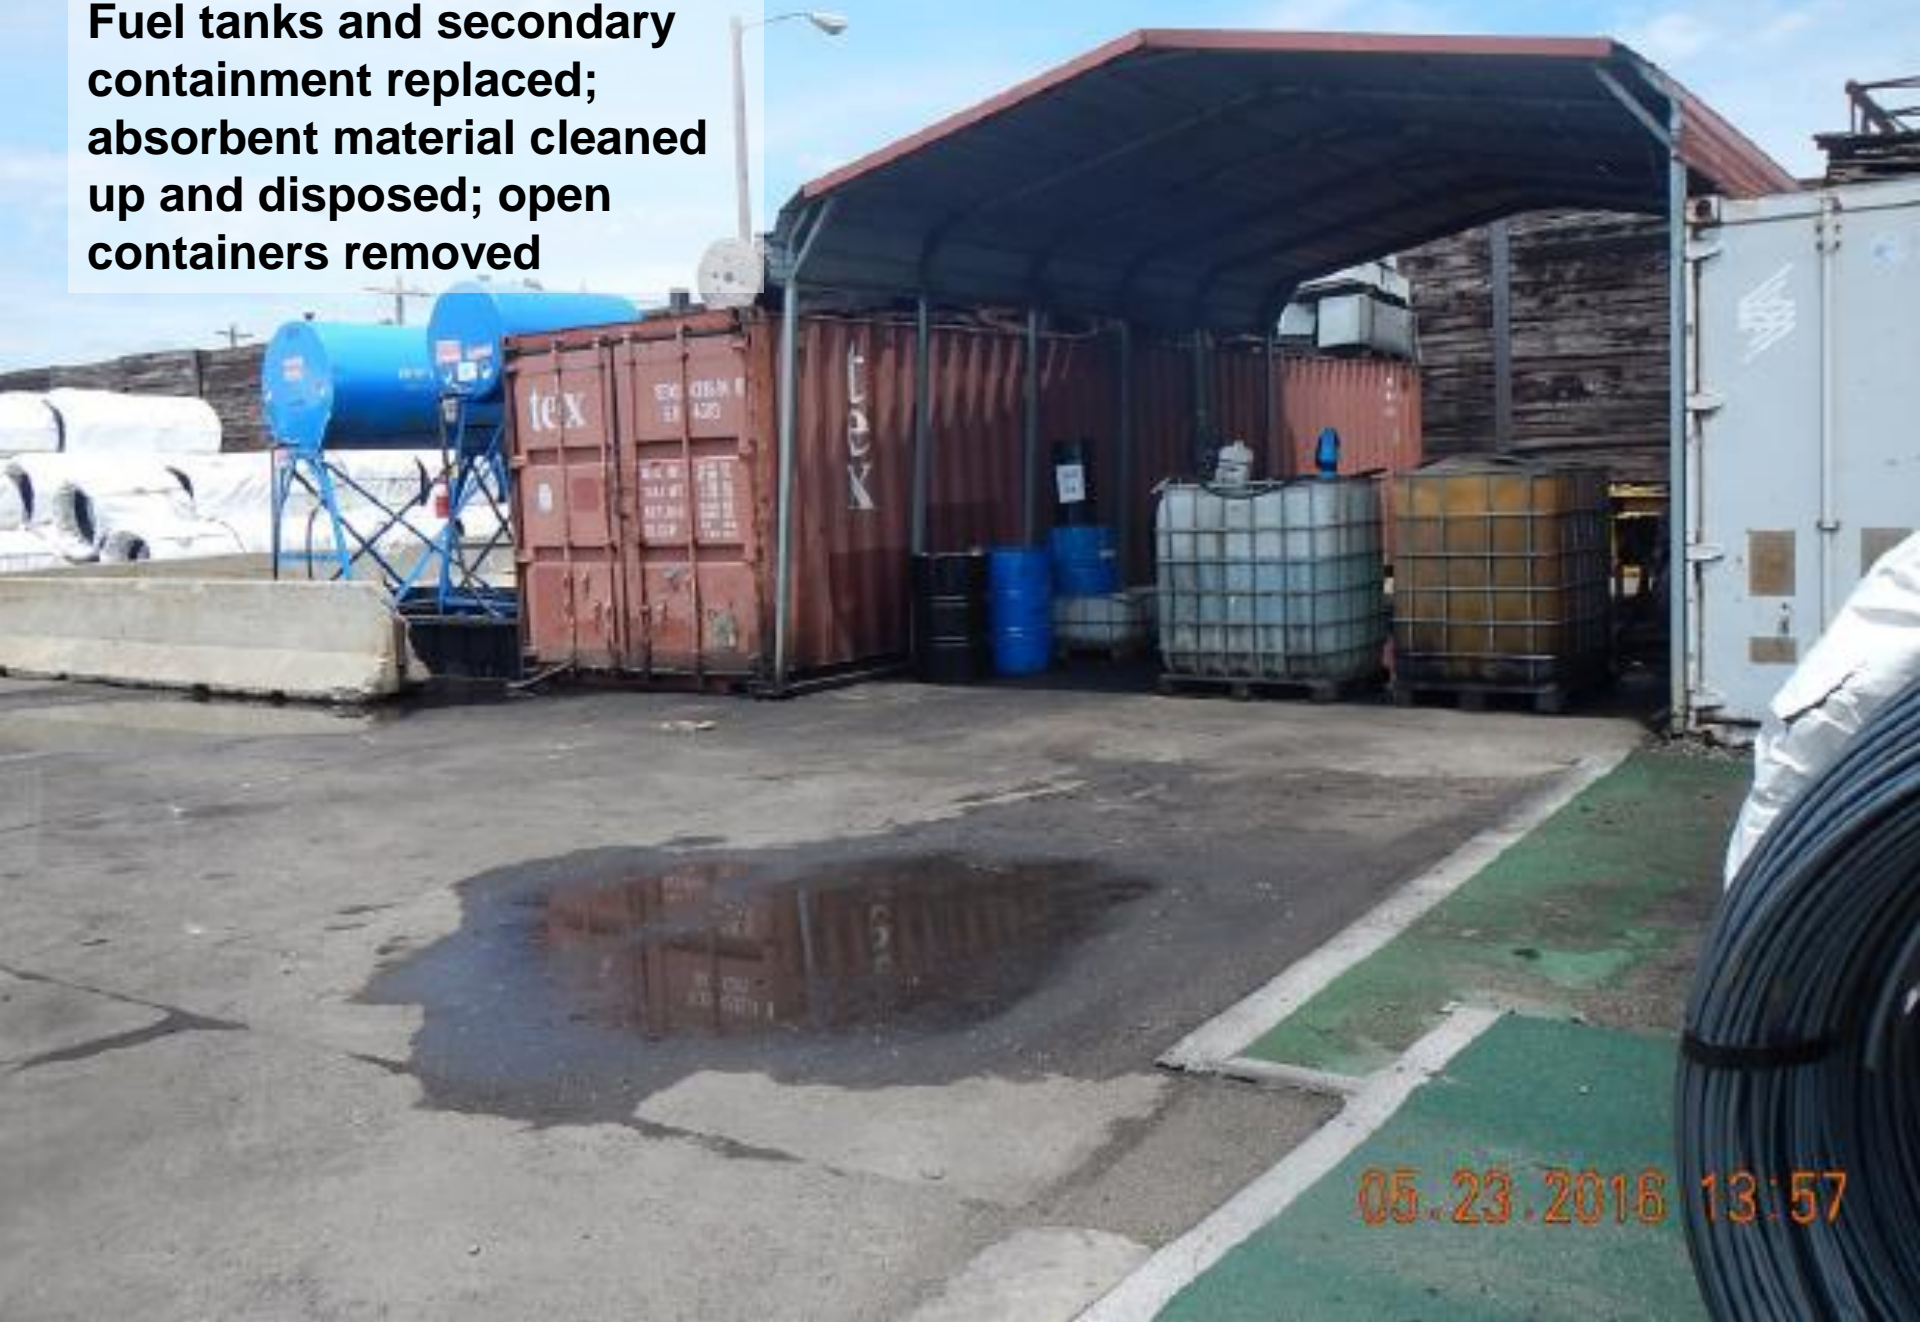
**Fuel tanks and secondary  
containment replaced;  
absorbent material cleaned  
up and disposed; open  
containers removed**

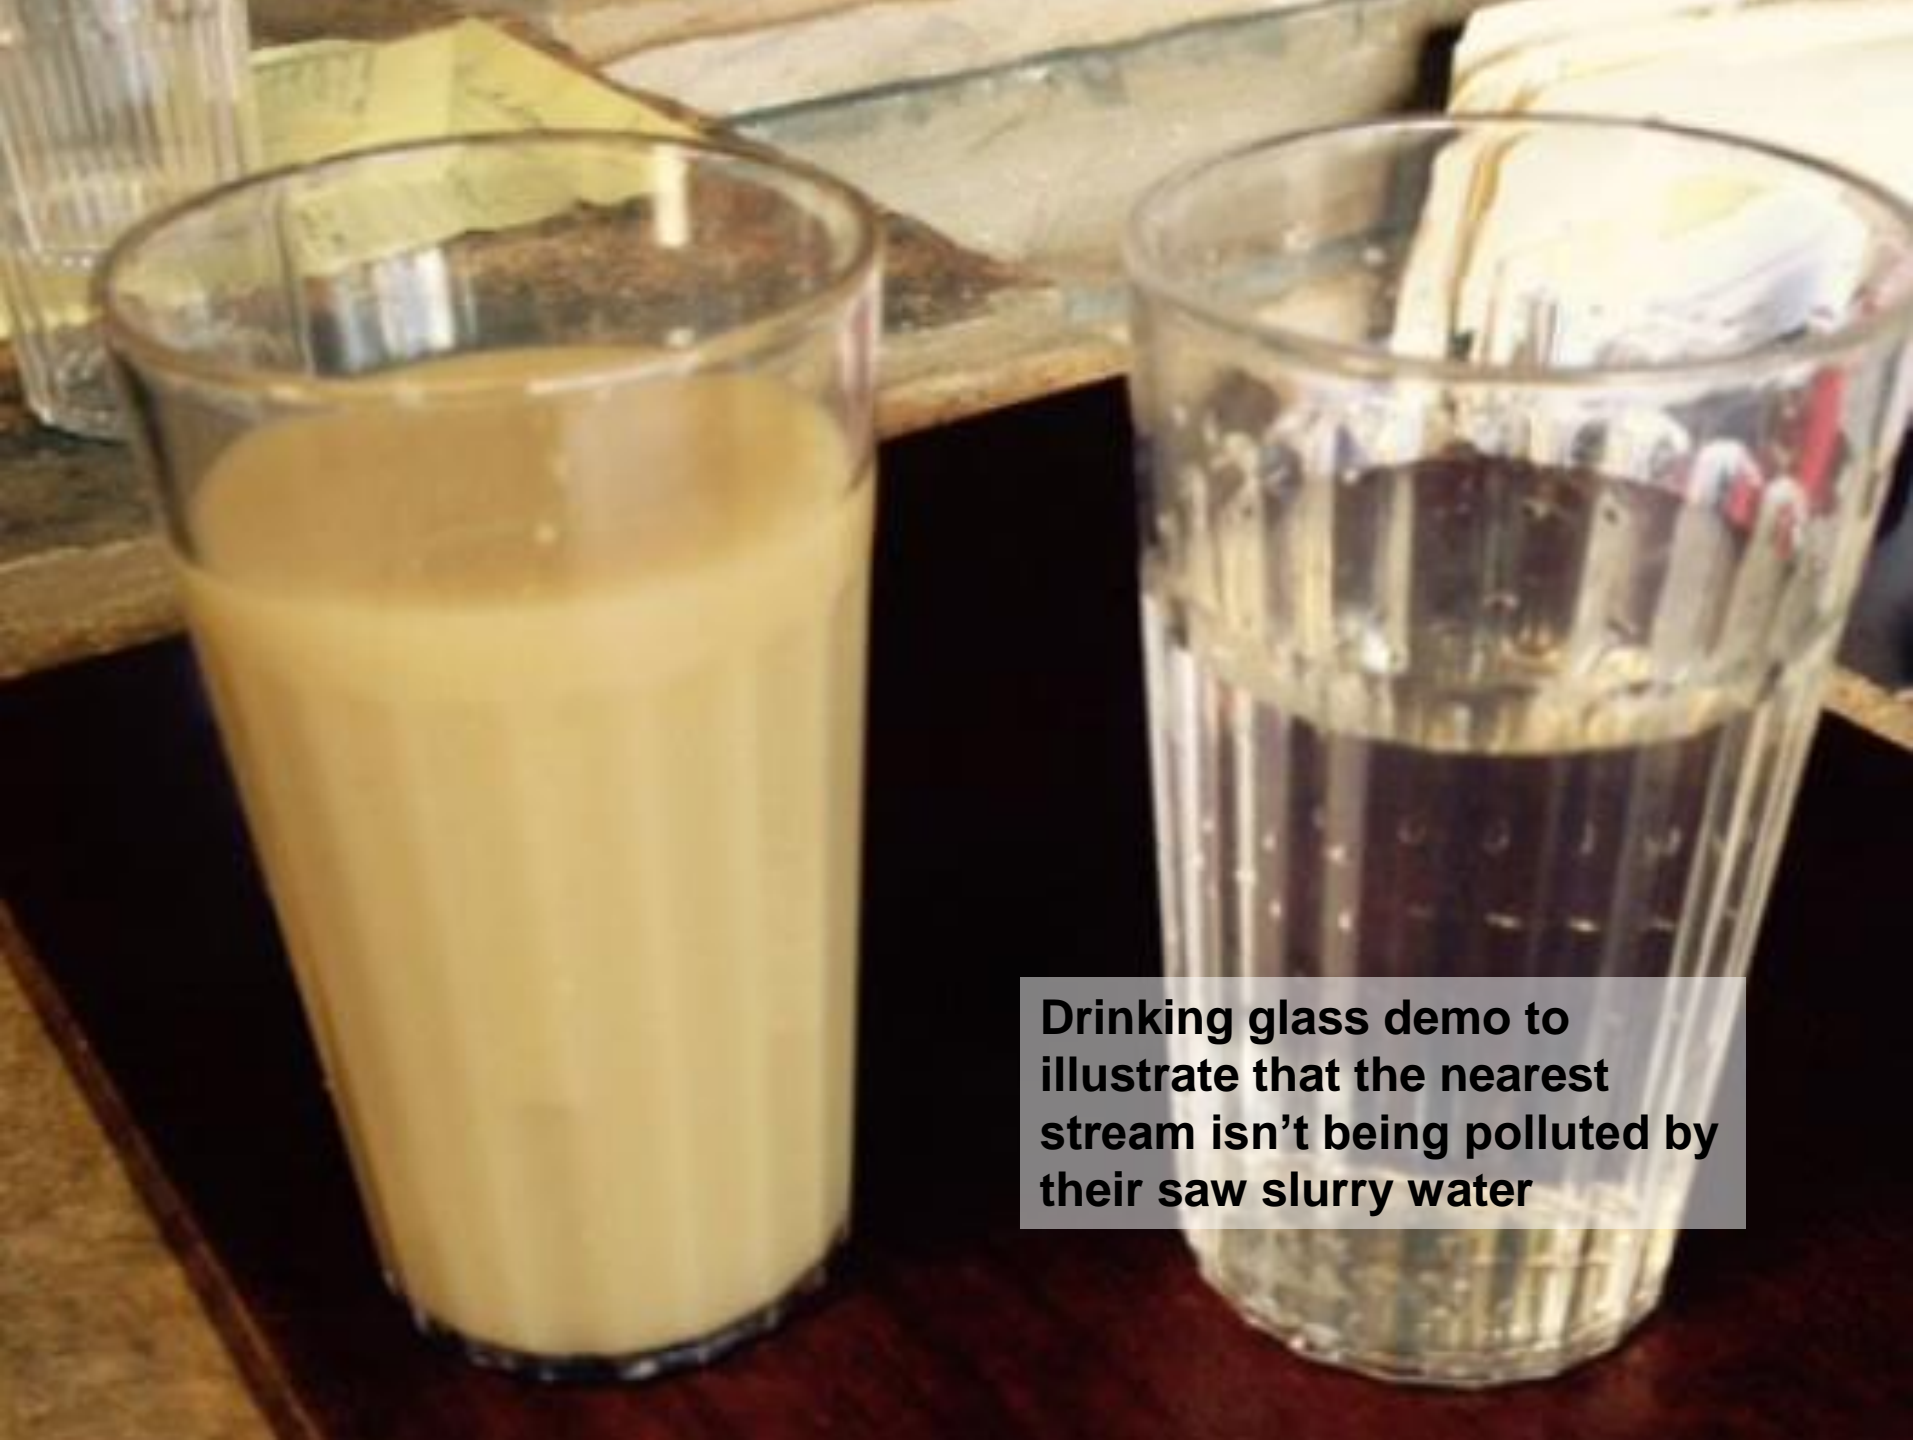
**Drinking glass demo to illustrate that the nearest stream isn't being polluted by their saw slurry water**
